# **SUMPTER WHARF OAMARU CONSERVATION REPORT**

Structural Assessment of Sumpter Wharf Oamaru  
For the NZ Historic Places Trust, North Otago Branch

**SUMPTER WHARF  
INSPECTION REPORT**

September 2011

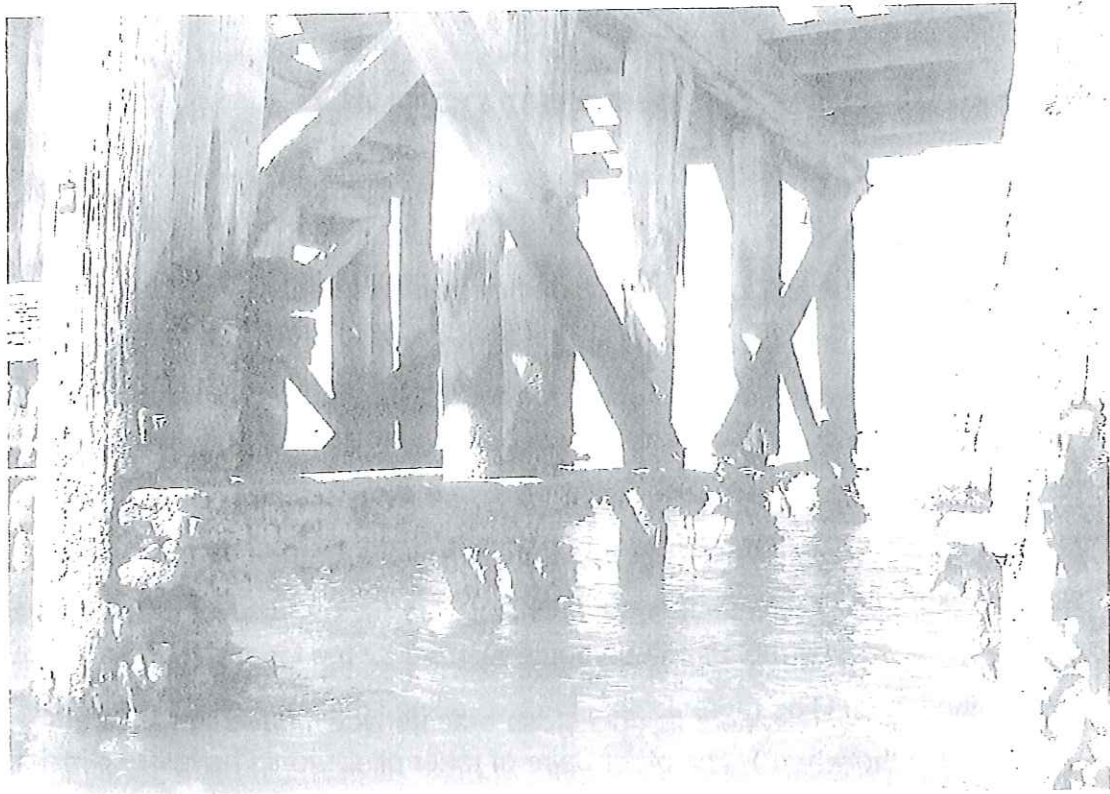
Typical Bankia attack near low tide levels on the lower waling of the pile bracing system.

Notice also the Limnoria pile thinning that has occurred around the half tide mark.

The 'hour glass' type erosion of the piles indicates that Limnoria is the predominant cause of decay. This borer also known as the gribble or ship worm, has a woodlice shape and burrows through sound timber just below the surface with the attack concentrated around the low water mark.

Where a pile cross section has diminished to less than 160 dia then strengthening of the pile with a concrete sleeve is recommended.

Where Bankia attack is minor cavities can be plugged with an underwater plaster mix and the pile wrapped. Capacity of the pile will then be based on Limnoria thinning of the pile as above. Piles that have Bankia/Limnoria attack leaving minimum pile diameter between 160mm and 250mm of sound timber should be protected from further decay with the installation of "Denso Seashield" pile protection wrapping.

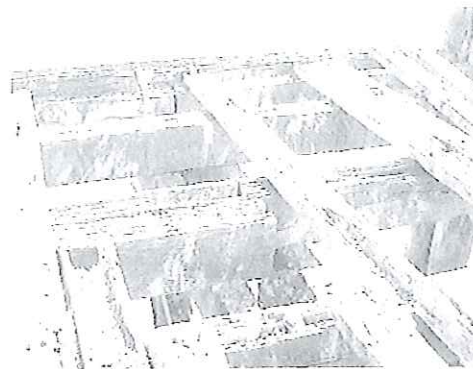
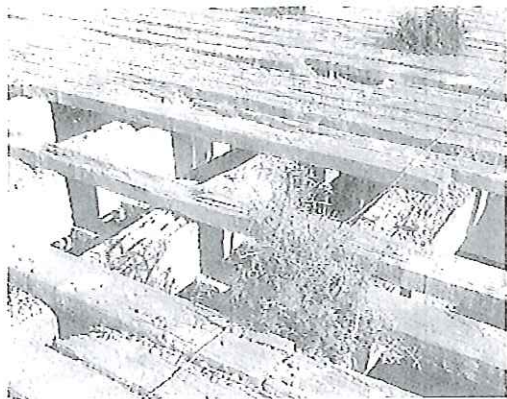
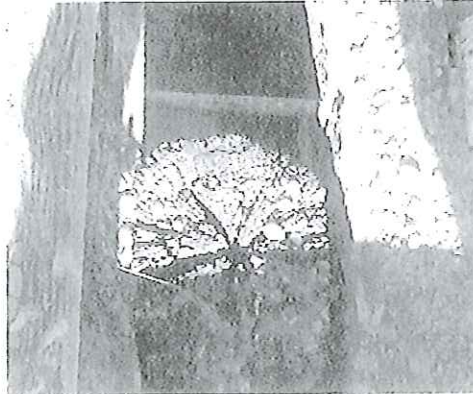
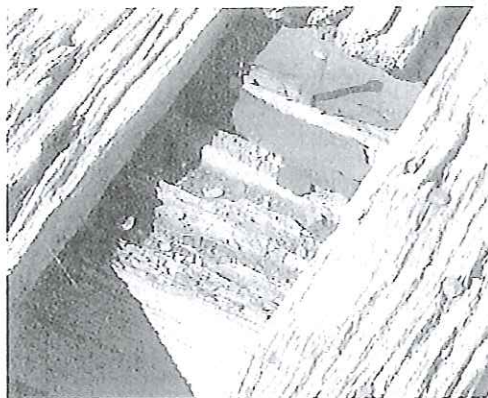
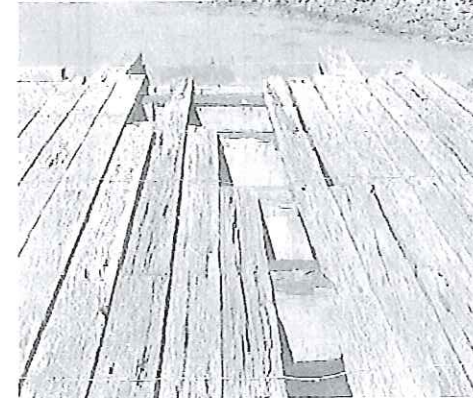
Deterioration caused by fungus flourishing in areas where rainwater has been able to accumulate and dampen the timber for long periods of time. Note that where Malthoid has survived the ravages of time the beams underneath are in much better condition. (Stones have been deposited on the wharf by Spotted Shags.)

6. Decayed Pile Tops. Where the decay does not penetrate to where the bearers are seated on the rebates in the pile the tops can be cleaned with high pressure water blasting, treated with "C N" then protected from rainwater with a covering of "Multiseal."  
Where decay adversely affects the strength of the pile / cap joint the decayed top of the pile can be removed and a new top spliced in place or, alternatively if the damage is less severe, corbels can be installed to increase the load bearing area.

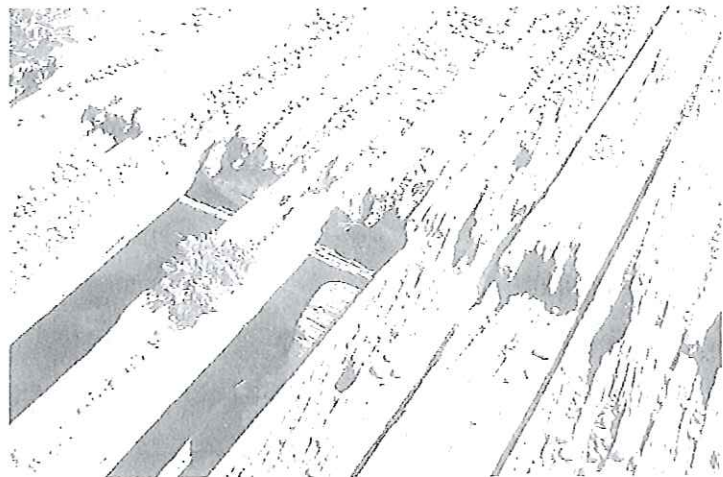
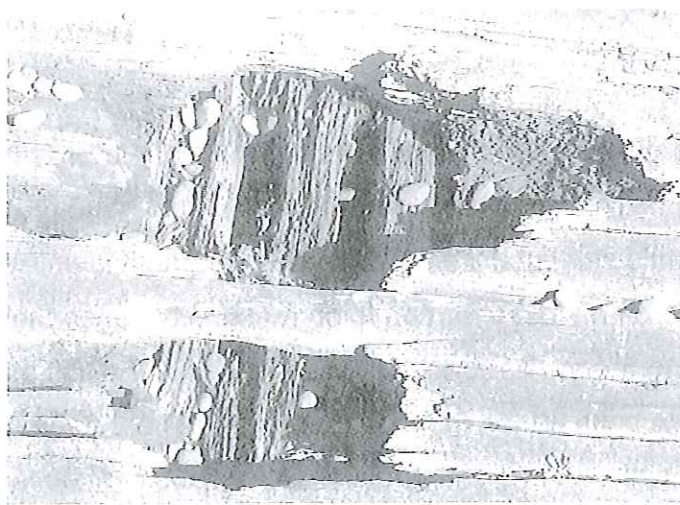
Rainwater was trapped in the dust & debris under the rail and fungus attack created cavities for the trapping of further moisture.

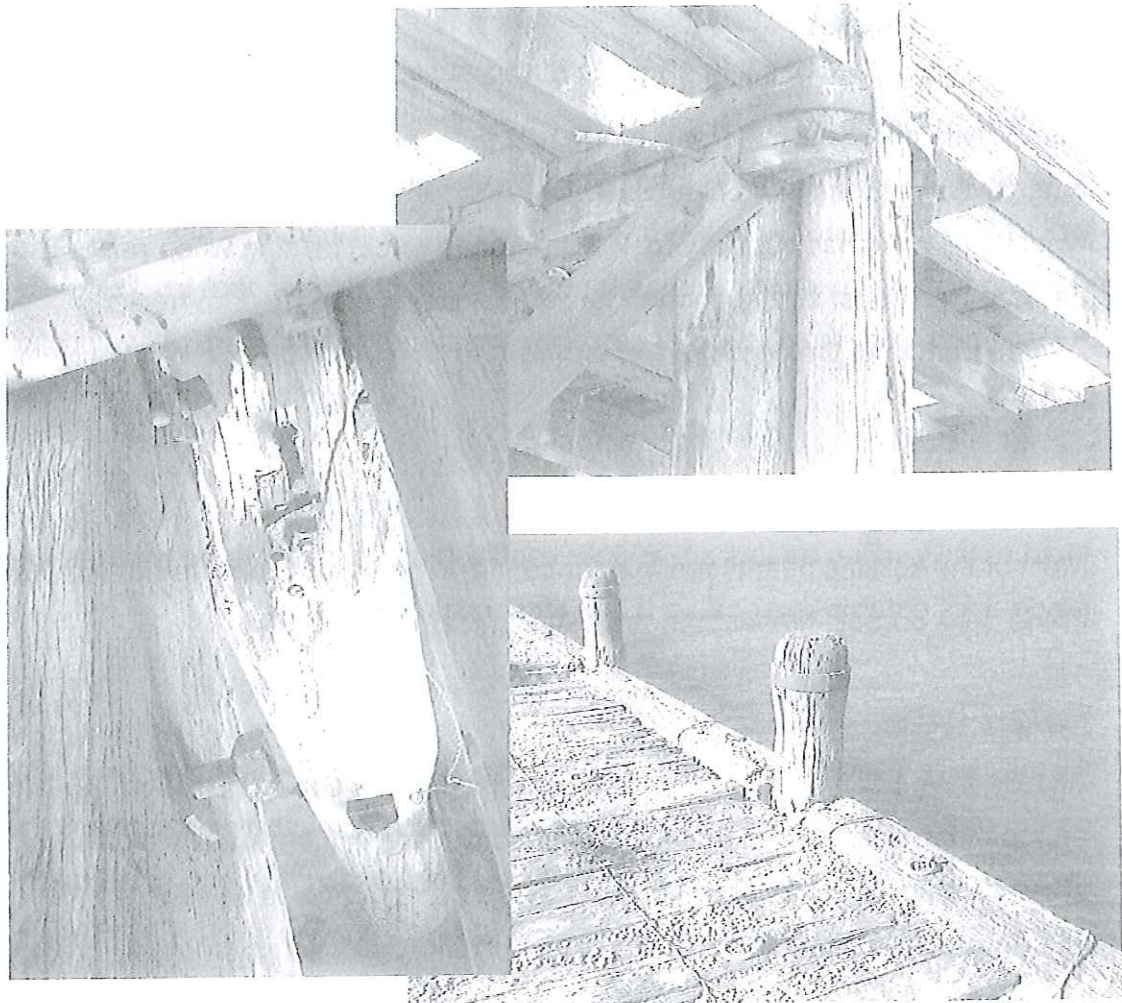
Examples of the original forged iron bolts, straps and rings that have survived in relatively good condition after 120 years.

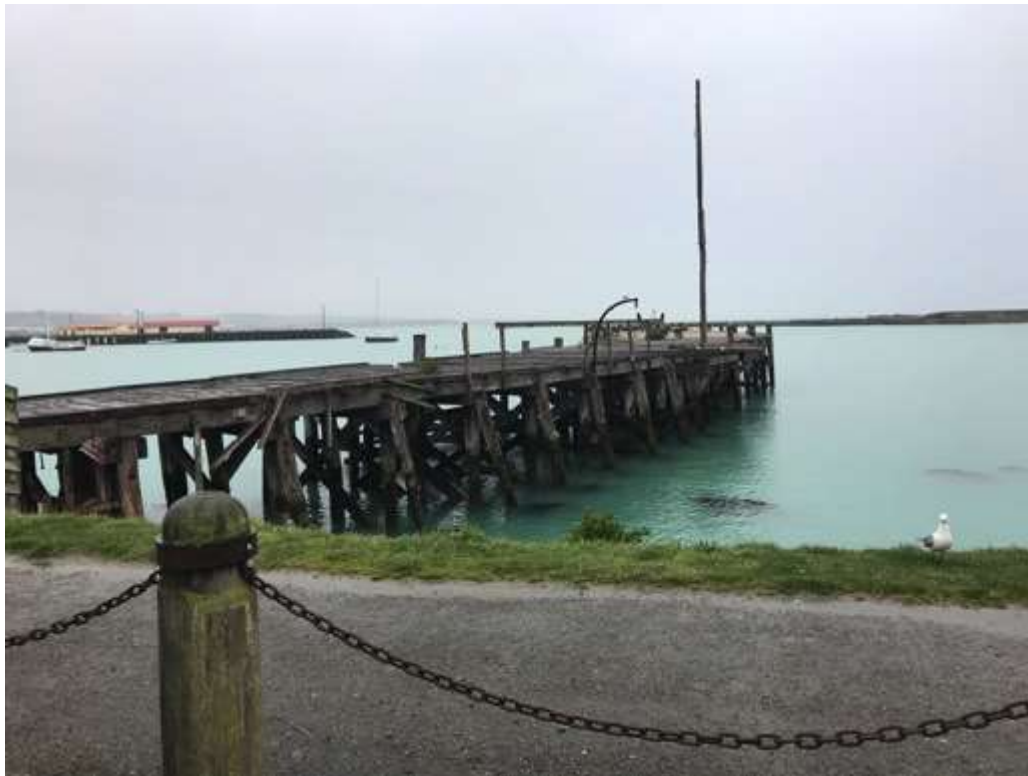
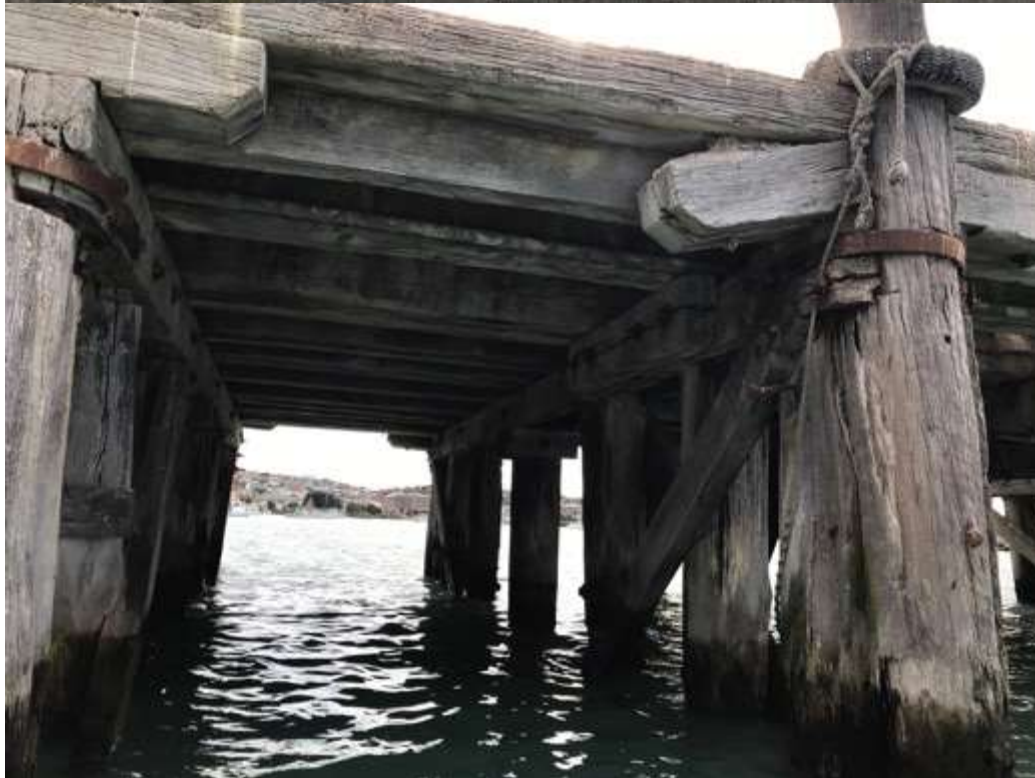
Outer section of wharf.

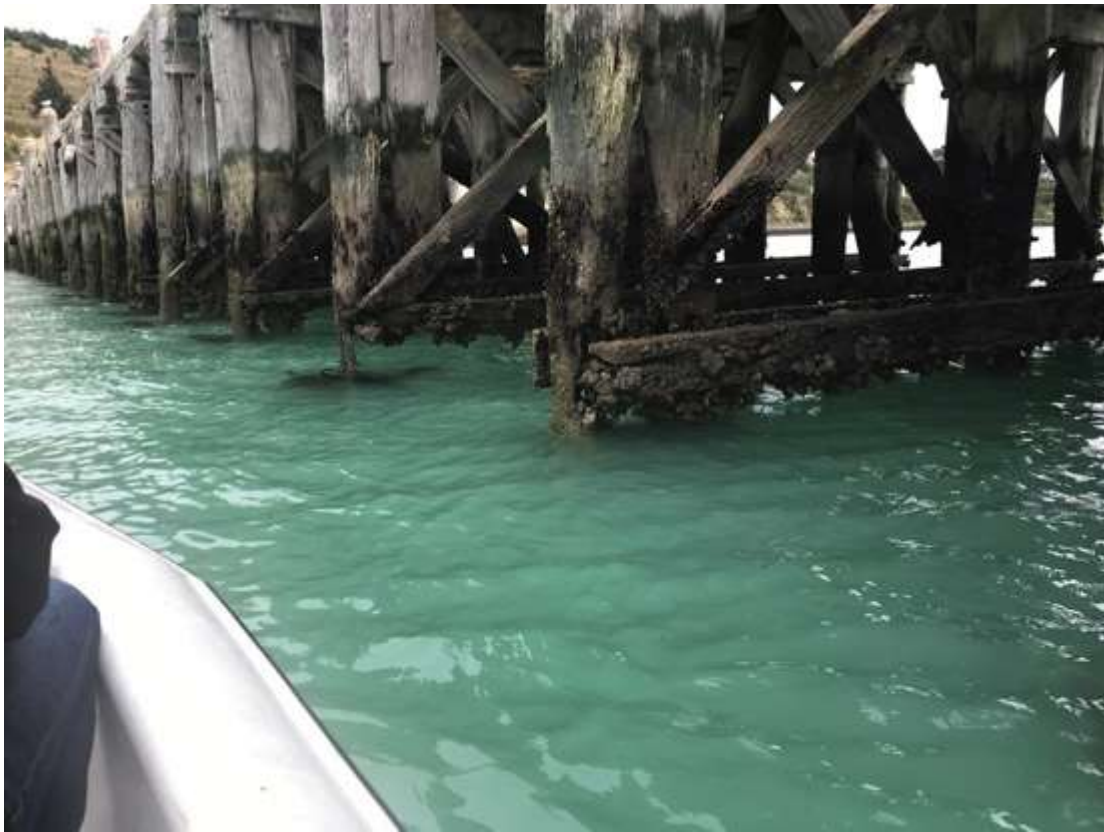
Piles completely missing in parts

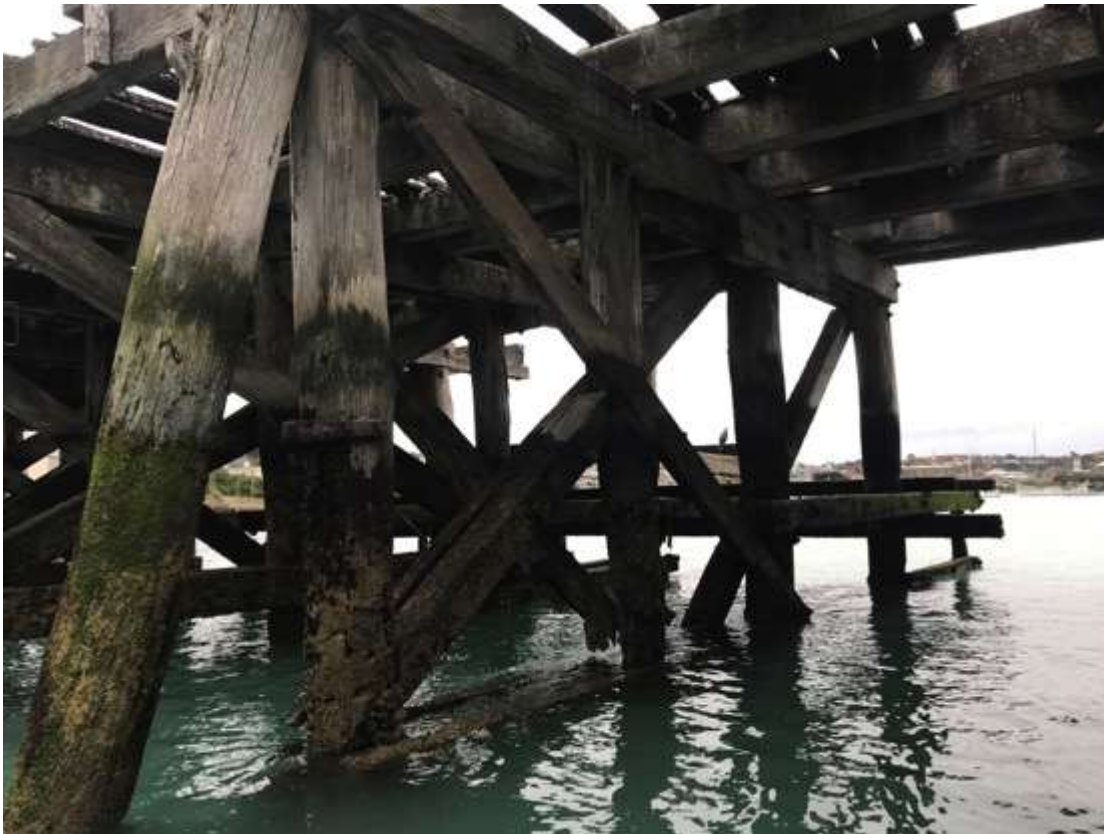
Typical pile bent that is proposed to be repaired for pedestrian access only.
