### *Harbour Area Committee*

## OFFSHORE & COASTAL ENGINEERING LIMITED

27 March 2018

### **INSPECTION REPORT: SUMPTER WHARF, OAMARU HARBOUR**

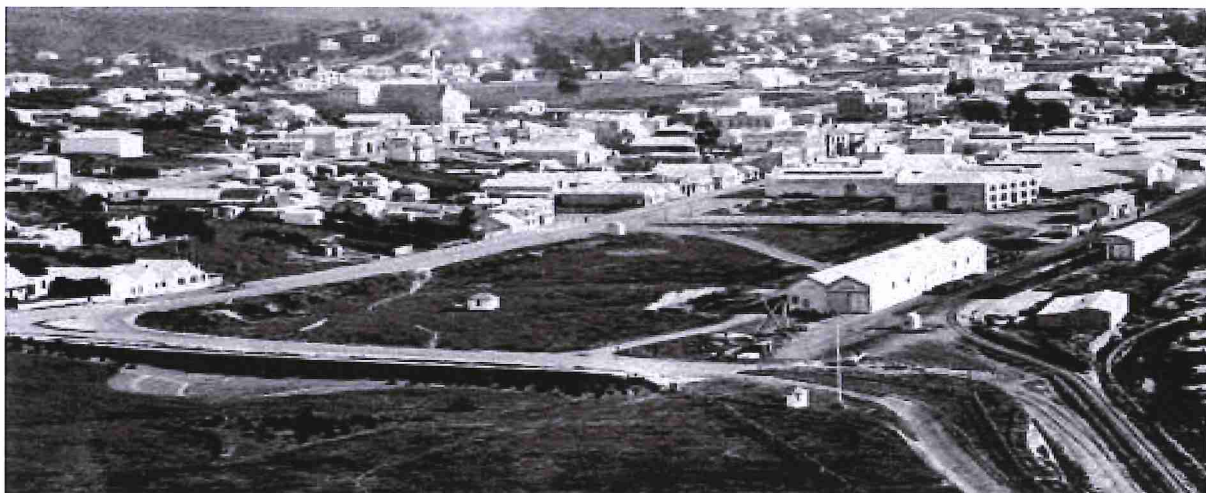
Leading marks for the harbour entrance channel have been installed near the boat launching ramps. The Harbour Master has identified that there is significant visual clutter around the lead marks due to several structures, all of which are painted white. These structures include a hut and flagpole.

Image 1 – Hut situated next to a flagpole

### Option 2 – Relocation (recommended)

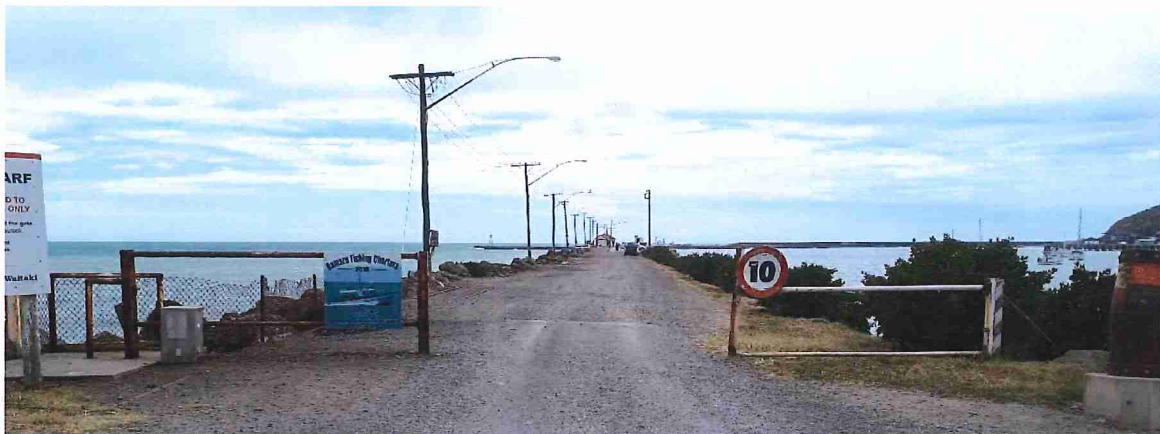
The entrance to Holmes Wharf is dated and in need of replacement. The existing fencing and netting has been removed from the left side of the entrance. However, the entrance needs to be addressed. Materials currently used in and around the harbour area include Oamaru stone blocks and Corten steel. It is suggested that, to ensure continuity within the area, these materials are used again. This theme could be continued on for the naming of the other wharves in the future. Based on the proposal in image 2, the project is estimated to cost \$1,415 + GST.

Image 1 - Existing fencing

### Option 2 – Approve replacement of the wharf entrance (recommended)

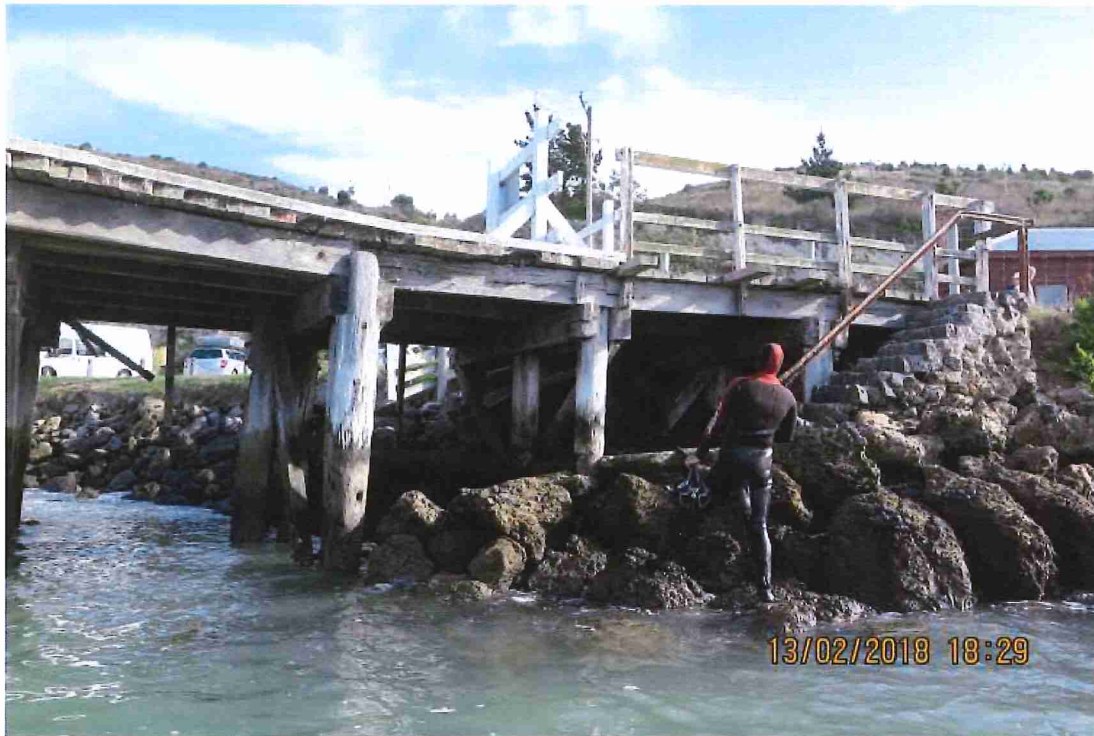
Photograph No 1: Pile bents 1 – 3 (from right to left). White barrier fence above bent 2

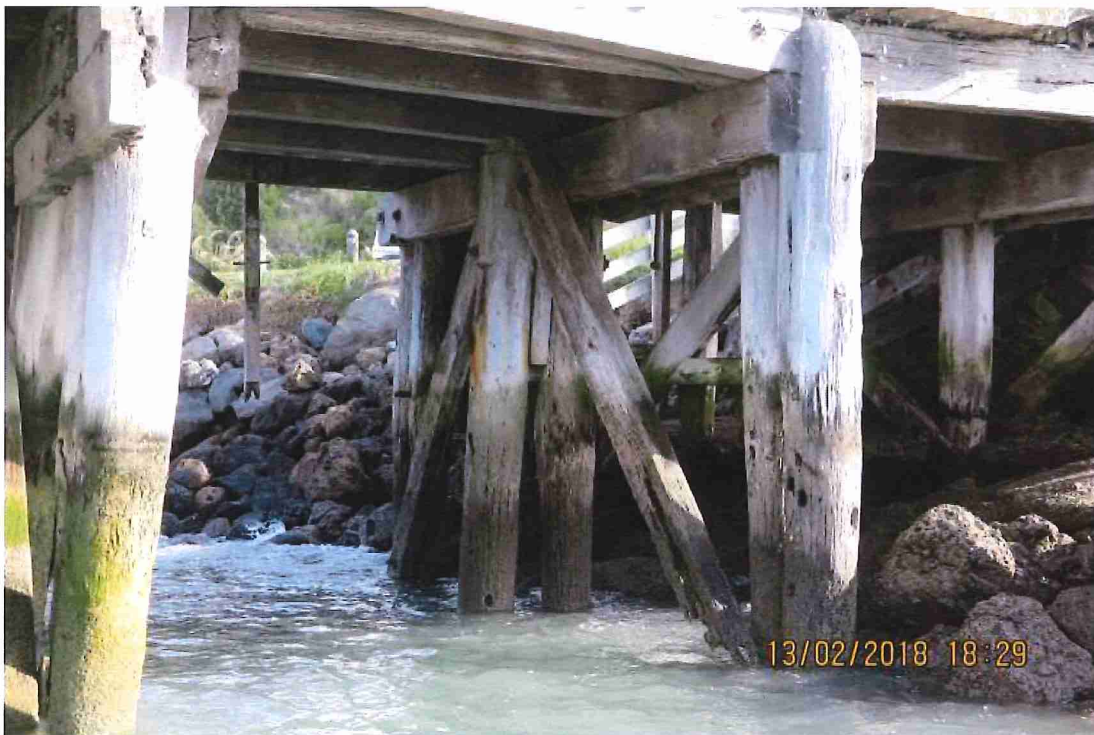
Photograph No 2: Pile bent 3

The condition of the piles on bent 3 – Photograph No 2, was representative of the results from previous inspections, the majority of pile deterioration principally due to marine borer, either *Limnoria* or *Bankia*, attack. One of the load bearing piles was assessed as nonviable having effective 100% waisting – Photograph No 3. The two other load bearing piles had approximately 20% and 50% waisting. Furthermore, the raker pile on the eastern side had sustained 50% waisting, while the mooring pile on the western side had 100% waisting.

The cross bracing along bent 3 – Photograph No 2, was found to be nonviable, the timbers having deteriorated around the bolt holes through marine borer attack. The ability of the cross bracing to distribute load from a badly deteriorated or discontinuous pile to other piles through truss action developed by the cross bracing is therefore non-existent.

Pedestrian access could be extended out to pile bent 3 subject to replacement or repair of one of the three load bearing piles, and full reinstatement of cross bracing utilising new timber braces and bolt fixings. The heavily deteriorated mooring pile on the western side can be disregarded as it serves no purpose as a load bearing pile. Furthermore the eastern side raker pile's purpose to provide capacity against vessel berthing impact is irrelevant to pedestrian loading on the wharf deck and can also be ignored.

The diagonal cross bracing along bent 3 would require complete removal and replacement with new timber sections and bolted connections. The estimated cost for this is in the order of \$5k ex GST.

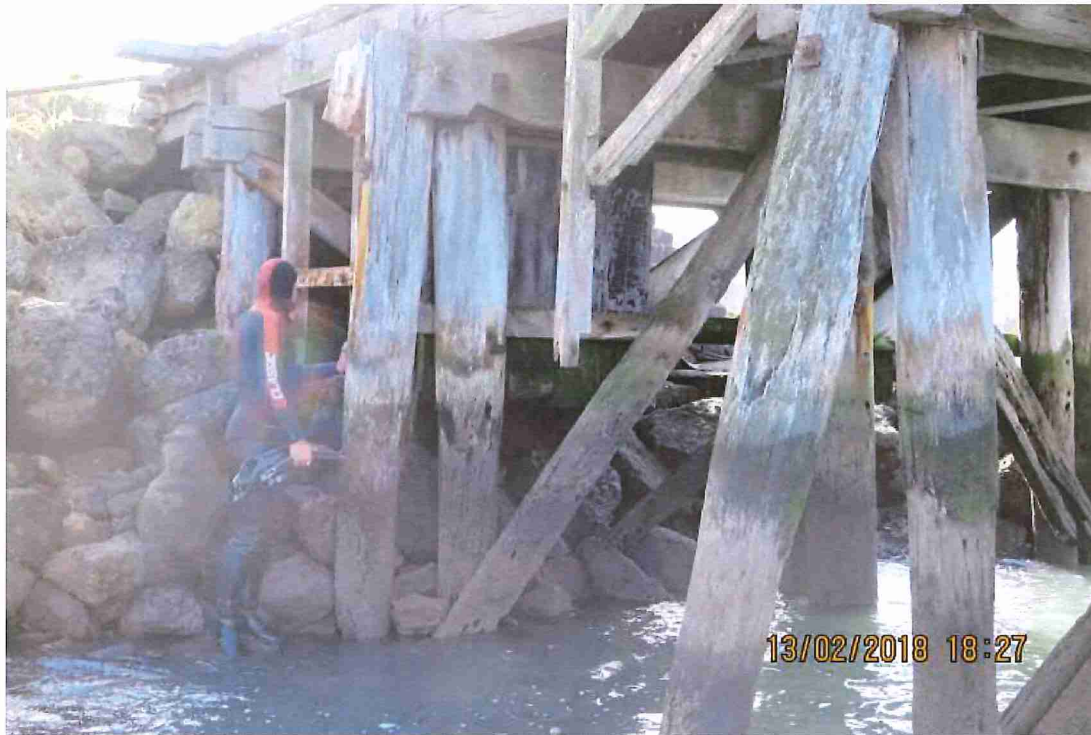
Photograph No 3: Heavily waisted load bearing pile second from left - pile bent 3

The affected load bearing pile could be repaired by bolting a steel jacket around the pile and the space between the pile and inside of the jacket grouted. The steel casing forms a structural component. This method has been applied for repairs to council wharves in Banks Peninsula, Christchurch, and on commercial wharves. Based on the degree of necking and slender tapered profile of the pile above low water it may be beneficial to cut out the pile at the capping beam connection and install a new pile section spliced to the existing pile stub below low water

using a grouted steel jacket. The cost for a pile jacket repair in consultation with an experienced marine contractor is in the order of \$10k ex GST. The viability of this repair depends on the quality of the timber below the waisting and ability to excavate material where required to expose a sufficient length of pile stub. Removal of rock armour around the pile is anticipated although the extent of this would be confirmed at the time of the work. Alternatively a new timber pile could be driven through the existing deck although this would need to be offset from the original pile location unless the original pile could be removed entirely. To achieve this would require floating plant with heavy driving gear, and is not the preferred solution. Shore based plant would require access to the deck which would likely require complete restoration of the wharf deck structure to allow the piling rig to progress.

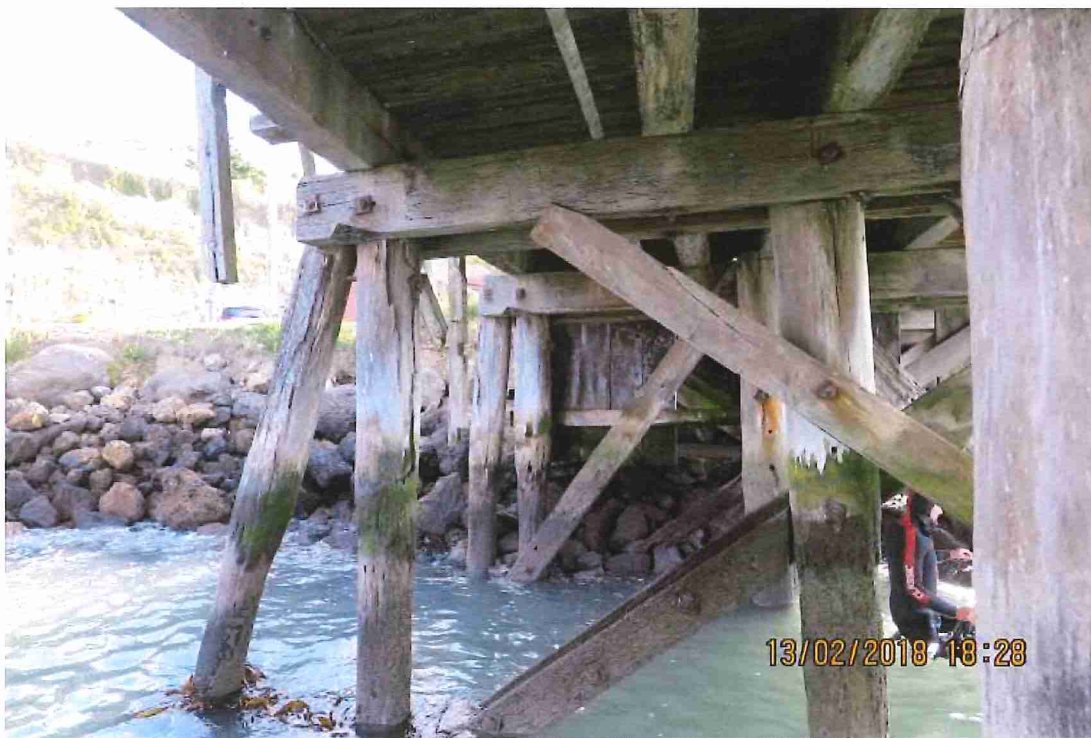
The capping beams and stringers – Photograph No 4, appear structurally sound in general with localised deterioration occurred at the connections through moisture or water ingress. However the timbers in their current state would be considered capable of taking pedestrian access loads. A further assessment would have to be made of each element following removal of deteriorated decking timbers. The decking timber was assessed from the previous inspection to be badly weathered and affected by fungal attack.

Photograph No 4: Bent 4 (foreground), bent 3 (background)

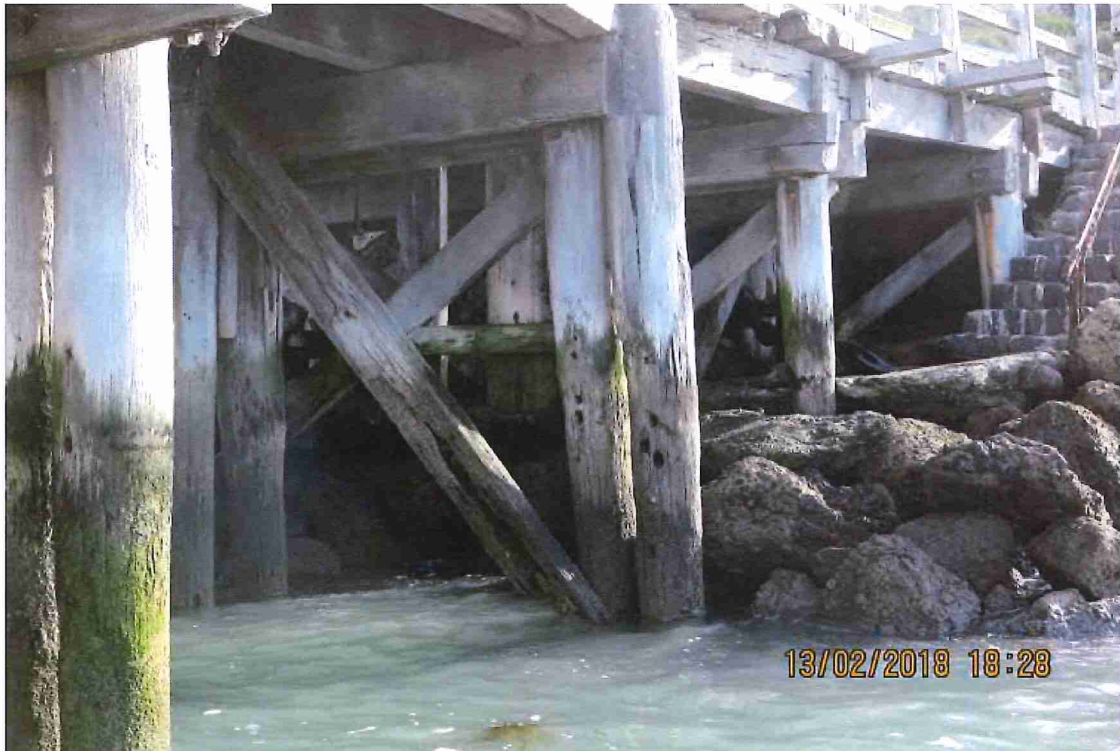
Piles on bents 1 and 2 visible above the rock armour slope were deemed in generally acceptable condition – Photograph No 5. Although the full extent of their condition could not be determined below the rock line it is unlikely any marine borer attack would have deteriorated the concealed pile lengths to the same scale as the exposed piles at low water. Notwithstanding this it is recommended a selection of piles driven within the rock armour, and also on bent 3 are load tested to prove their capacity to take imposed loads. This could be carried by placing concentrated loads over a selected pile representative of pedestrian surcharge over the area of the pile load catchment.

Photograph No 5: Timber piles appear generally sound above water
