WAITAKI DISTRICT COUNCIL

Geotechnical Investigations Test Street Subdivision, Oamaru

March 2005

Job no: 890917

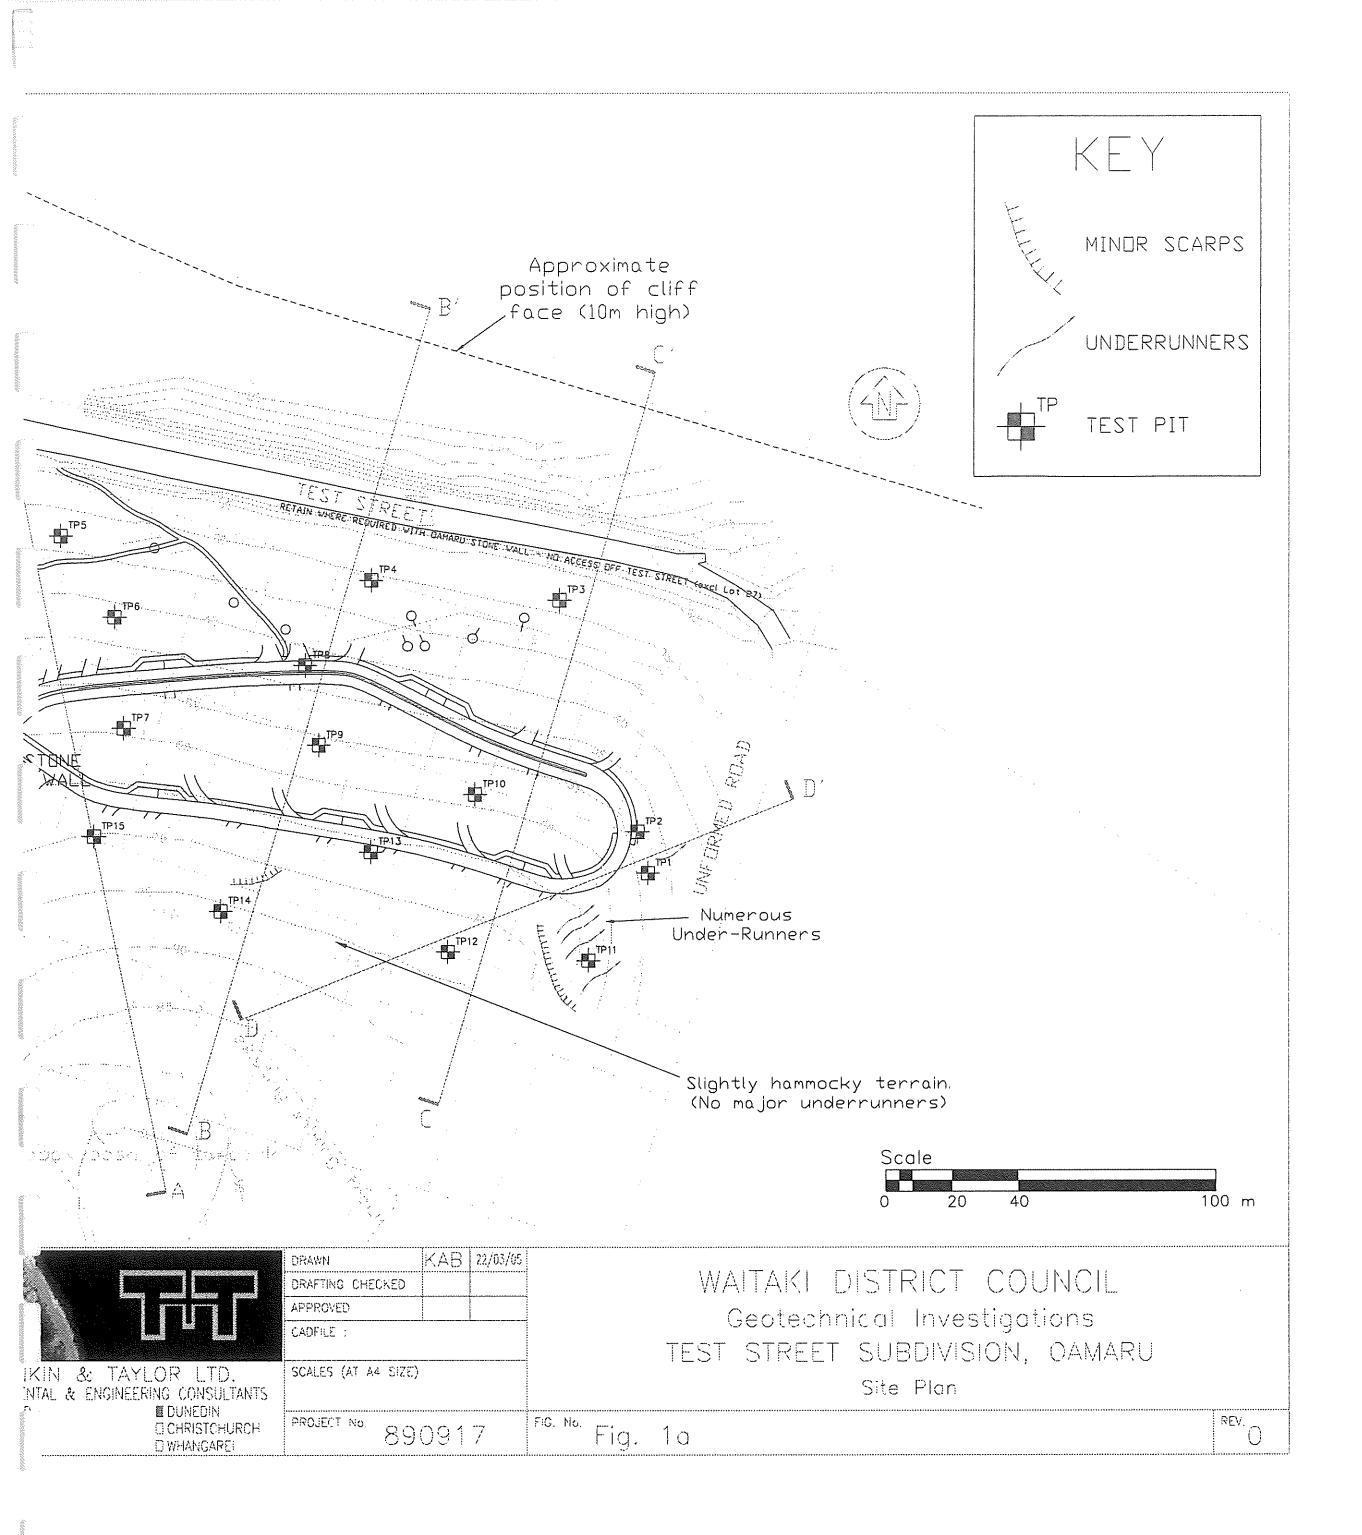
The proposed development is for subdivision of the site into 27 allotments and associated access road, as shown in Fig 1, Appendix A. No specific plans for buildings are available at this stage, although conceptual plans indicate that many will require significant cuts (3-4 m) as a consequence of the moderate slopes on site.

The site is legally described as SEC'S 1-23, BLK 31 and SEC'S 1-22 BLK 32 and is shown in Fig 1, Appendix A. The upper part of the site includes the eastern part of the currently unformed continuation of Avon Street.

Topographic contours can be seen in Fig. 1, Appendix A. The majority of the site slopes at moderate inclination towards Oamaru Harbour, with a northerly aspect. Most slopes are no greater than 2.5:1 (horizontal : vertical), however, Lot 9 is steeper (2:1) owing to its position on the flank of an incised gully. The difference in elevation between the upper and lower parts of the site is approximately 50 m.

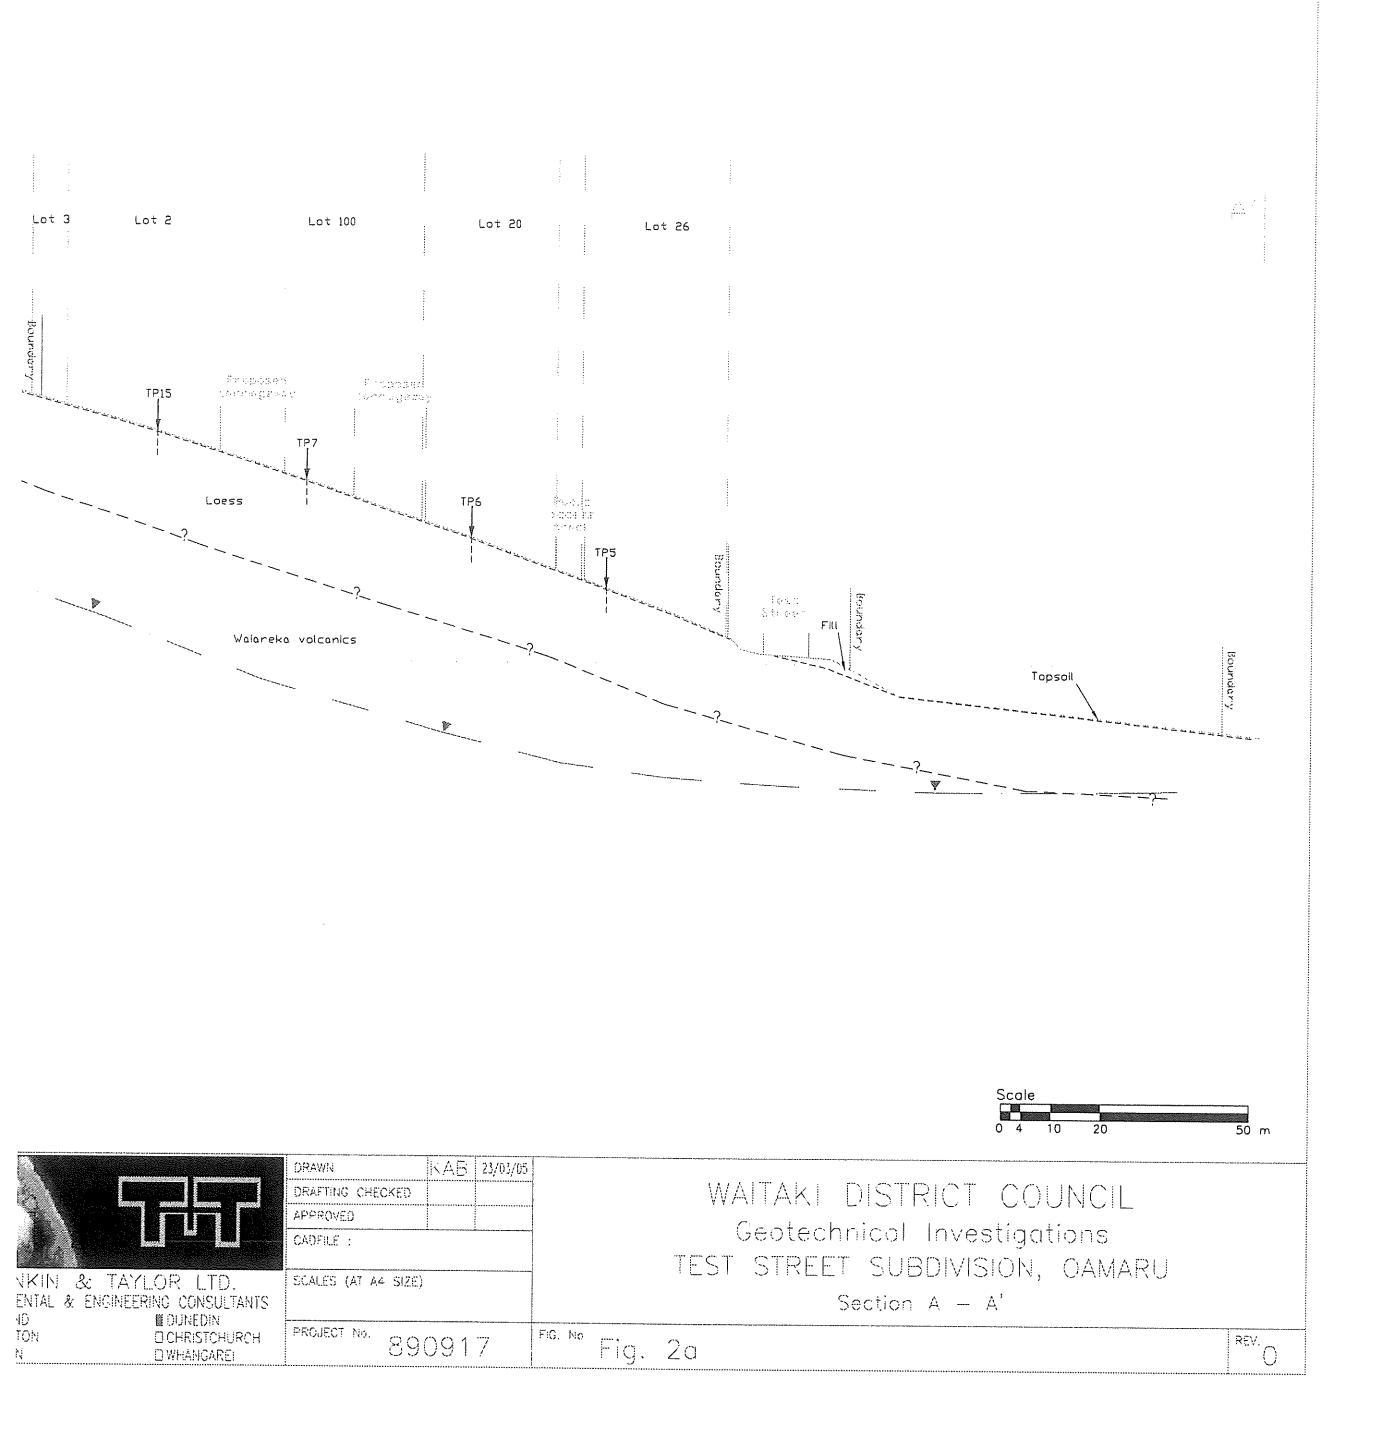
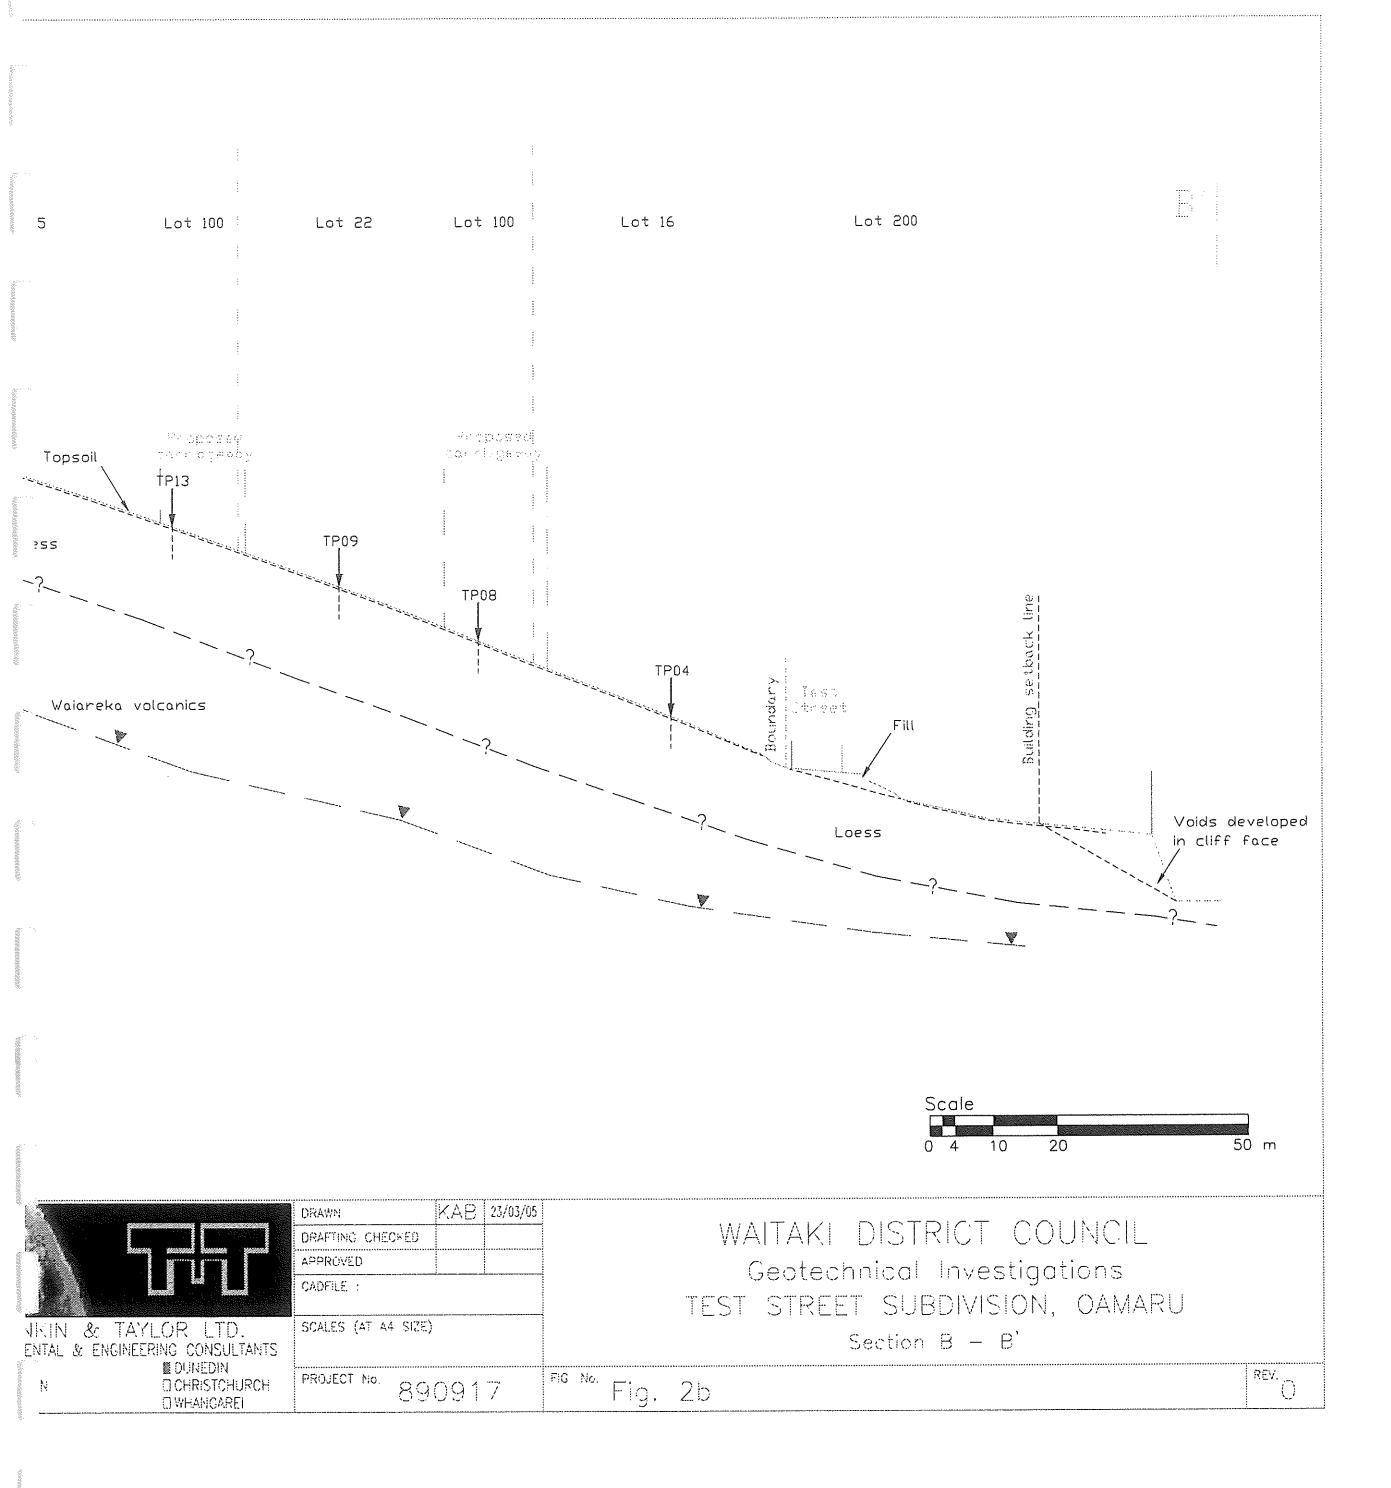
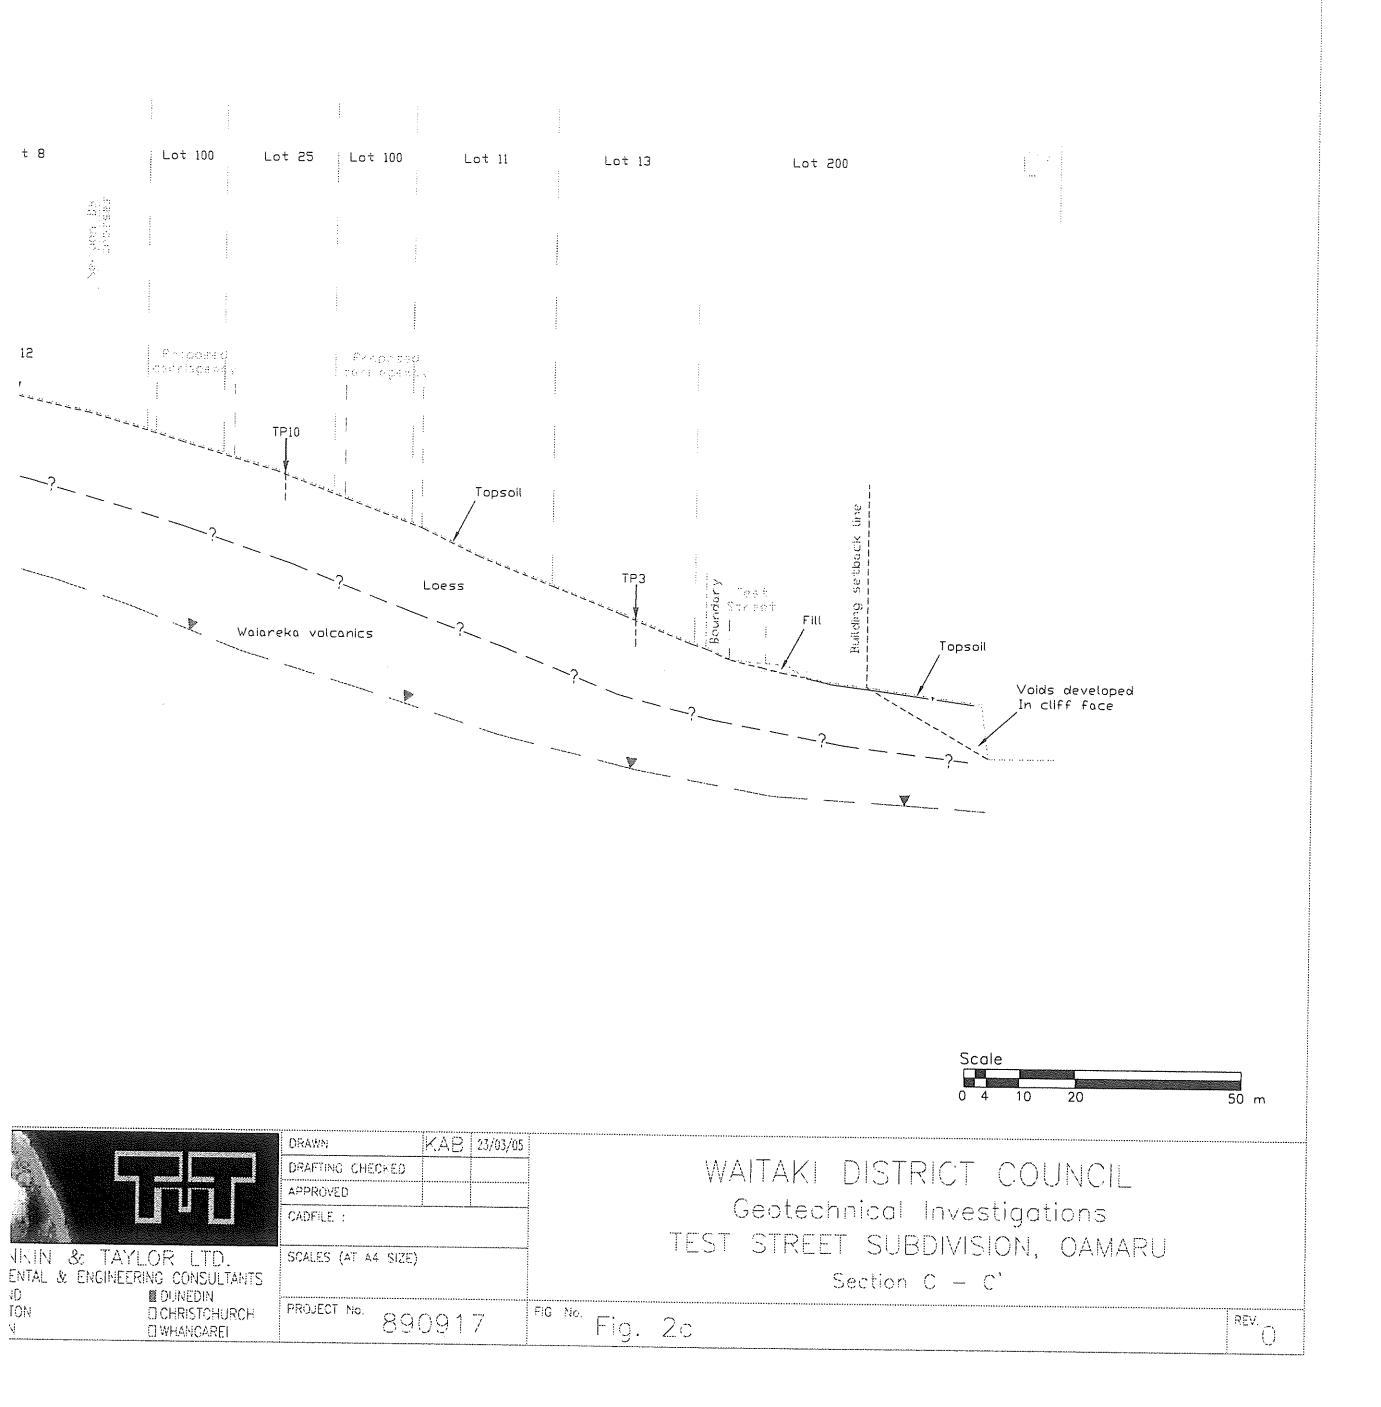
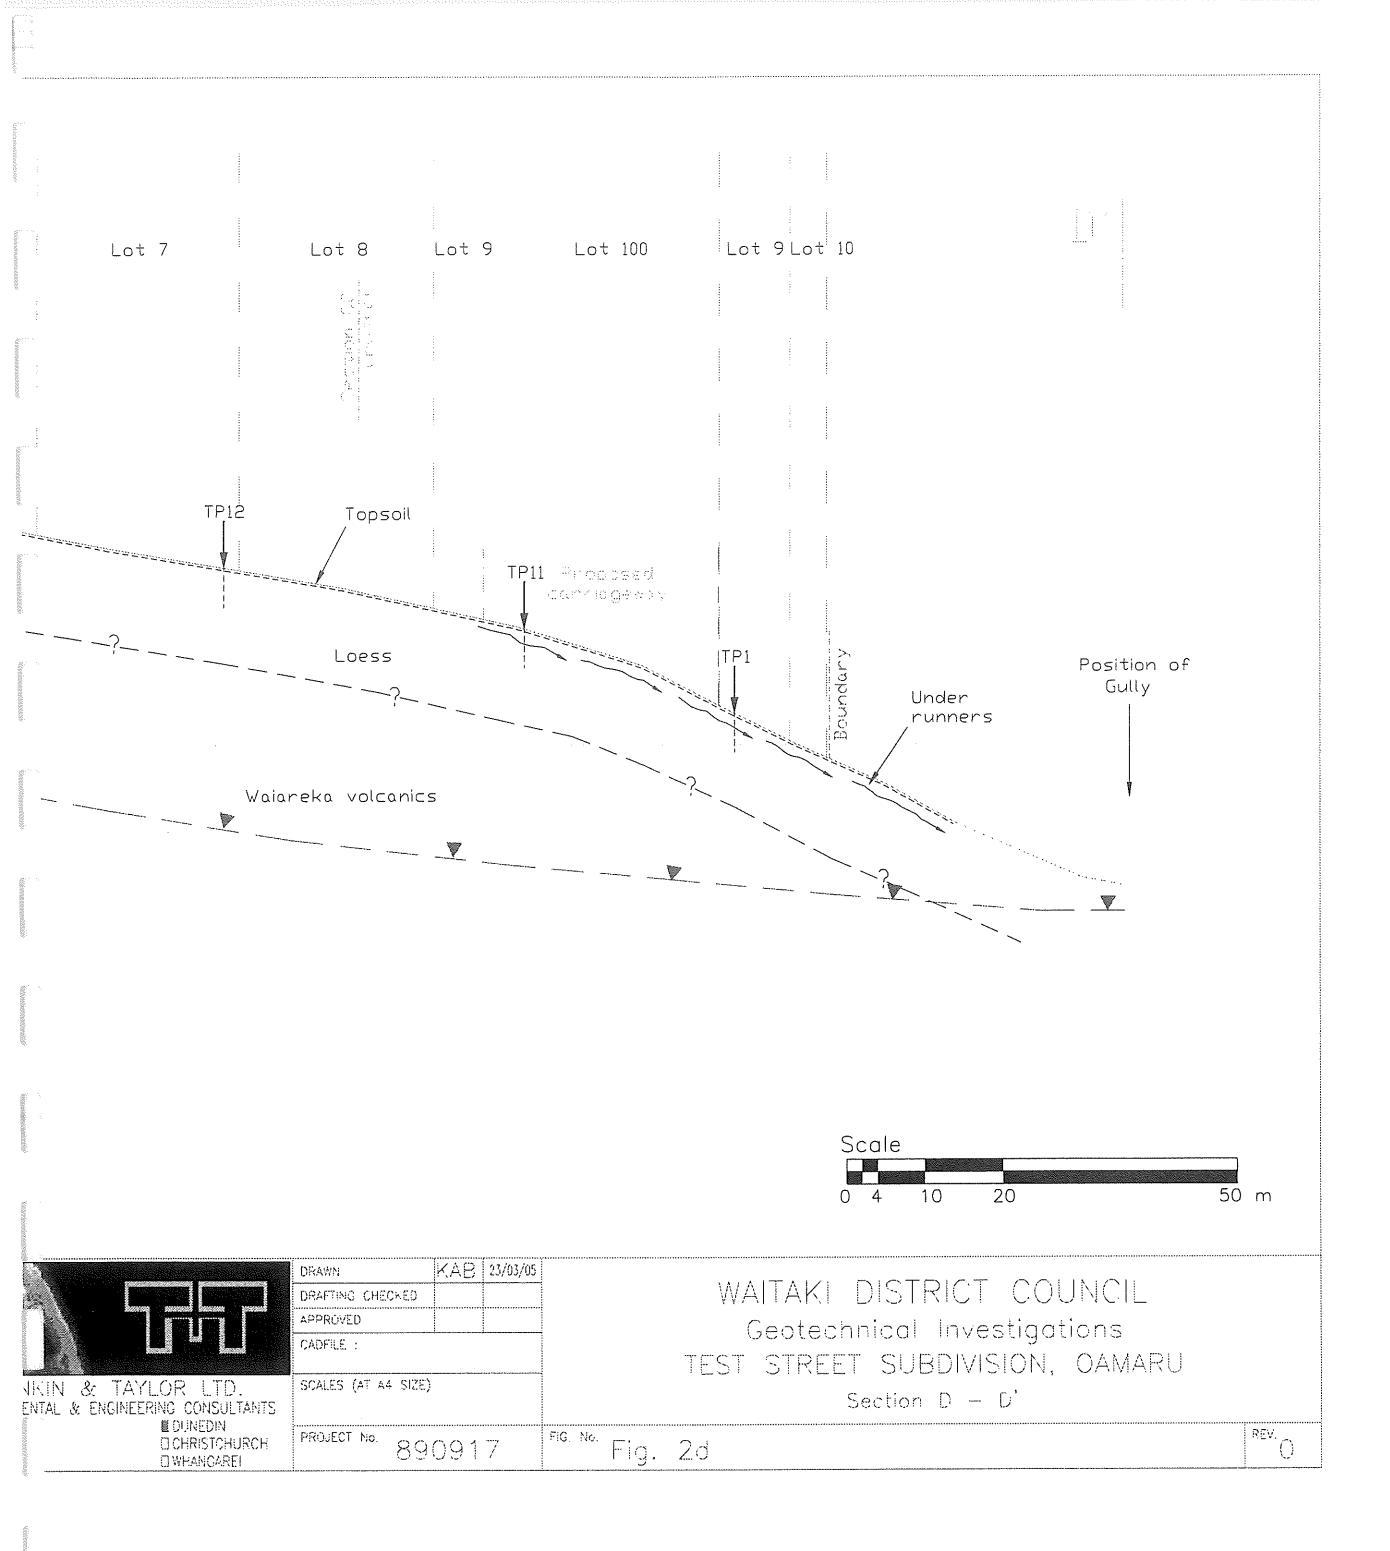
A geological model for the site is presented in Figs 2a-2d, Appendix A. The stratigraphy comprises a surface layer of topsoil and roots underlain by thick loess. Locations and logs of test pits (including penetrometer results) are presented in Appendices A and B respectively.
