24 December 2009
Project No. 42172547

Subject: Ground Investigations at Forrester Heights, Oamaru

WAITAKI DISTRICT COUNCIL
GROUND INVESTIGATION
FORRESTER HEIGHTS, OAMARU
LOCATION PLAN

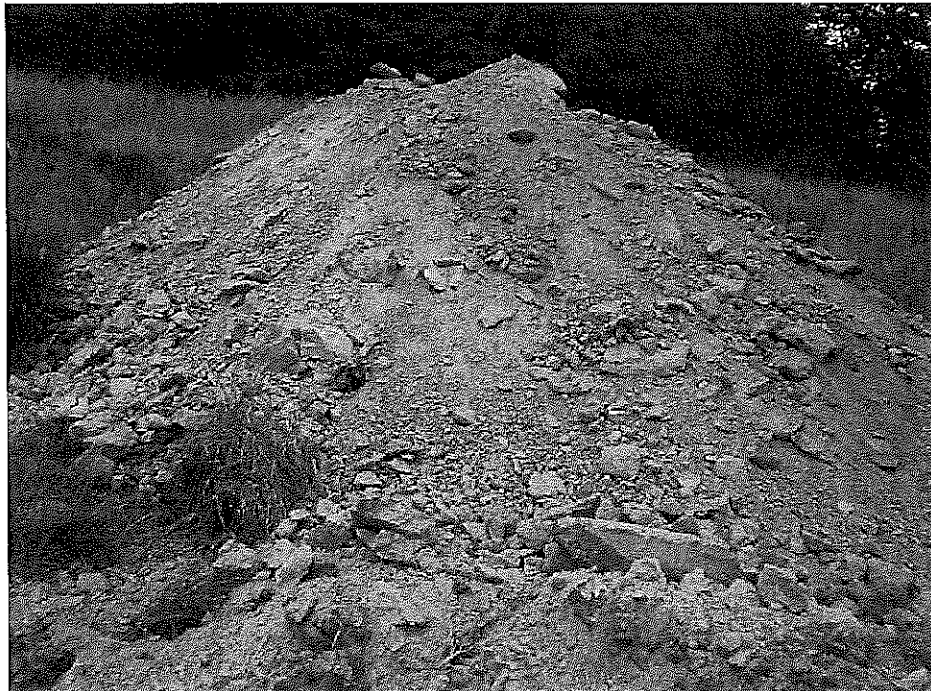
Test Pit TP2

All test pits encountered loess below topsoil. Topsoil depths varied from nil to 0.2m. Loess was encountered to a maximum depth of 4.5m (TP2, which was terminated at target depth).

| DESCRIPTION OF STRATA | | GRAPHIC LOG | DEPTH (m) | GROUND WATER DATA AND COMMENTS |
|---|---|---|---|--|
| Pit walls stable | | | | Target Depth <input checked="" type="checkbox"/> |

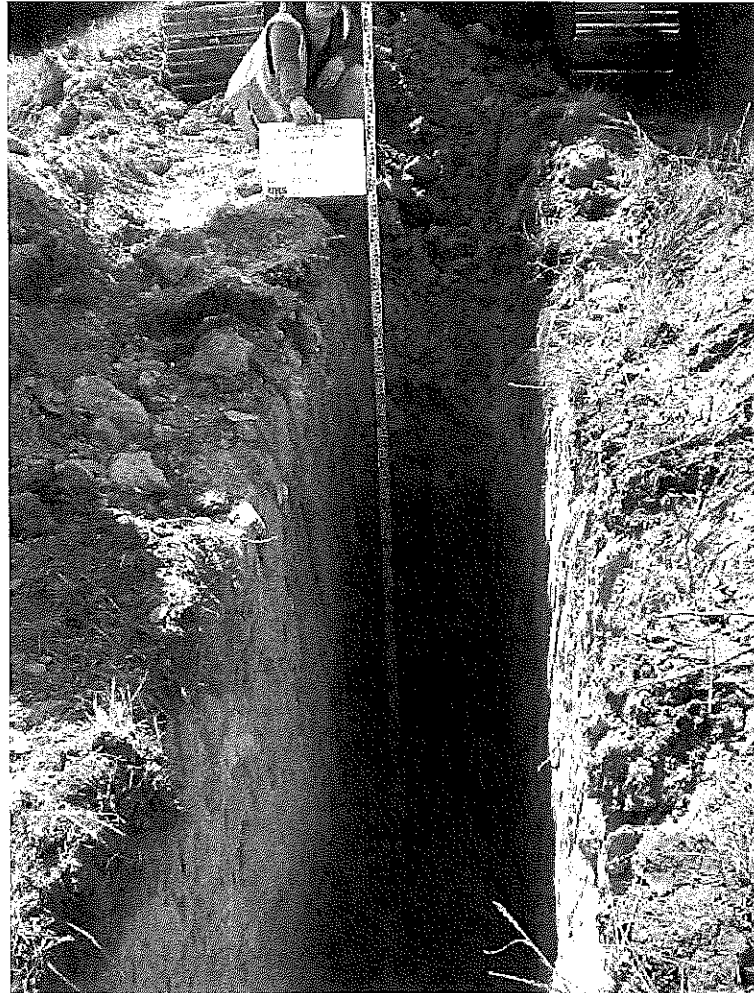
Test Pit TP3

Excavation of the Loess in TP3 was difficult from a relatively shallow depth due to the soil being hard and dry. Refusal was reached at a depth of 3.9m below ground level.

| COMMENTS | TEST PIT SECTION | | | | | | | | | | TEST PIT TERMINATED AT: | | |
|---|---|--|--|--|--|--|--|--|--|---|---|---|--|
| Pit walls stable Slow digging due to hard ground Refusal at 3.9m, no pieces of material could be brought to surface for identification, suspected igneous material. | | | | | | | | | | | Target Depth | <input type="checkbox"/> | |

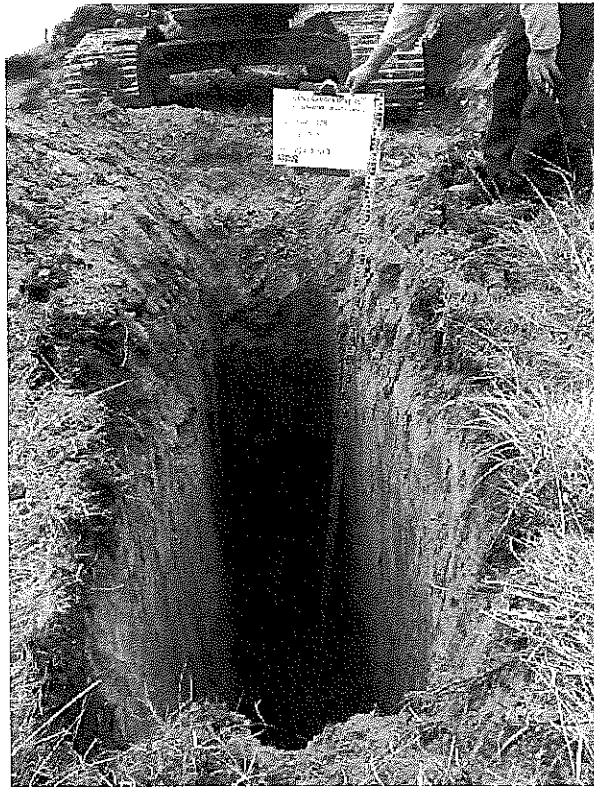
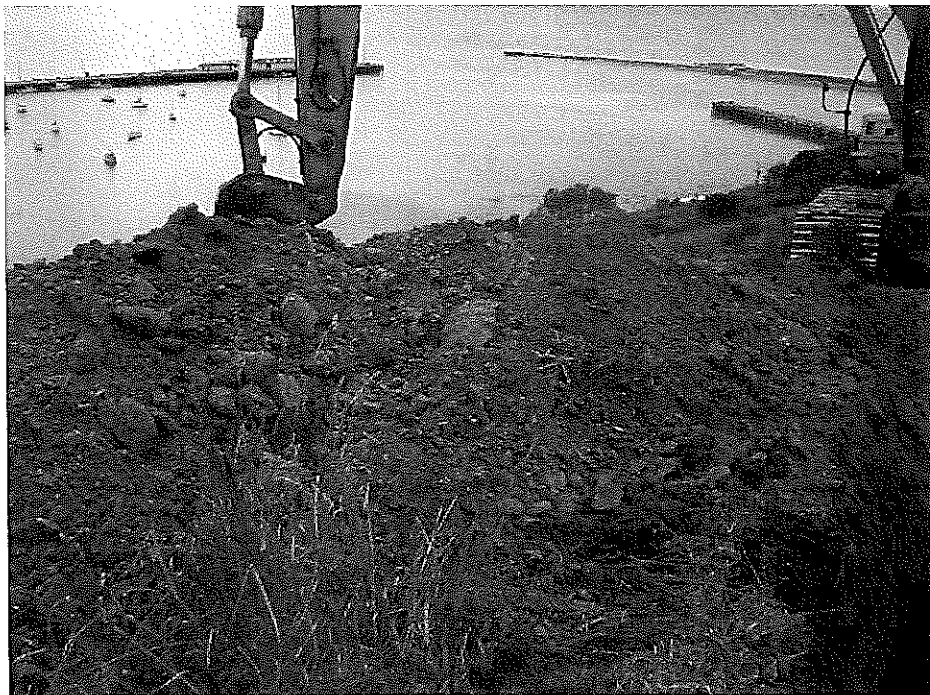
Test Pit TP6

SILT, light brown, homogeneous. Stiff, slightly damp, moderate plasticity,
with rare patches of white staining around rootlets at 1.2m.

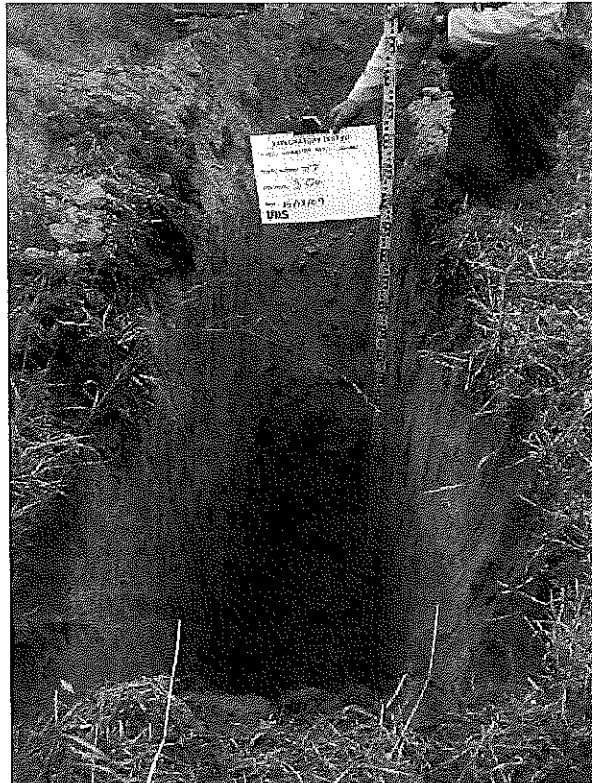
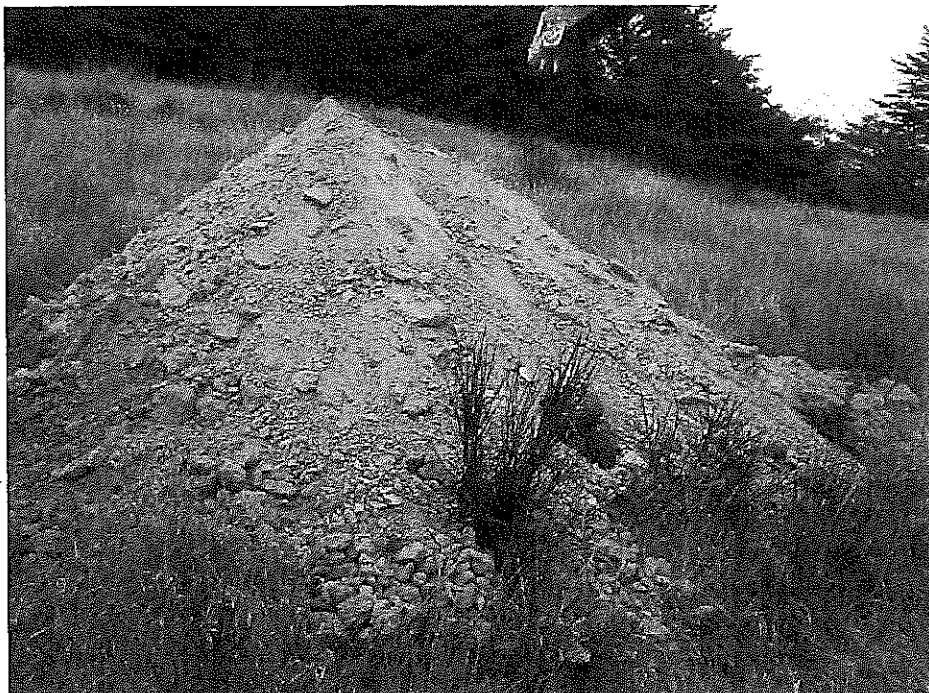
Test Pit TP7

| DESCRIPTION OF STRATA | | | | | | | | GRAPHIC LOG | DEPTH (m) | GROUND WATER DATA AND COMMENTS |
|---|---|--|--|--|--|--|---|--|--|--|
| CLAY/SILT, light brown, homogeneous. Stiff, dry, moderate plasticity. becomes light yellowish brown at 0.5m. | | | | | | | | | 0.5 1.0 1.5 2.0 2.5 3.0 | Dry. Dry. Dry. Dry. |

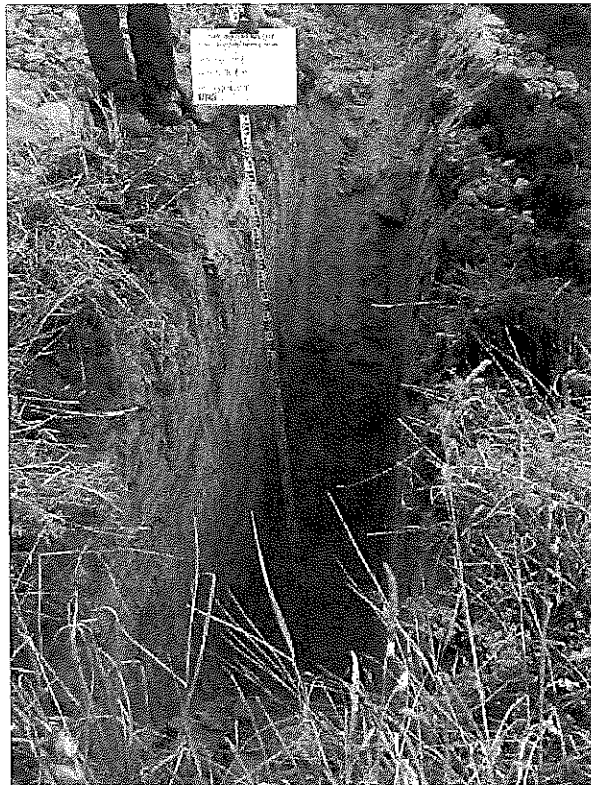
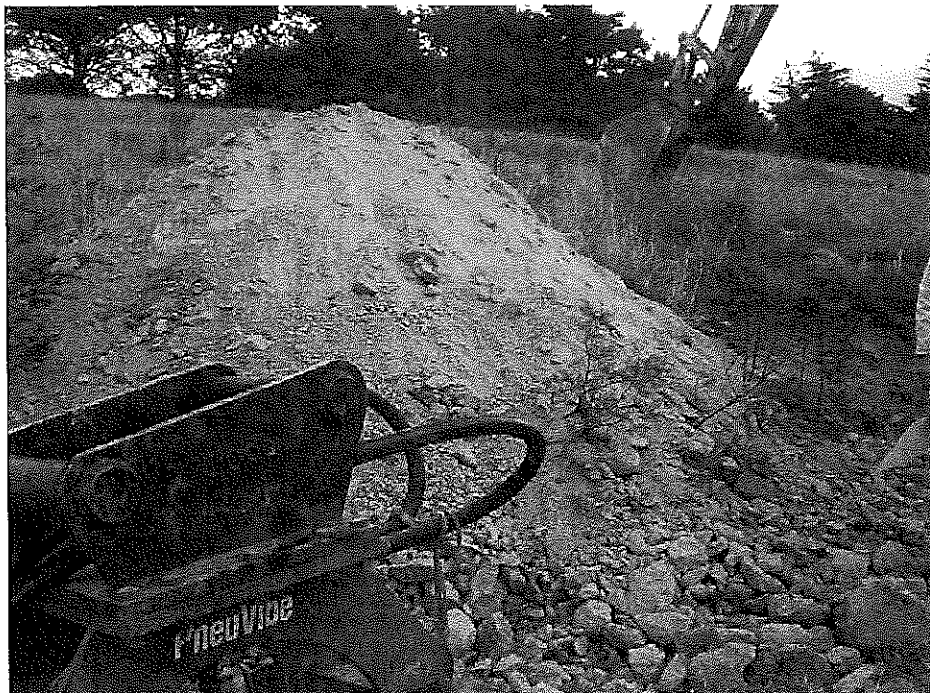
Test Pit TP8

CLAY/SILT, dark brown, homogeneous. Firm to stiff, dry, moderate plasticity.
becomes brown at 0.1m.
becomes light brown at 0.8m.
