**Waitaki District Council
Contract No. 442
Report on Engineering Issues
Of a Coastal Roads Strategy**

Oamaru to Waianakarua

Report on Engineering Issues

Date: November 2009
Reference: 6-TWT12.00
Status: Final

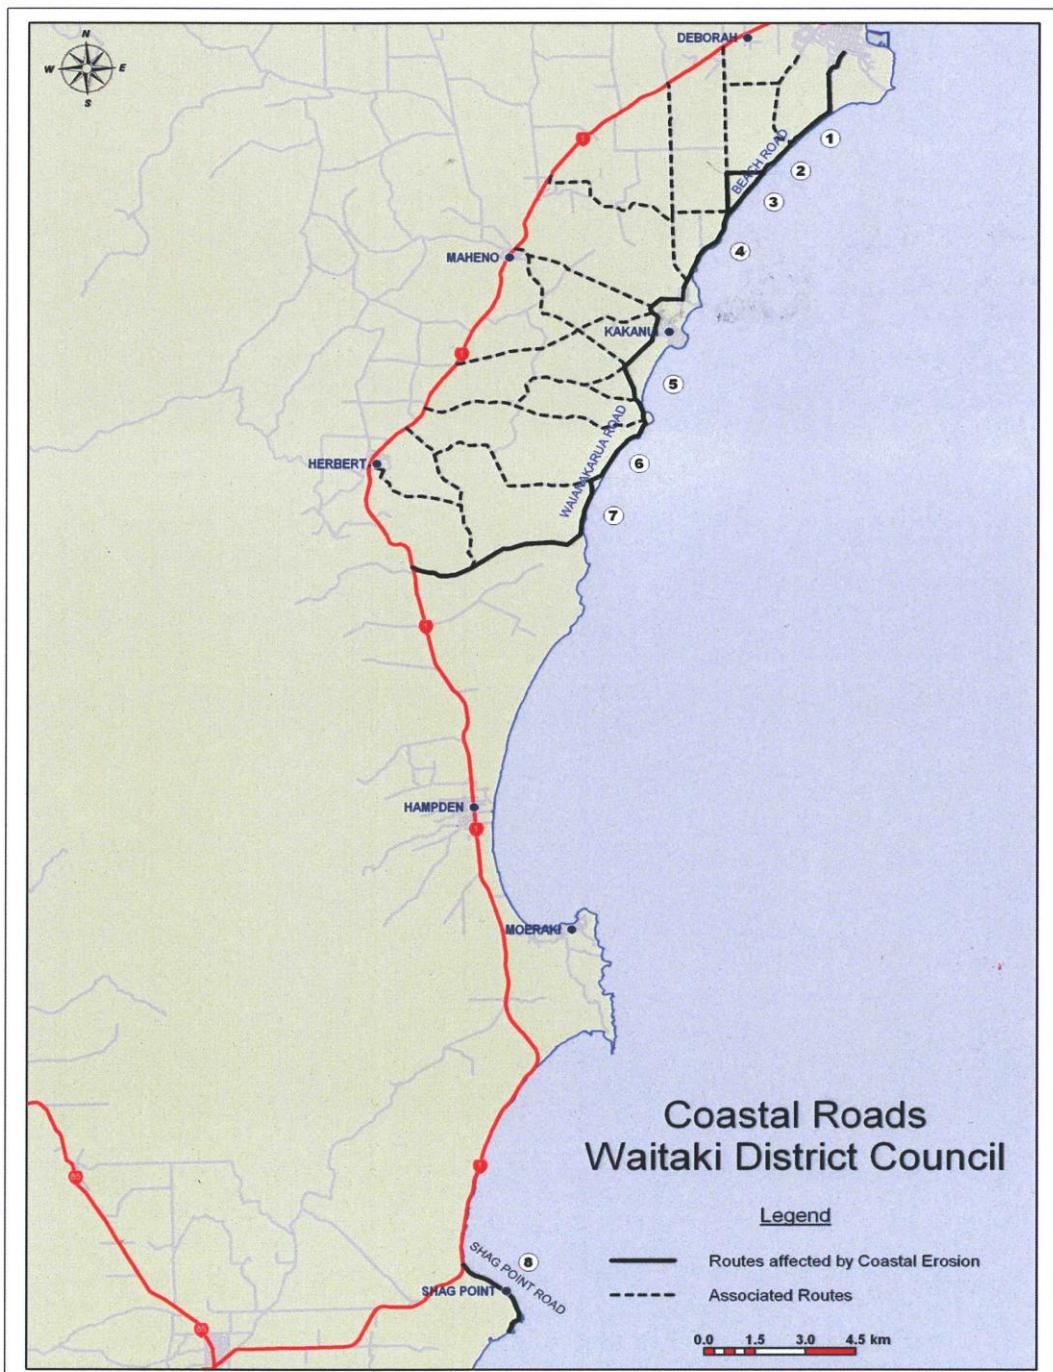
Map Showing the Eight Coastal Road Investigation Sites

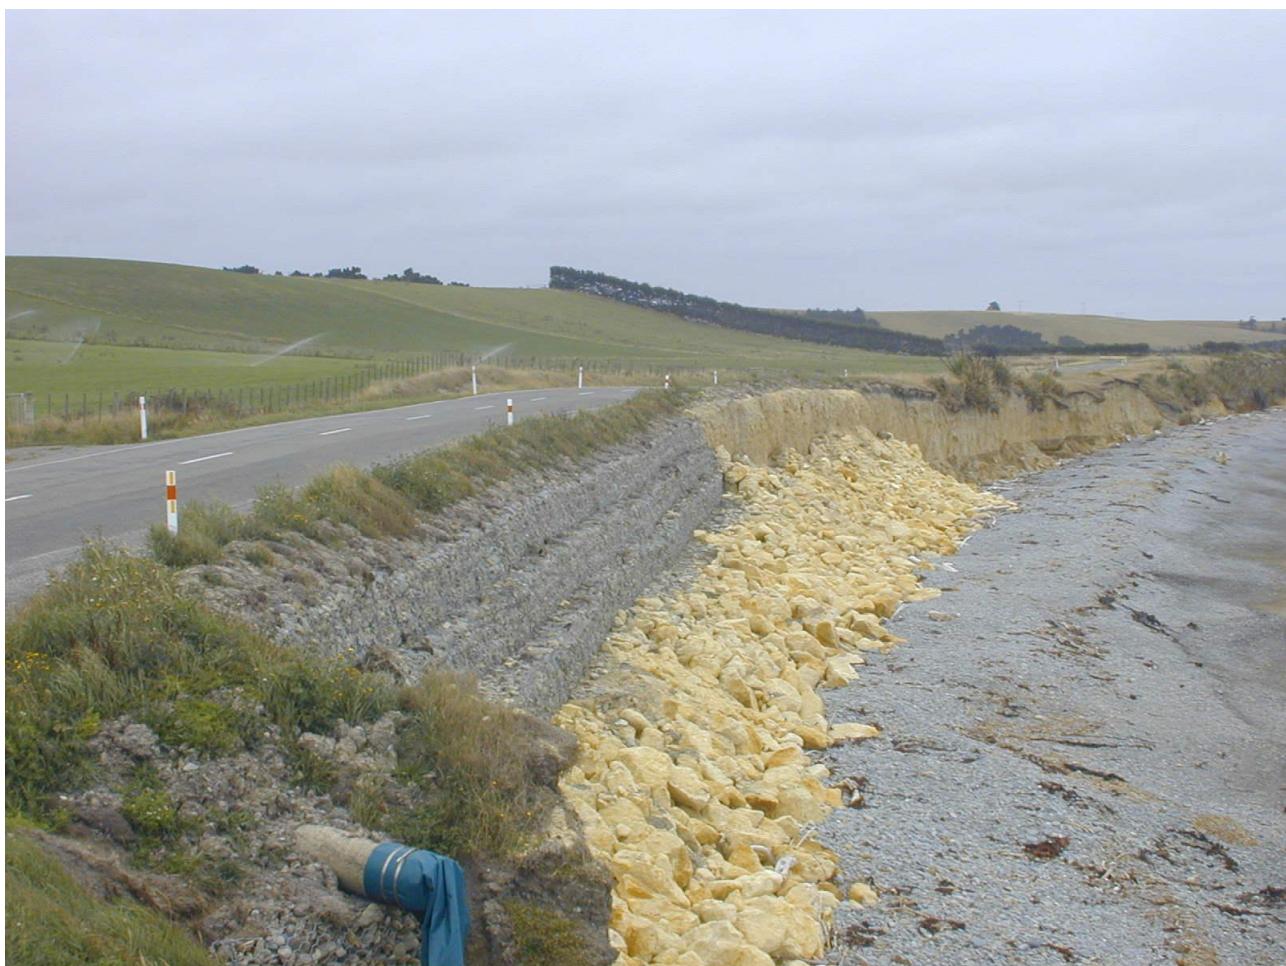
Site 7, The Section of Seawall built in 2007

A 100m section of seawall was constructed at this site in 2007 and cost about \$3,000 per lineal metre. This structure consists of an armour rock apron, extending down the beach, upon which a three tier gabion wall was constructed.

The cliff face at this location is higher than normal along this section of coastline due to its proximity to the promontory where the ground levels are somewhat higher. For future seawall construction a seawall of a lesser height may be able to be used which would reduce the cost of construction. In addition, the urgency of the work done in 2007 and lack of experience of the contractor may have also added to the cost of this project.

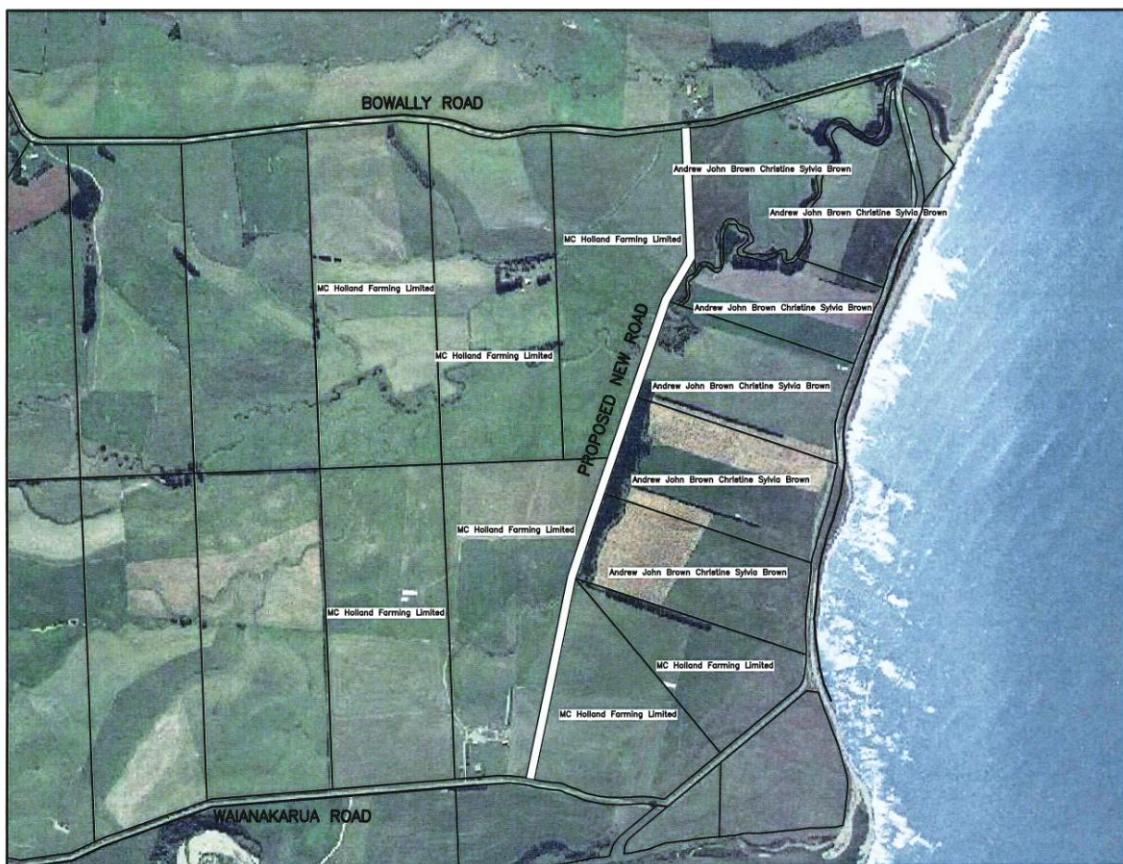
Plan of Proposed New Inland Road

An alternative to protecting the existing road from coastal erosion is to construct a new road further inland. A possible route has been found located about 600m inland and running parallel to the current shoreline. The new road would require the purchase of an area of land 20m wide by about 1900m long – approximately 3.8ha. The route would deviate from the existing Waianakarua Rd at the Site's southern end and intersect with Bowalley Rd at its northern end.

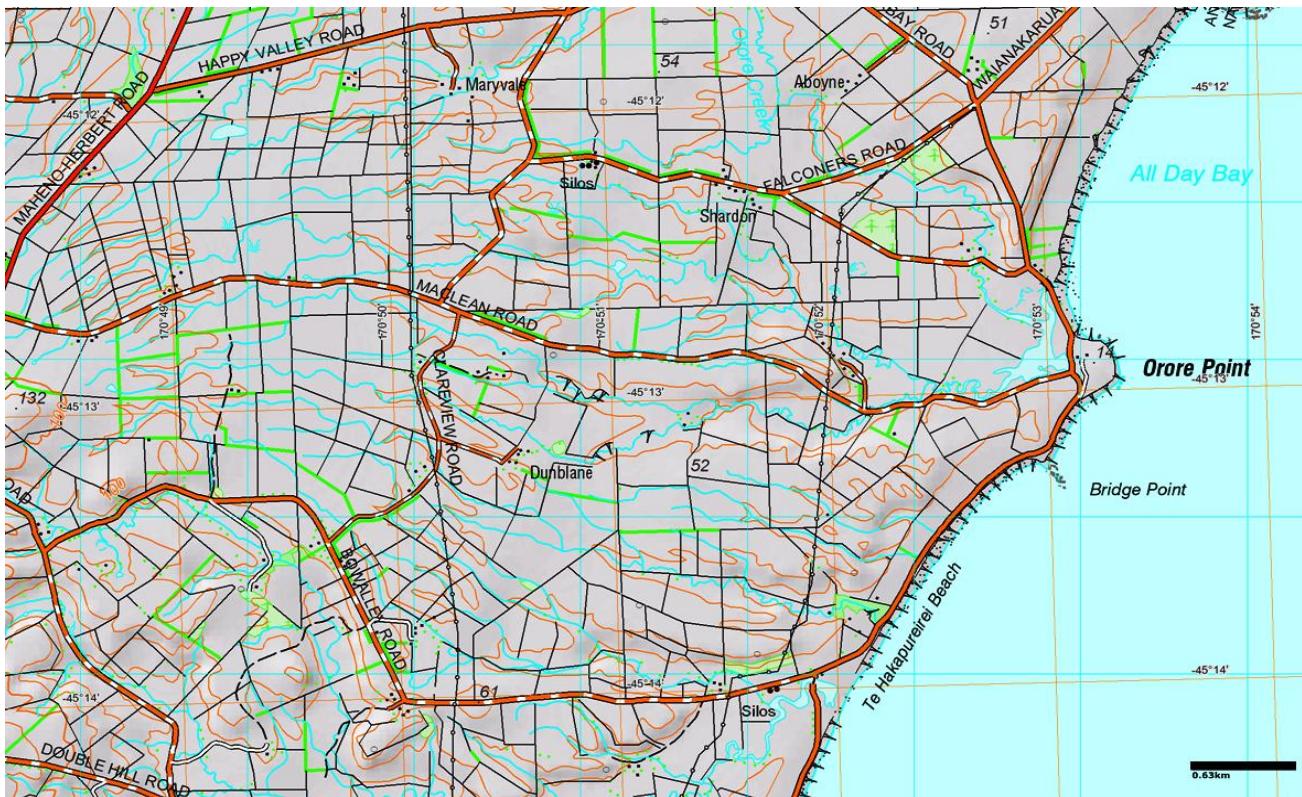
Site Map – Site 6 and the southern part of Site 5

Three hundred and seventy metres north of its intersection with Bowally Rd, Waianakarua Rd returns to the coast and then runs parallel to the coastal bank for 1.6km. The road then travels over a headland called Bridge Point, which is protected by an offshore reef. North of the Point the road rejoins the coastline where there is another bay 400m long. At the north end of this bay is a large headland called Oroe Point. Here the road heads inland again and intersects with Maclean Rd at the northern limit of Site 6.

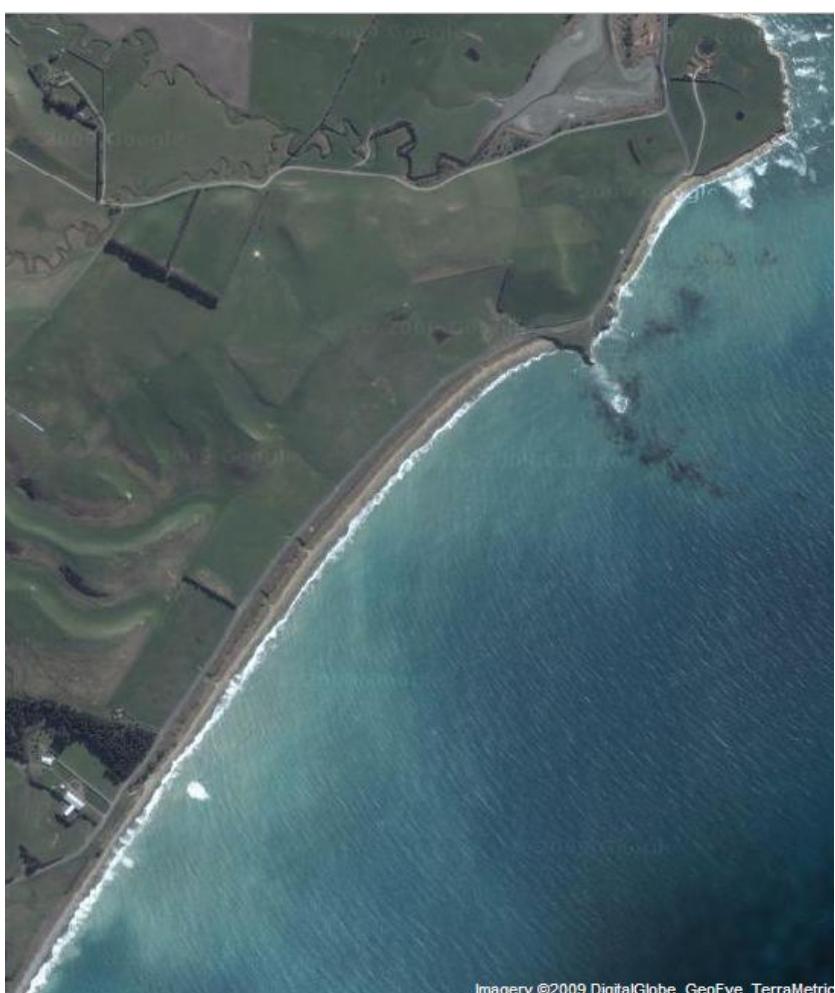
Aerial Photograph of Site 6

The long beach (Te Hakapurerei) that takes up most of Site 6 has a buffer of at least 10m between the road edge and coastal bank. There is vegetation growing down the bank which indicates that it is not being actively eroded. The photograph below shows a stratum of sandstone exposed at the base of the bank and this will be providing protection against wave action. Some rock protection work to check an isolated pocket of erosion is shown in the foreground.

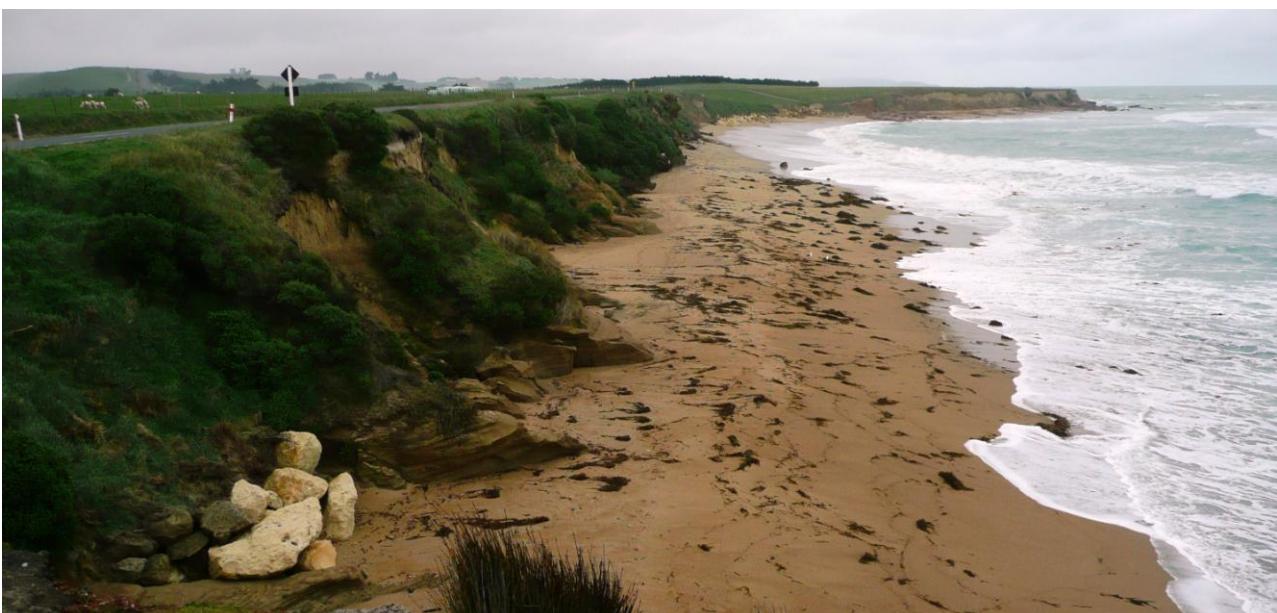
Site 6 Southern Beach – Looking North, Sandstone strata present at base of the coastal bank.

Earlier coastal erosion reports do not mention issues at this beach so the overall impression is that it is relatively stable. There are four minor gullies in the coastal bank where natural land stormwater run-off discharges onto the beach. Protection works may be necessary at these gullies in the future, due to either run-off flood damage or storm sea surges being channelled up these gullies and putting the road at risk.

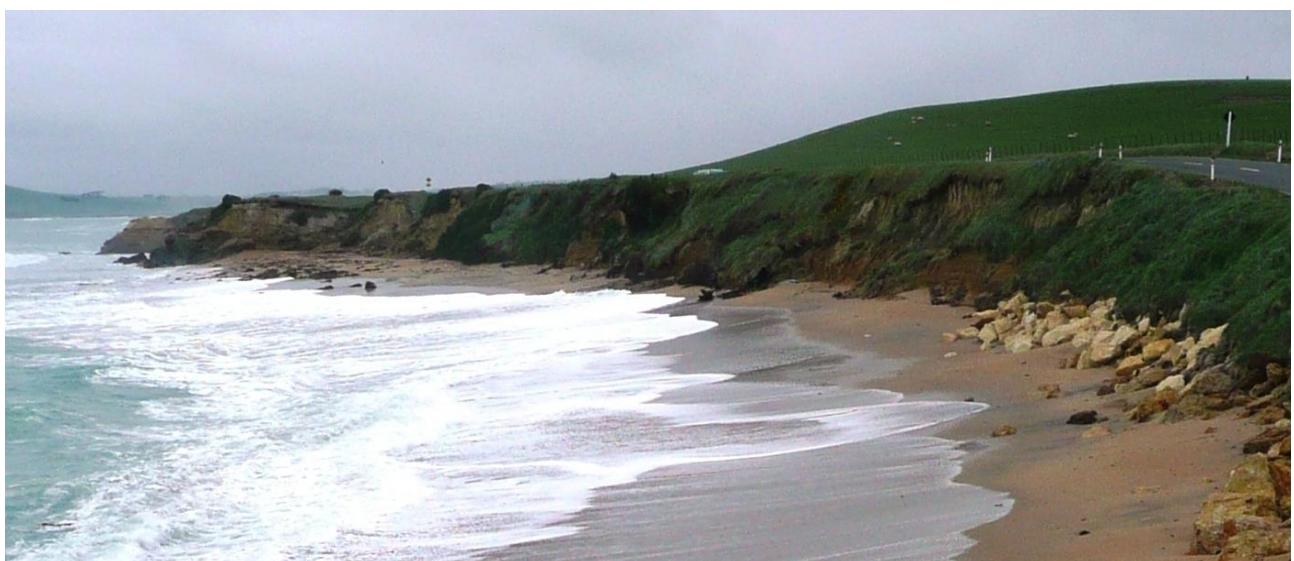
Site 6 Northern Beach – Looking South, Active bank erosion

The 300m section of road adjacent to the beach at the north end of this Site, north of Bridge Point, is under immediate threat of erosion damage. The coastal cliff face is located directly adjacent to the road shoulder. The photograph below shows Bridge Point in the background, created by the sandstone reef extending out to sea (also visible on the aerial photograph of this Site). Recent slumping of the clay bank in the middle-ground of the photograph indicates active erosion in this area, contributed to by the absence of the sandstone strata at this location. Some minor protection works are shown in the foreground which does appear to be having some effect.

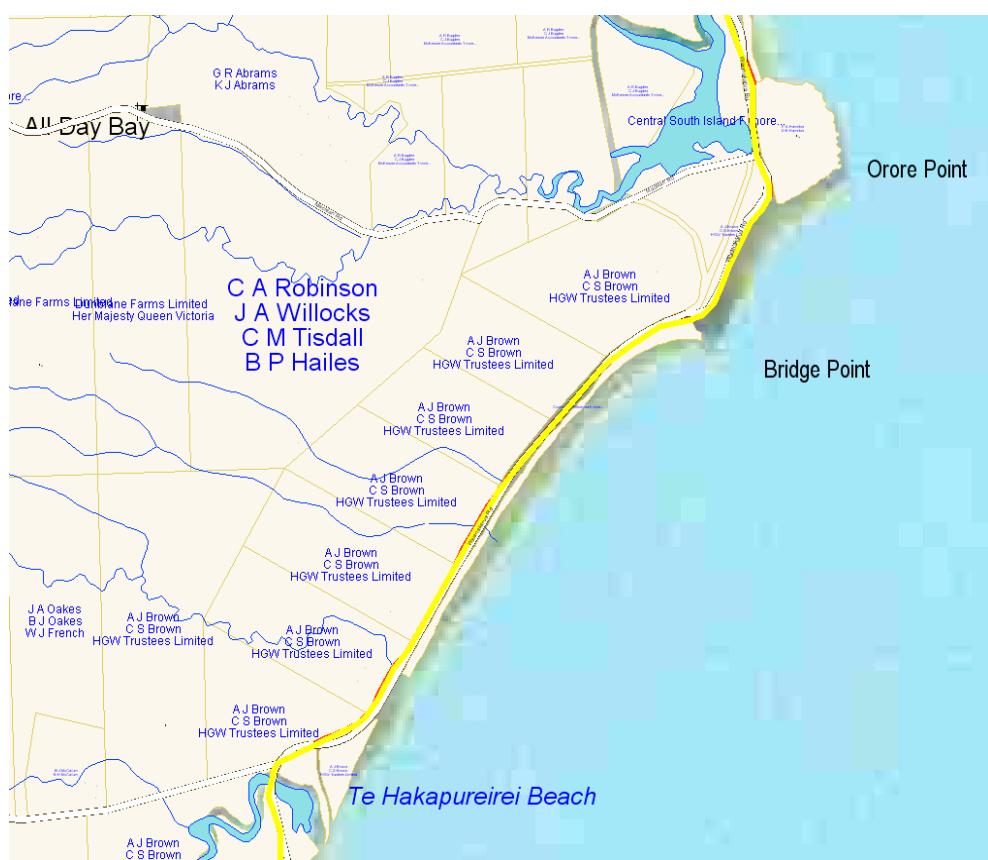
Land Ownership at Site 6

A very similar situation to Site 7 exists at Site 6, and coincidentally, it is the same land owner involved. The land adjacent to the threatened section of road is owned by one owner.

If the Recommendation for Site 6 is adopted then consideration needs to be given to the affect on access to land adjacent to the section of Waianakarua Rd that is to be closed.

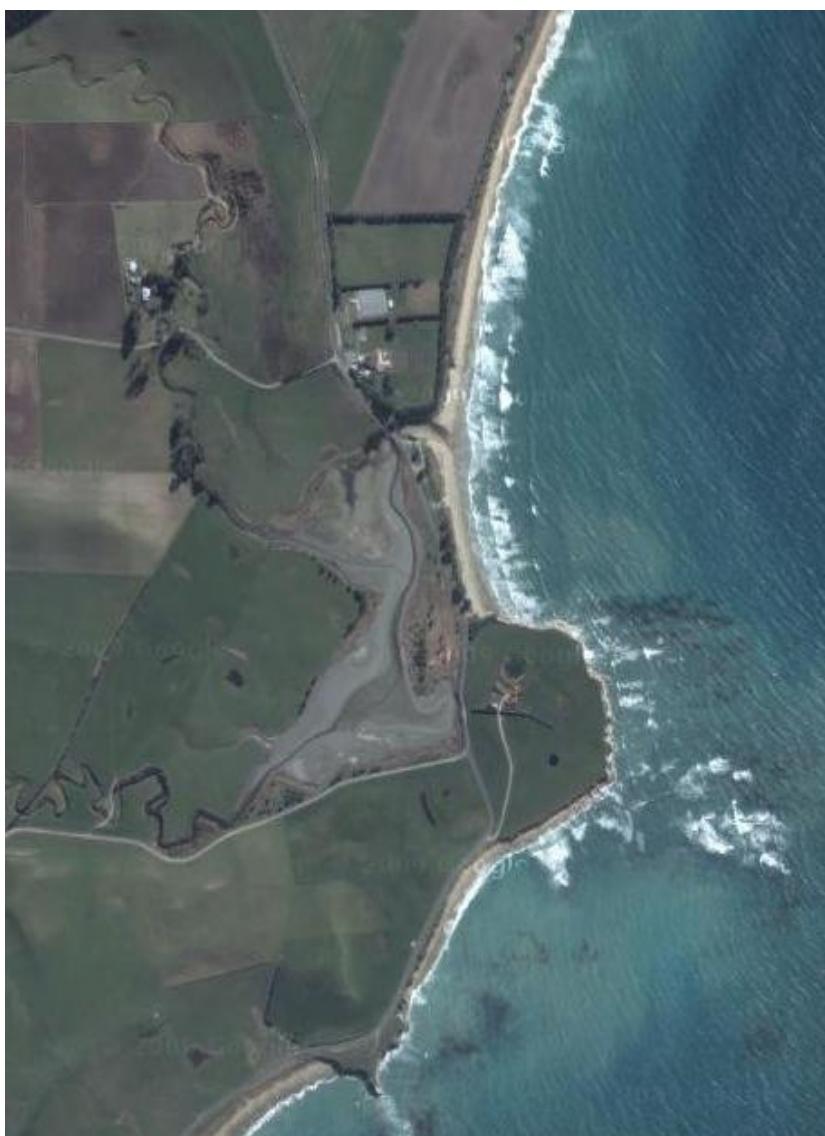
Aerial photograph of the southern portion of Site 5

Once past Maclean Rd, Waianakarua Rd travels across the northern flank of Oroe Point then descends onto a narrow strip of land between the coastline and the Oroe Creek lagoon. It then turns inland and stays inland from the coast until it reaches Kakanui.

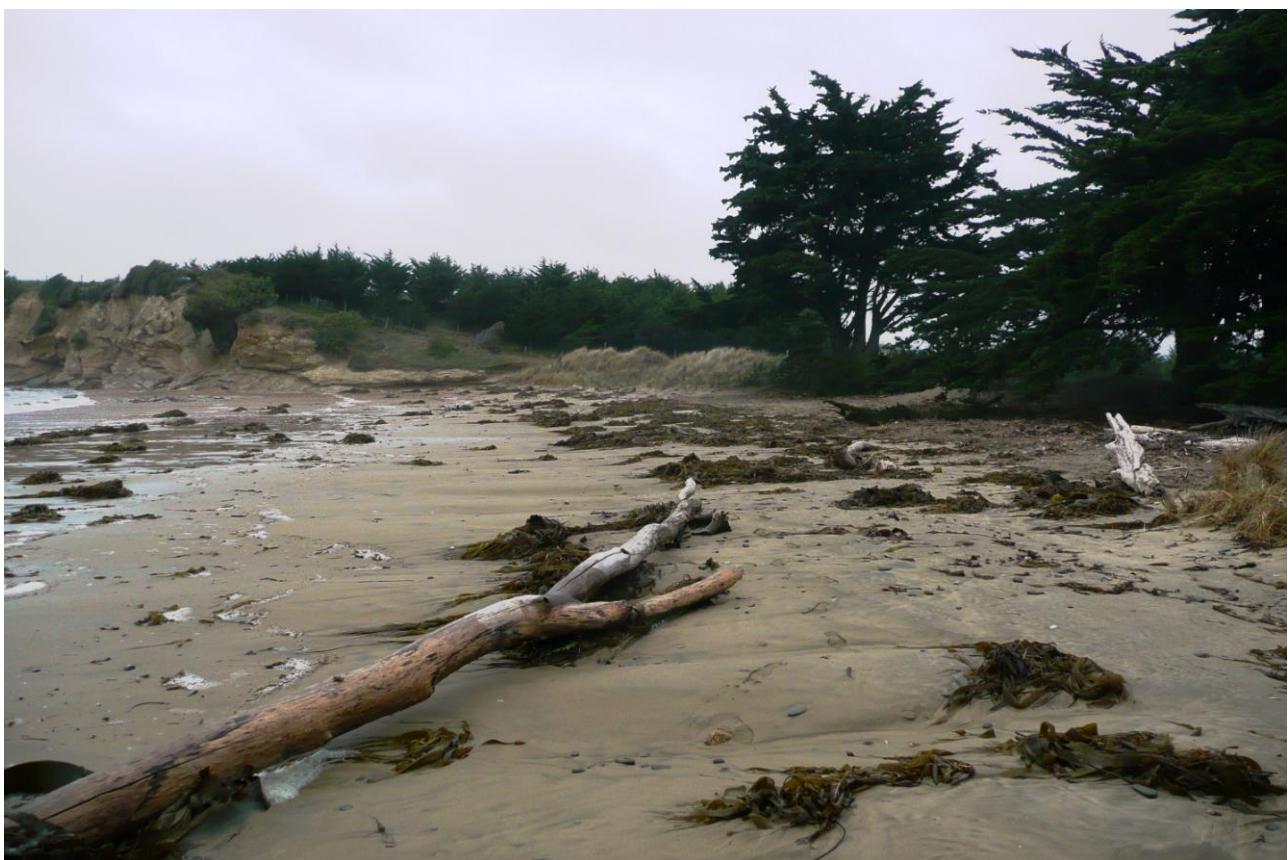
Site 5, Causeway at the mouth of Orote Creek - Looking South

The photograph above shows that seaweed and debris is washed up to underneath the trees during rough seas. The Waianakarua Rd is immediately behind the trees and at a lower level.

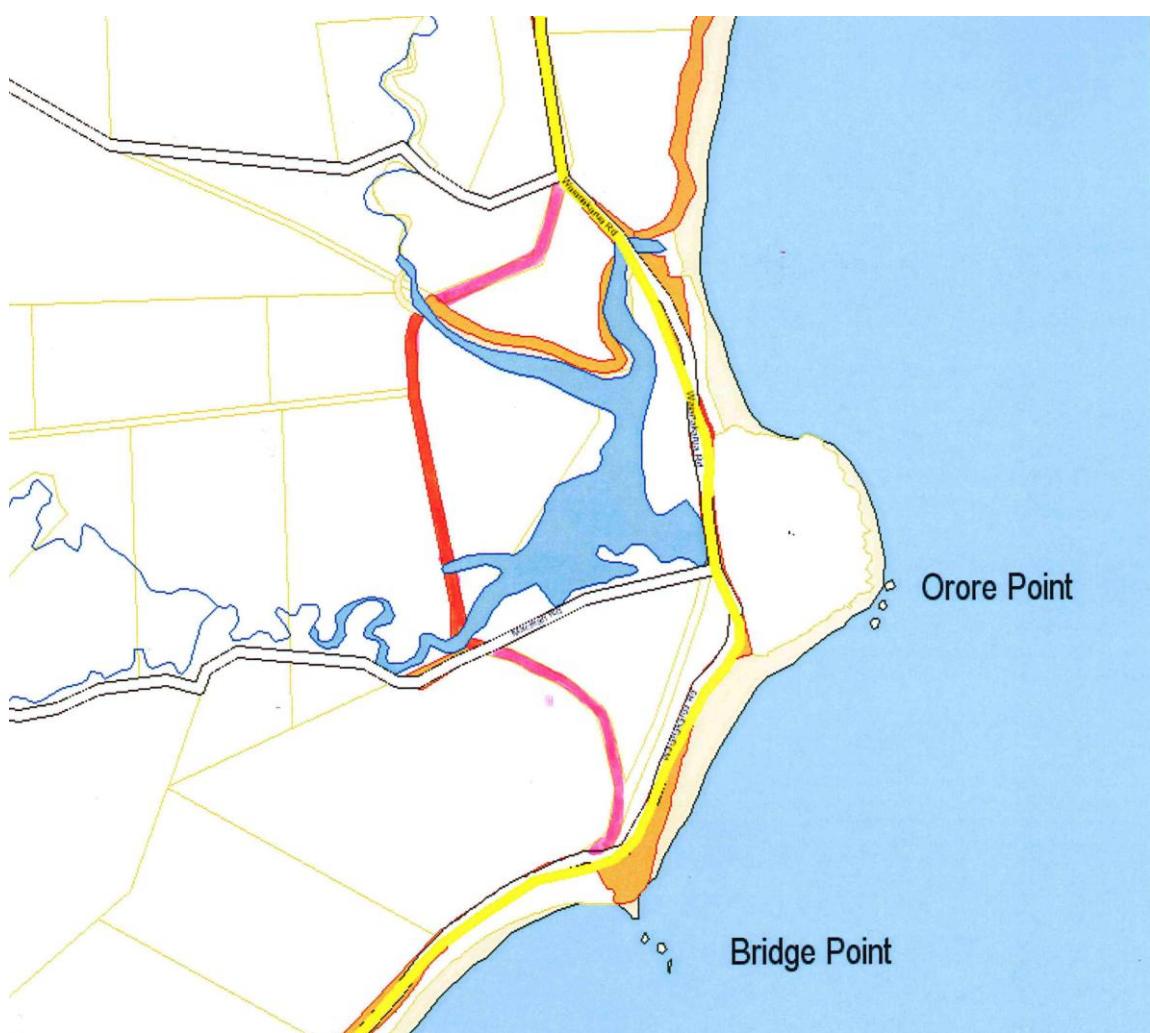
Future New Inland Route

Existing Waianakarua Rd shown yellow. Possible inland route shown red

Should the road causeway at the mouth of the Orote Creek lagoon be permanently breached then an inland route around the western side of the Orote Creek lagoon could be considered. Interestingly, this route appears to have been legal road at some time in the past and the land has subsequently been sold as the surveyed route now consists of several distinct land parcels. The route is shown on the following map. The length of the route is 1.6 kilometres. Since ground conditions in the vicinity of the lagoon are not known it is difficult to cost this new road. Using \$1,000/m as a rough order of cost the new road would cost \$1,600,000

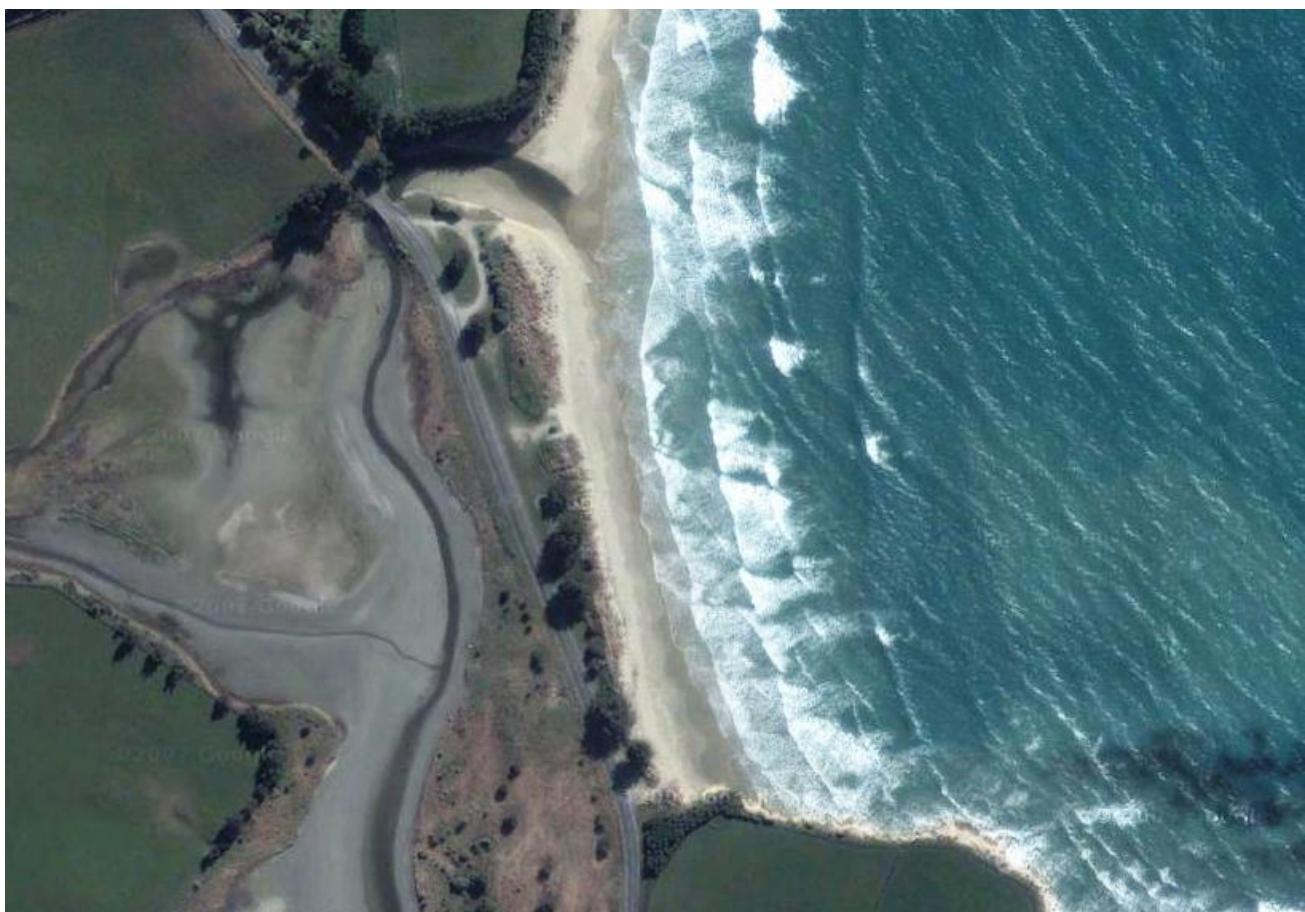
Aerial Photograph of Orote Creek Causeway

The southern end of the causeway appears to be particularly prone to breach due to the marram grass covered sand dunes, present at the northern end, being absent. The wave run-up height on the beach at the southern end is higher than the height of the adjacent road.

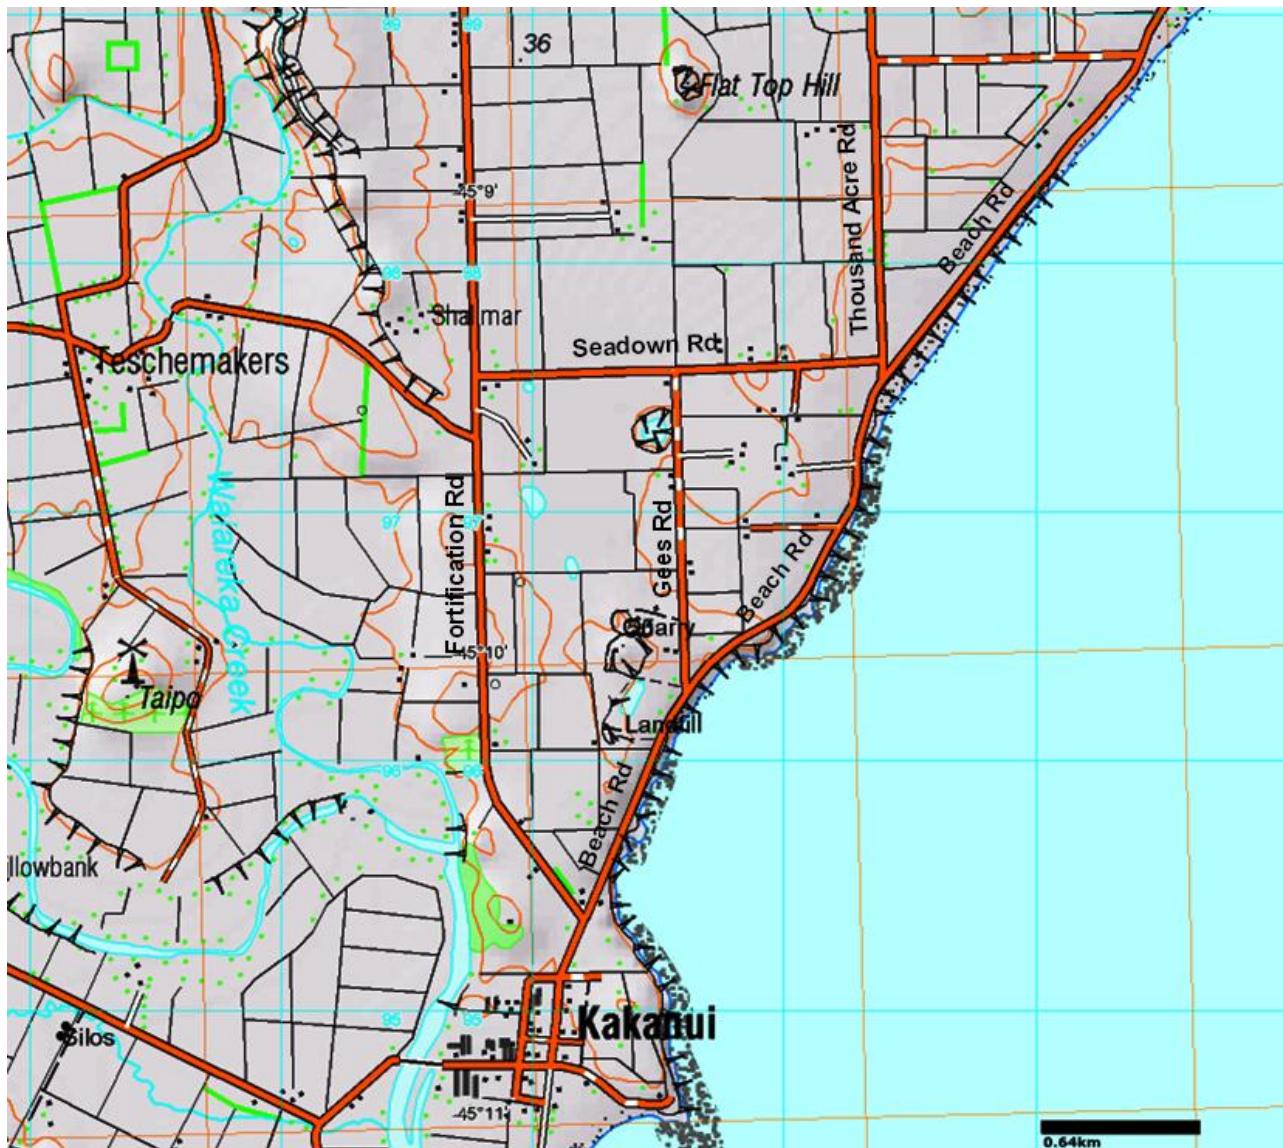
Site Map – Site 4

Site 4 consists of the section of Beach Rd from the intersection of High and Tyson Sts, Kakanui, north to Thousand Acre Rd, a distance of 2.8km.

The road strikes the coastline 460m north of Tyson Rd and is situated atop a 20m high cliff with the sea beneath. The road follows the cliff edge for the remainder of Site 4

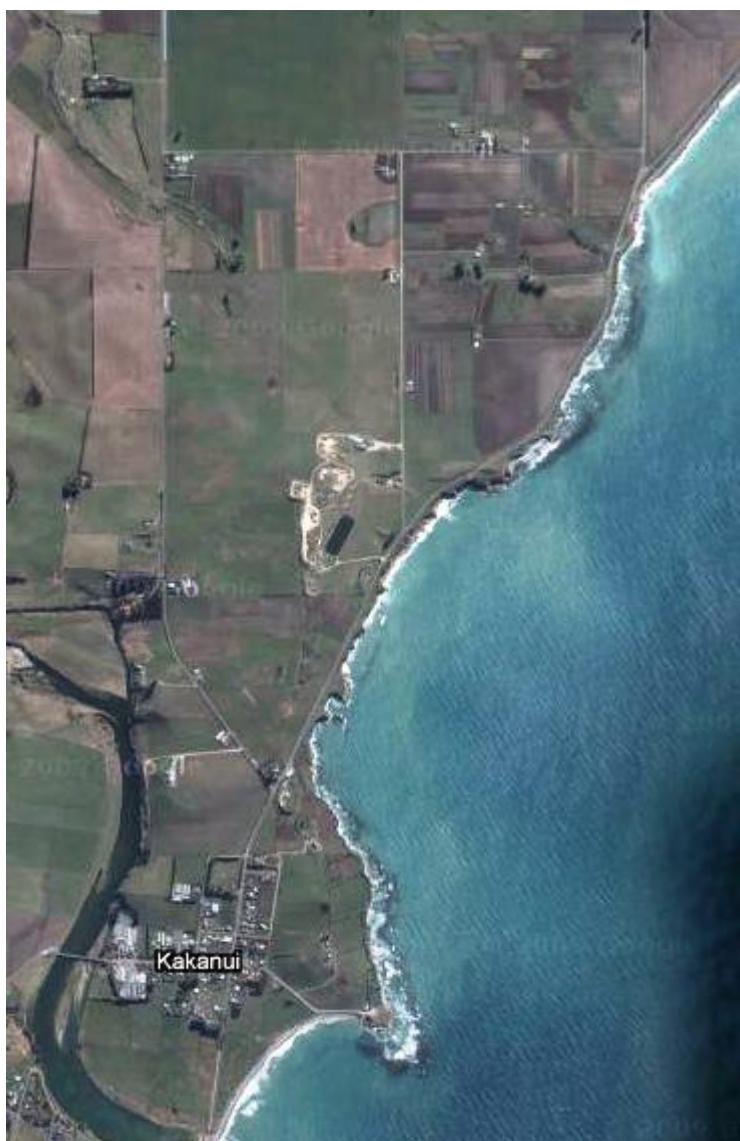
Aerial Photograph of Site 4

This section of coast fortunately has a sandstone strata located at the correct elevation to resist wave attack of the shoreline. Minor variations in the hardness of the sandstone has caused differential erosion resulting in a series of miniature bays and headlands. In several locations the upper edge of the cliff is in close proximity to the edge of Beach Road. This is particularly evident on the section of coastline adjacent to Kakanui's oxidation ponds.

Site 4 is not anticipated to have any erosion issues during the time period under consideration. The aerial photograph of Site 4 shown in this report indicates the presence of two dwellings with accessways onto Beach Road; these are shown diagrammatically on the Land Ownership map for the Site. Access to the land containing the dwelling labelled 1 and access to the dwelling itself may become a problem if ever the adjacent Section of Beach Rd is closed.

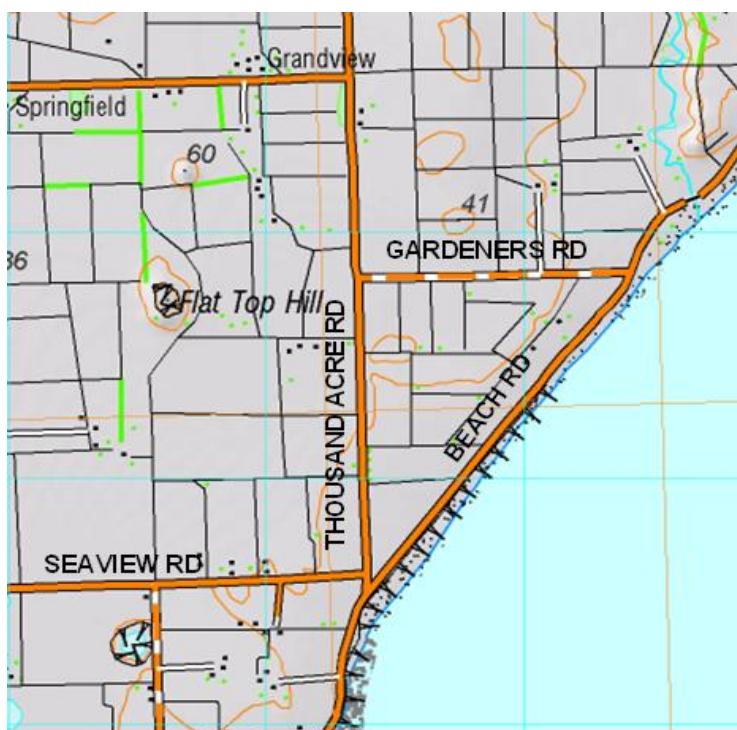
Site Map – Site 3

Beach Road, at this Site, has been closed to traffic by the construction of earth bunds at each end. It was closed in February 2007 when rough seas caused significant damage to the road, with several sections being washed away. The southern boundary of this Site marks the end of the sandstone strata at beach level which is providing erosion protection to sites further to the south. The coastal bank consists of what appears to be bands of ancient beach gravels along with silts and clay. This material is unconsolidated and very easily erodible. There is one dwelling using this section of Beach Road for access, the owners drive around the earth bund at the northern end.

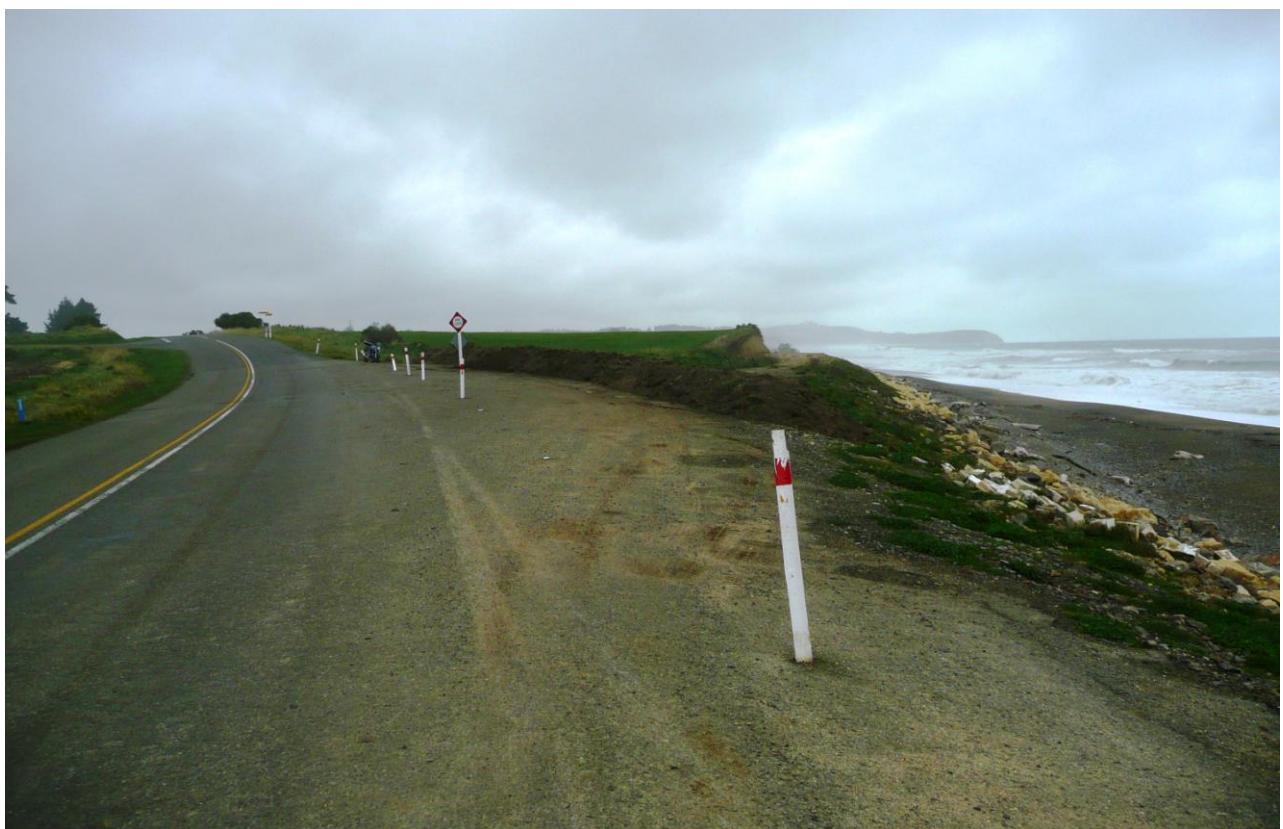
Beach Road closure at the southern end of Site 3

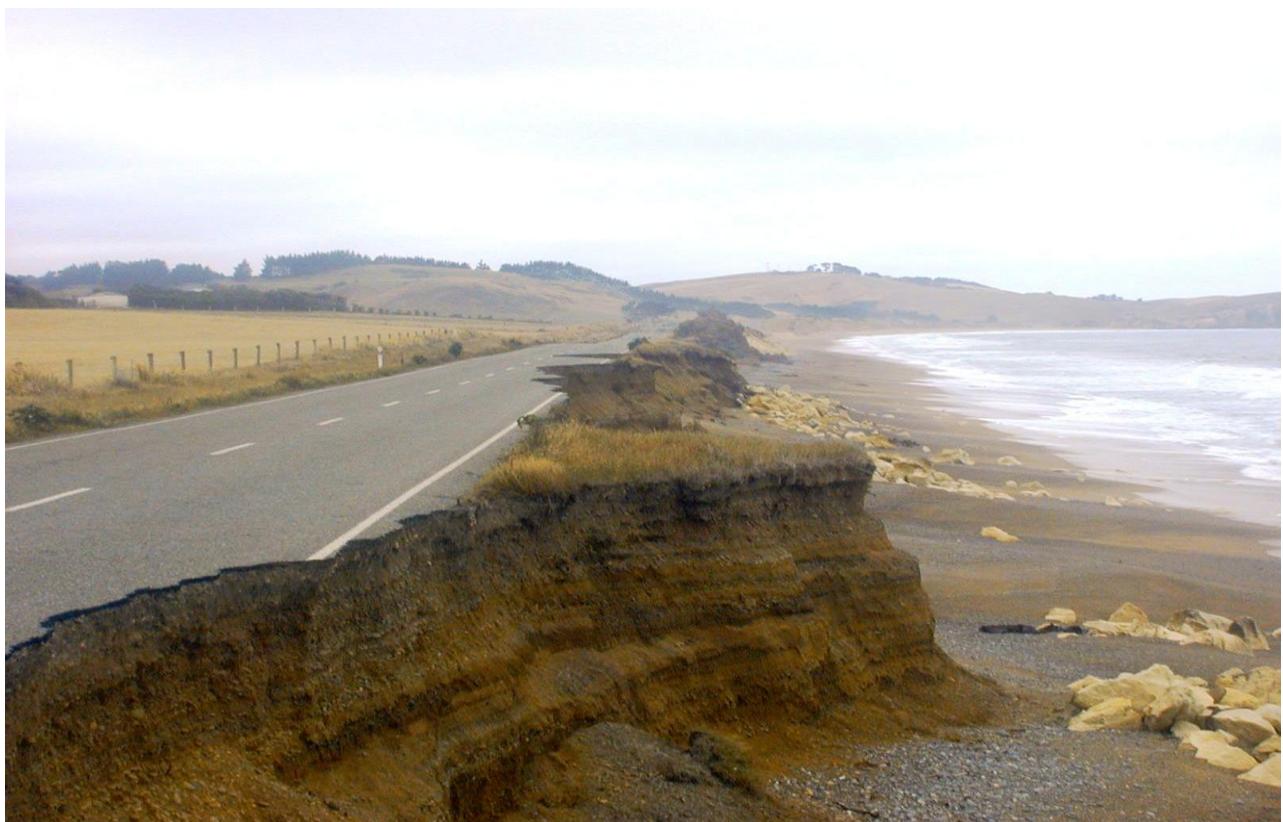
Site 3 – Significant damage to Beach Road

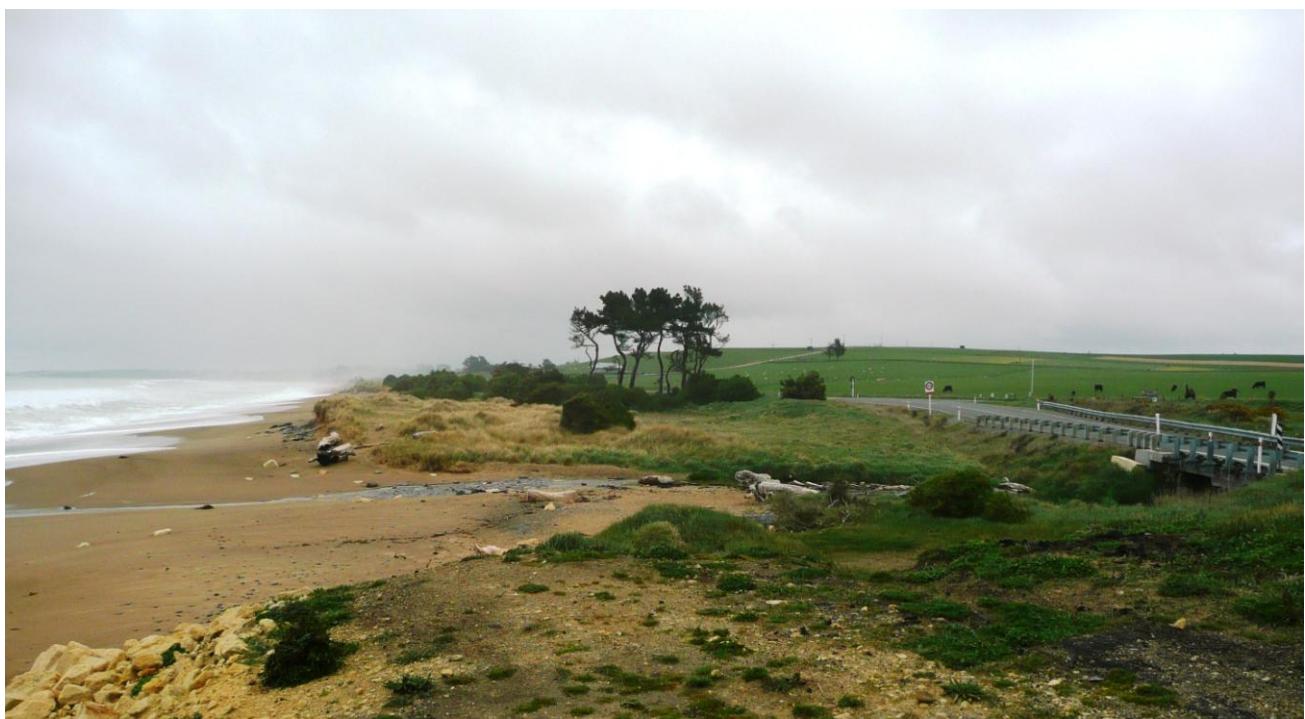
Site 2 – Mouth of Awamoia Creek

Erosion of the loess cliff north of the seawall is actively occurring.

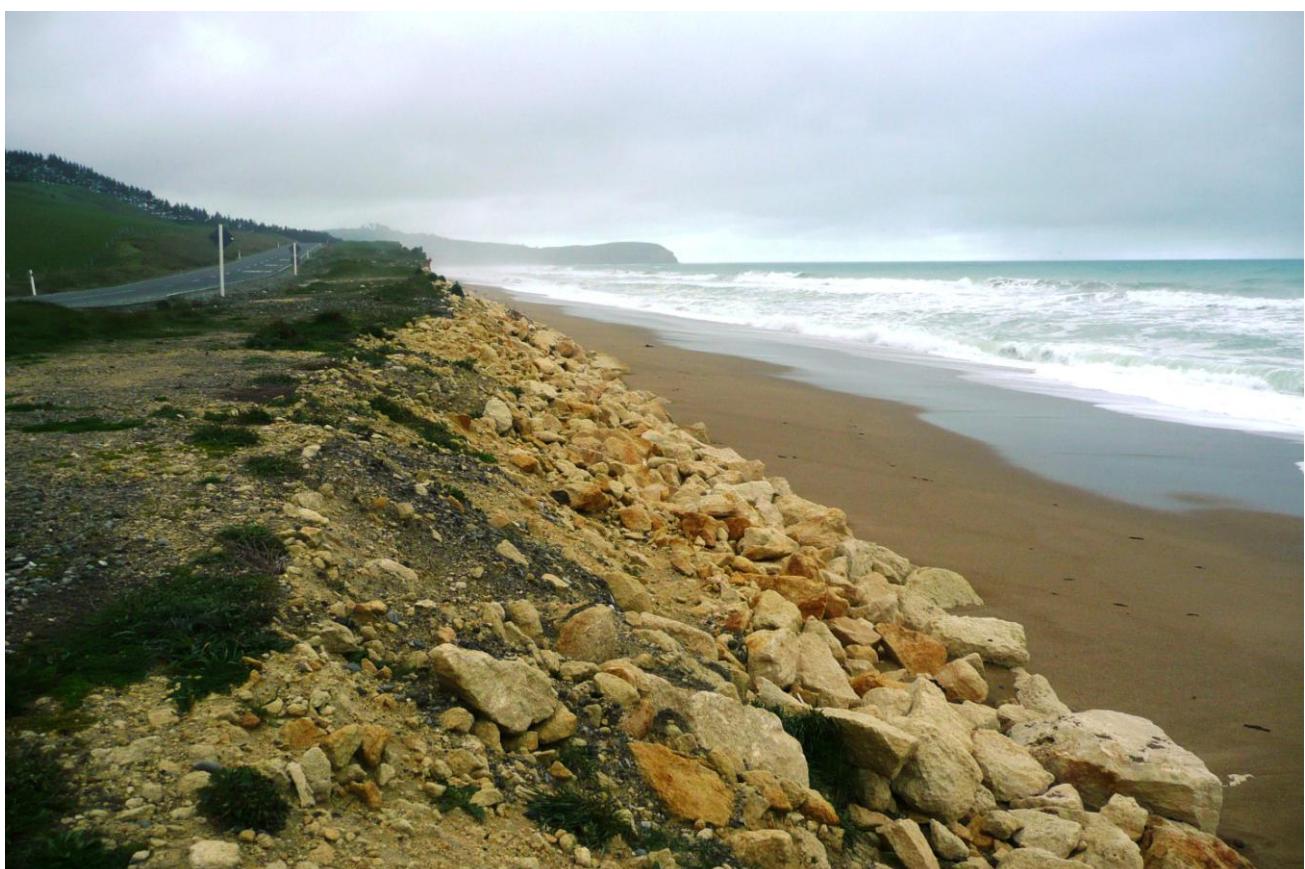
Site 2 – Random-rock Seawall north of Awamoia Creek

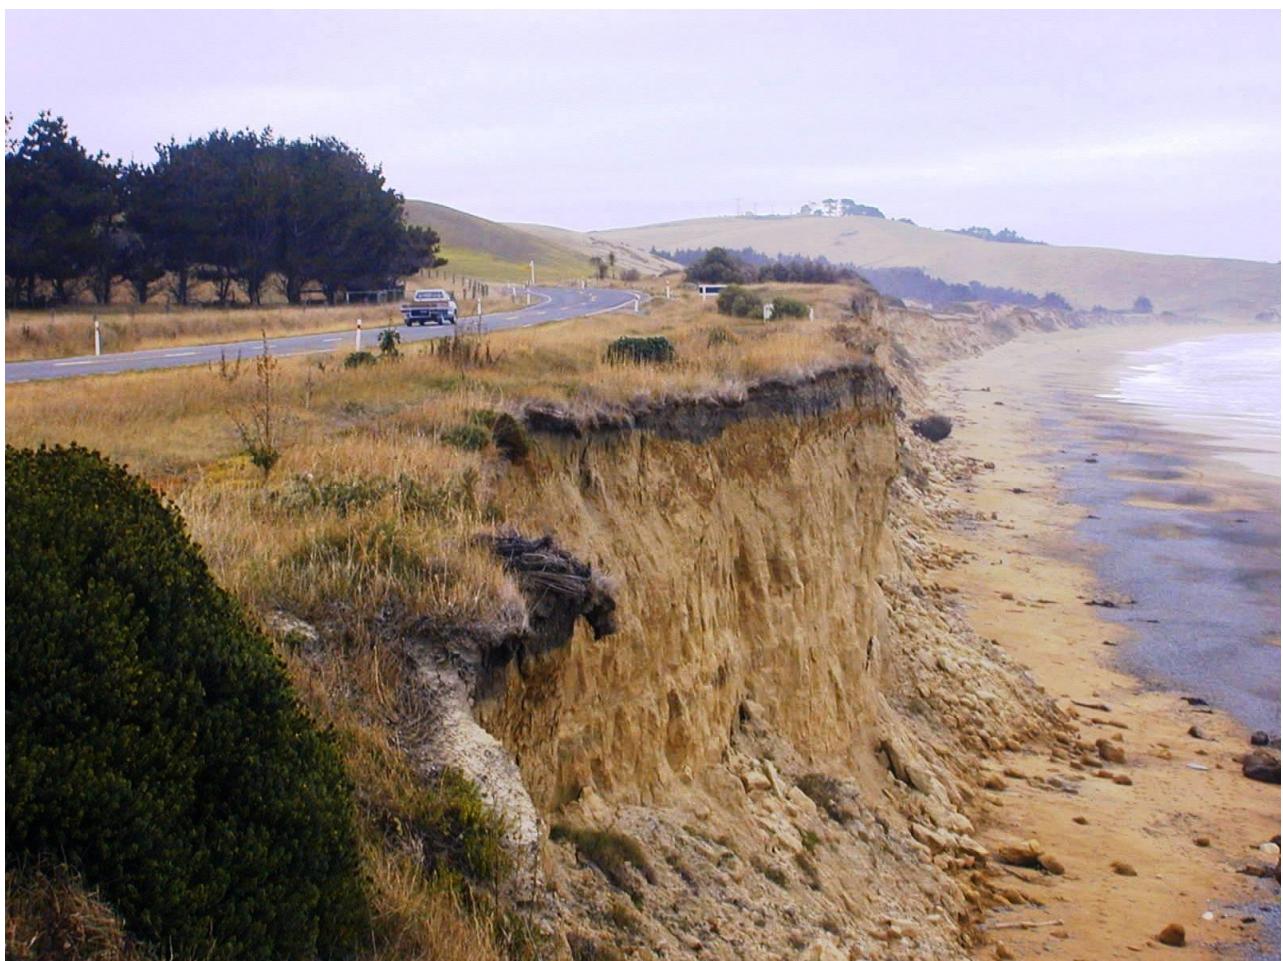
Site 2 – Active erosion of cliff face

A cost of \$3,000/lineal metre has been adopted as the cost of seawall construction. The cost to protect this site is therefore \$3,600,000. Coastal erosion protection is accordingly not considered a financially viable option. The distance from the cliff face to the road verge is typically 15m, with a long term erosion rate of 0.5 m/yr the road will theoretically be threatened in 30 years; however lateral instability of the cliff face could reduce this timeframe considerably.
