**Waitaki District Council
Contract No. 442
Report on Engineering Issues
Of a Coastal Roads Strategy**

Oamaru to Waianakarua

Report on Engineering Issues

Date: November 2009
Reference: 6-TWT12.00
Status: Final

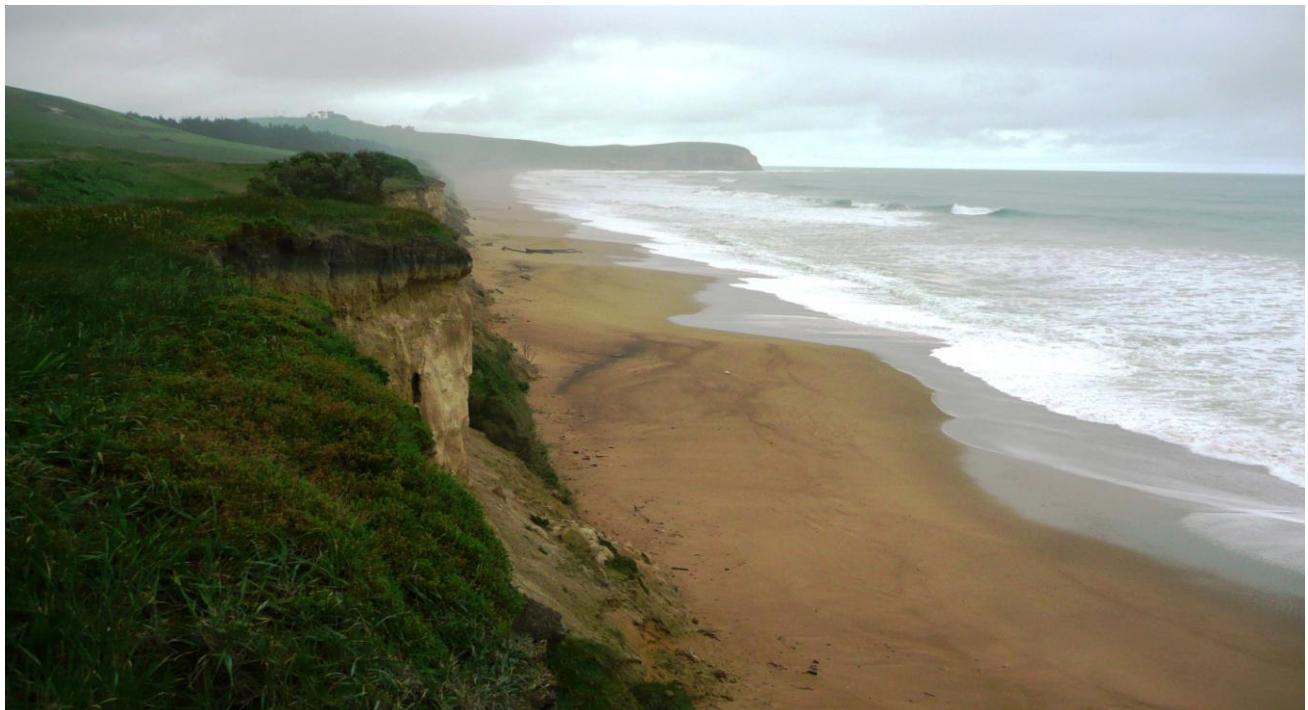
Site 1 – Southern end, looking north

At the southern end of the site wave run-up reaches the base of the cliff. Progressing northwards the beach widens and marram grass has become established along the landward area.

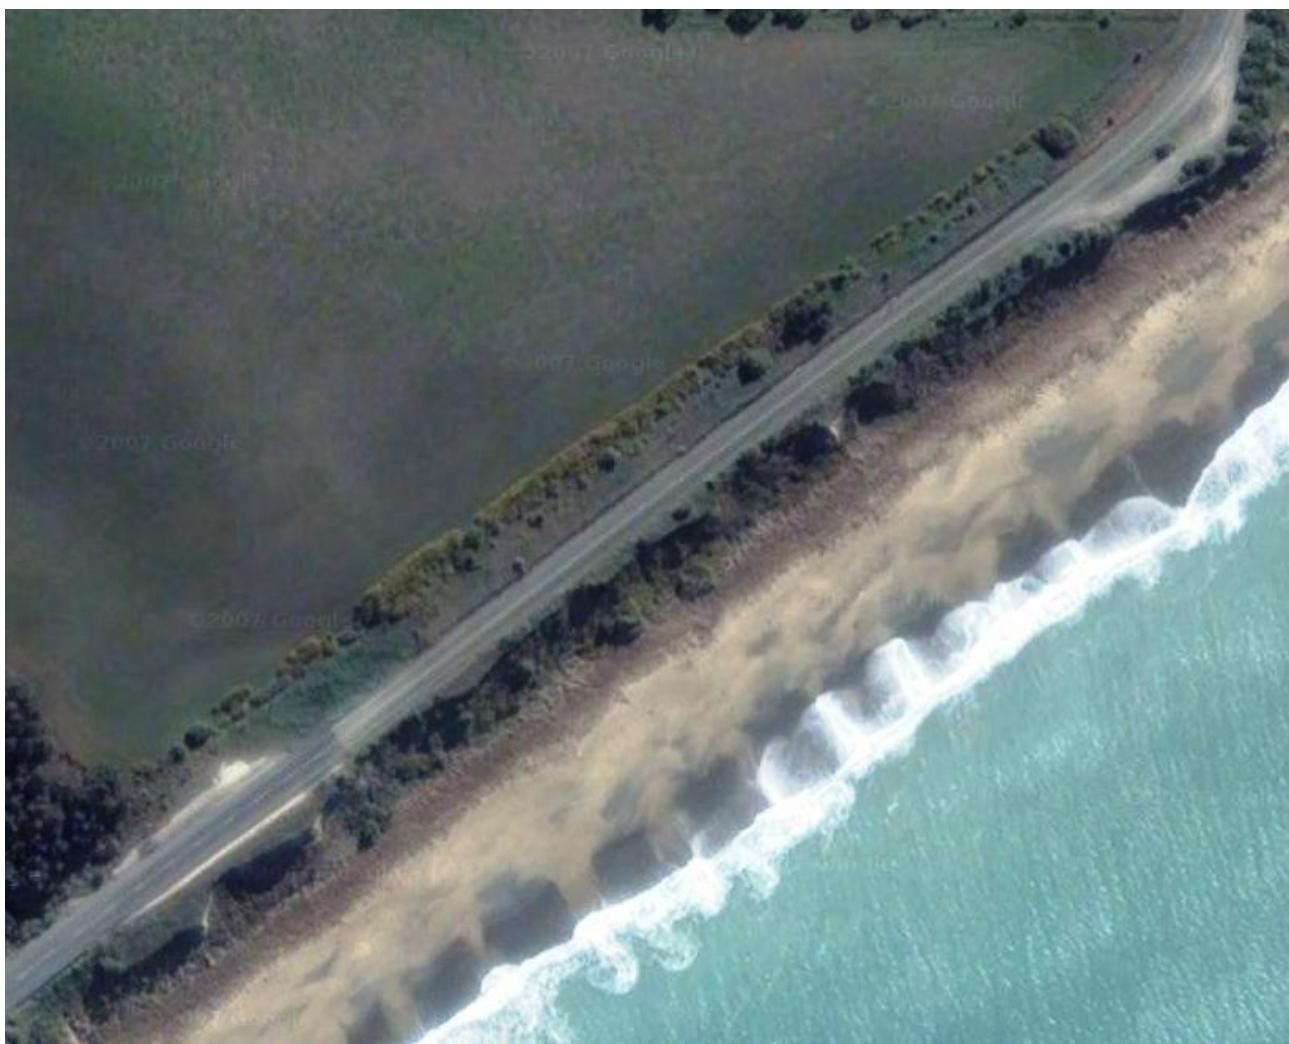
Site 1 – Irregular cliff face close to road edge.

Site 1 commences at Awamoia Rd in the south and the northern boundary is located where Beach Rd turns inland to enter Oamaru. The higher coast cliff that commenced in Site 2 continues through this site, reaching 14m in height, to abut the Cape Wanbrow peninsula further north. Again, the coast road is located on top of the cliff. The line of the cliff its irregular and in several places the top edge is in close proximity to the road edge.

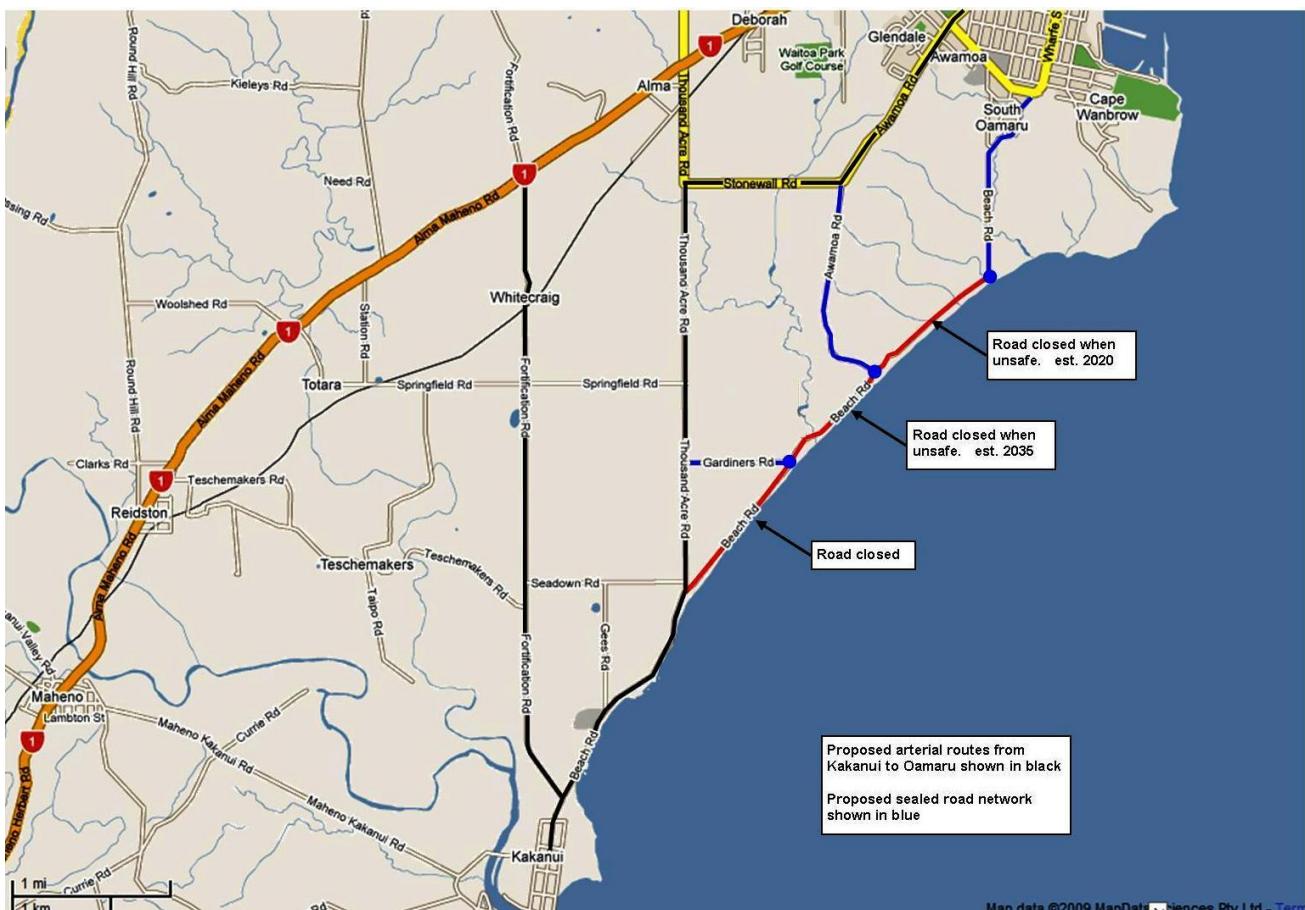
Final Roading Network – Kakanui to Oamaru

The plans below show the coastal roading networks for the areas Kakanui to Oamaru and Waianakarua to Kakanui once the threatened sections of the coastal road have been closed and the recommended road seal extensions have been completed. The road closure date estimates are those used in the Sequence of Events section.

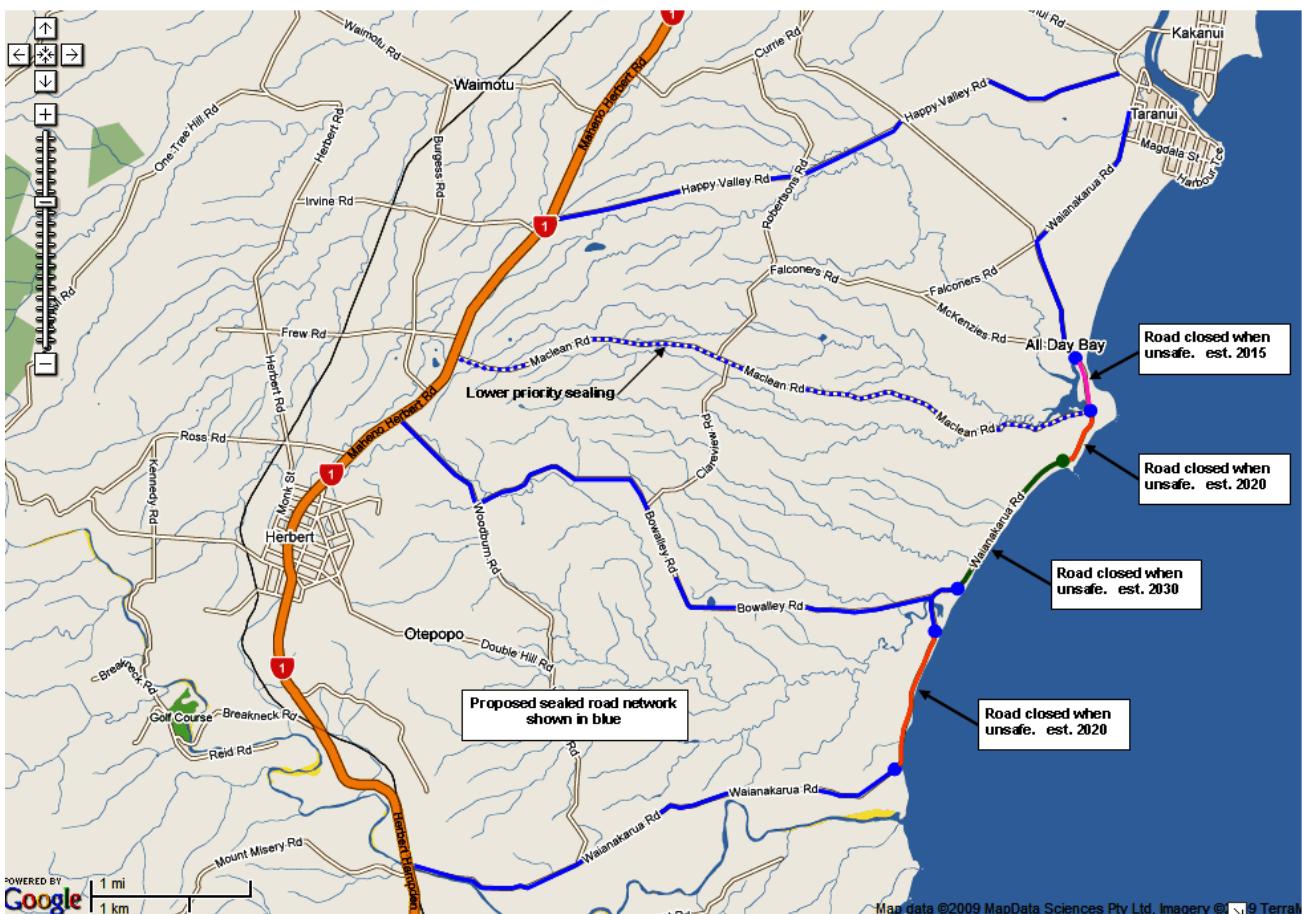
Final Roading Network – Waianakarua to Kakanui
