Forrester Heights Geotechnical reports

Test Street Subdivision - General Review

Subject: Ground Investigations at Forrester Heights, Oamaru

**Geotechnical Investigations
Test Street Subdivision, Oamaru**

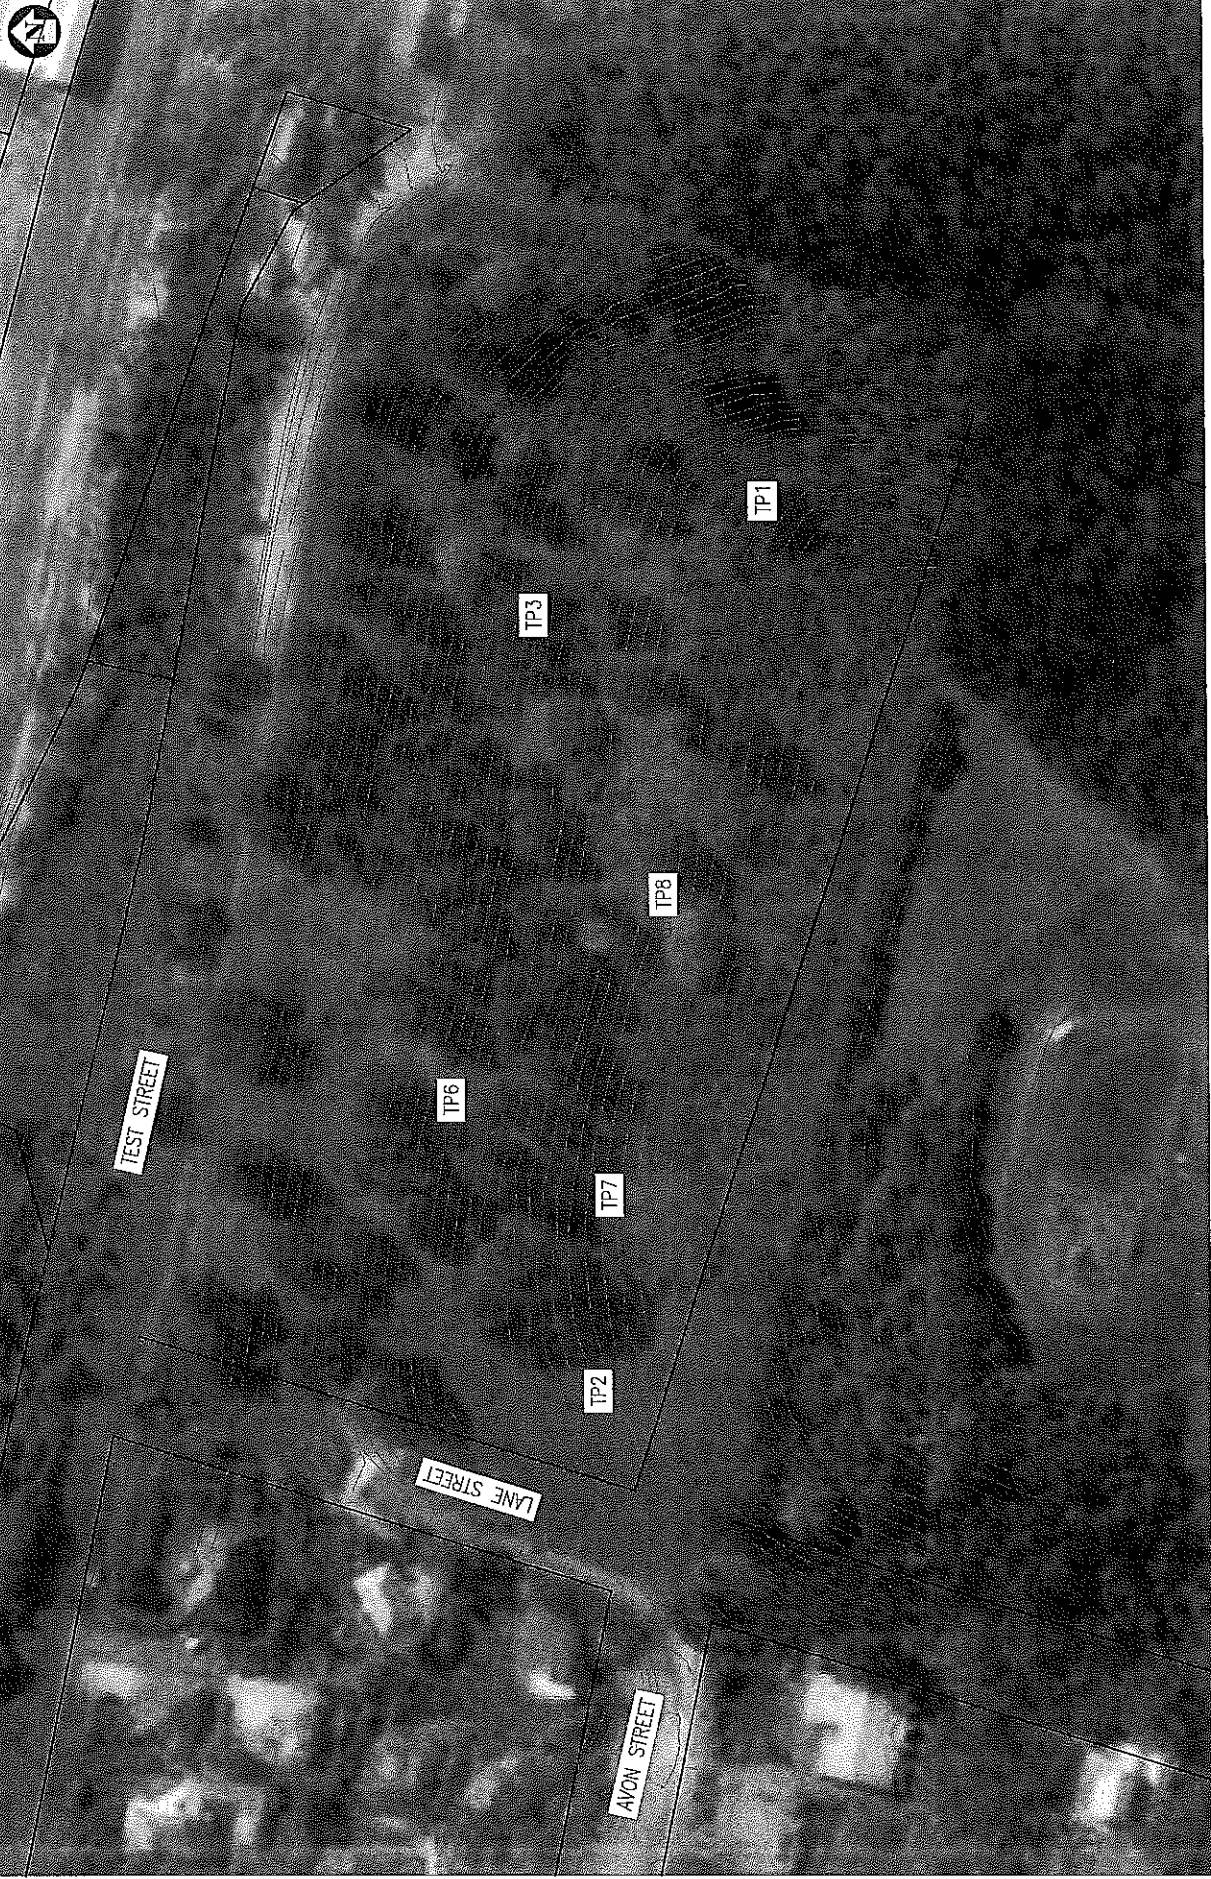
WAITAKI DISTRICT COUNCIL
GROUND INVESTIGATION
FORRESTER HEIGHTS, OAMARU
LOCATION PLAN

Nine test pit locations (TP1 to TP9) were initially considered for excavation (Figure 1), along the proposed roadway. The locations were chosen as the deepest points in cuttings for the proposed roadway. These depths varied between 3m and 6m. Two locations (TP4 and TP5) were eliminated from the proposed investigation due to their proximity to TP6 (within 20m). TP9 was also eliminated when the potential location was found to be on a public footpath and within a couple of meters of an existing roadway cutting, which would potentially be made unstable by excavation.

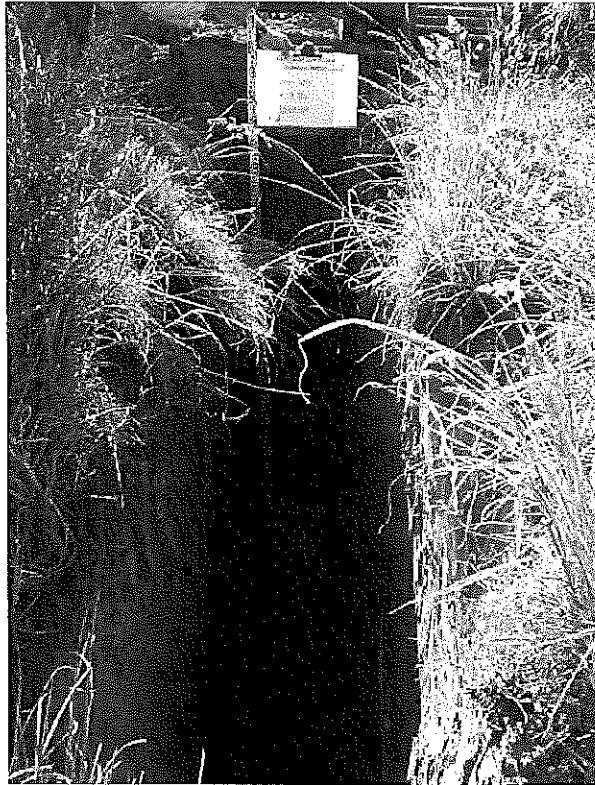
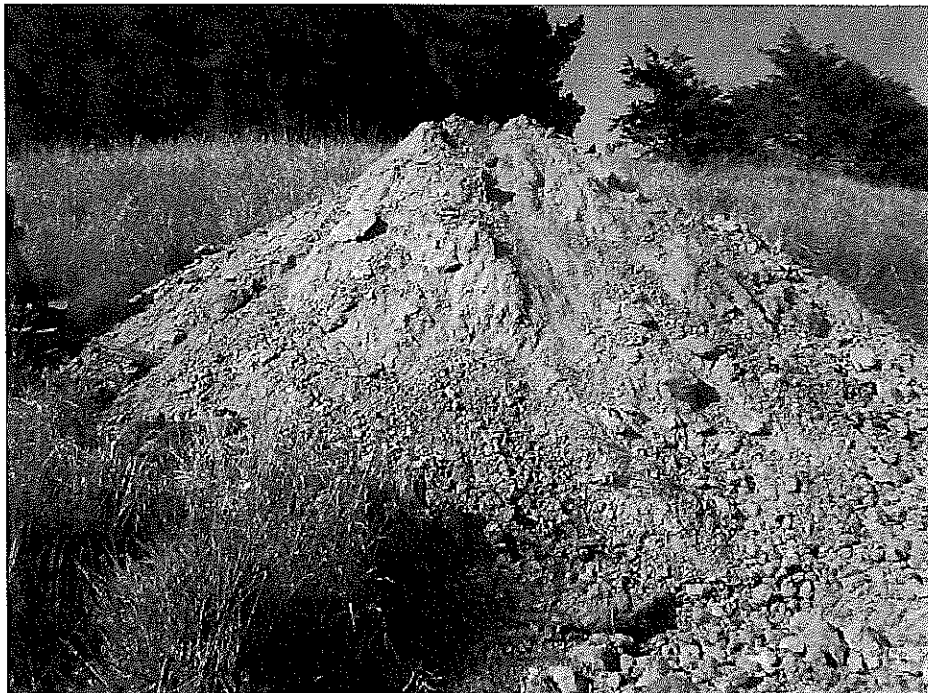
Test Pit TP1

TP1 encountered rock at 3.8m below ground level, which is above the expected road cutting base level.

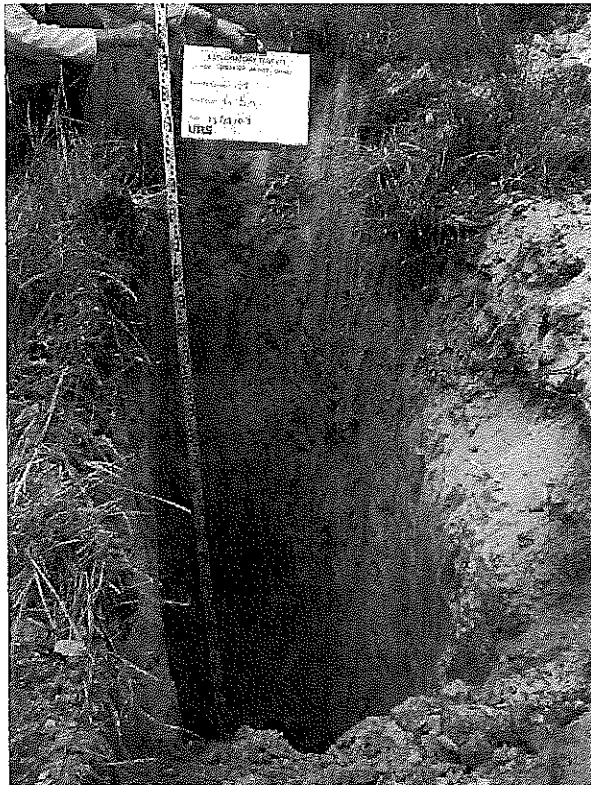
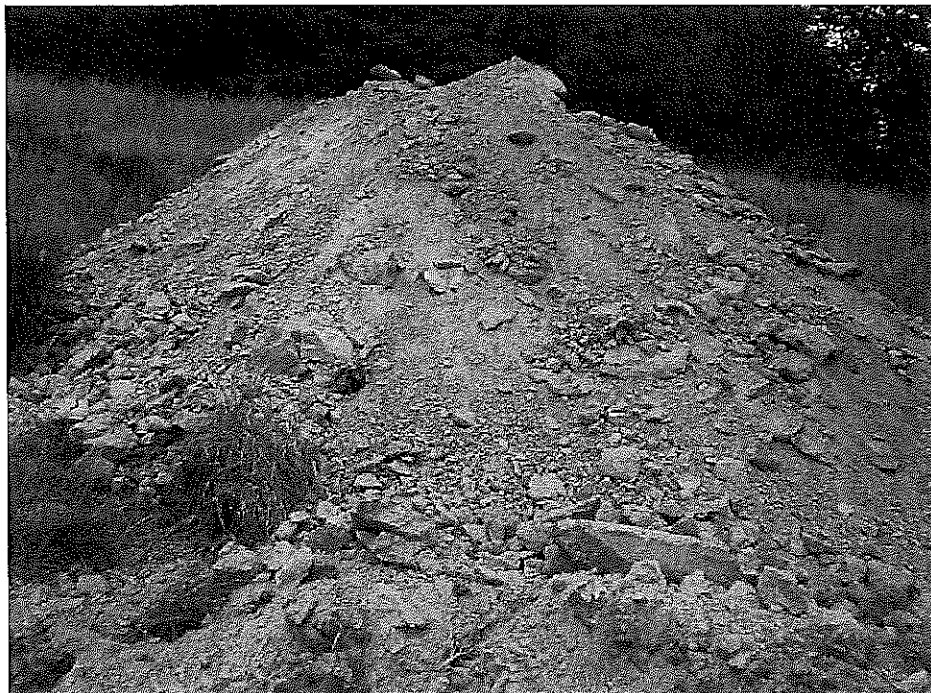
Test Pit TP2

All test pits encountered loess below topsoil. Topsoil depths varied from nil to 0.2m. Loess was encountered to a maximum depth of 4.5m (TP2, which was terminated at target depth).

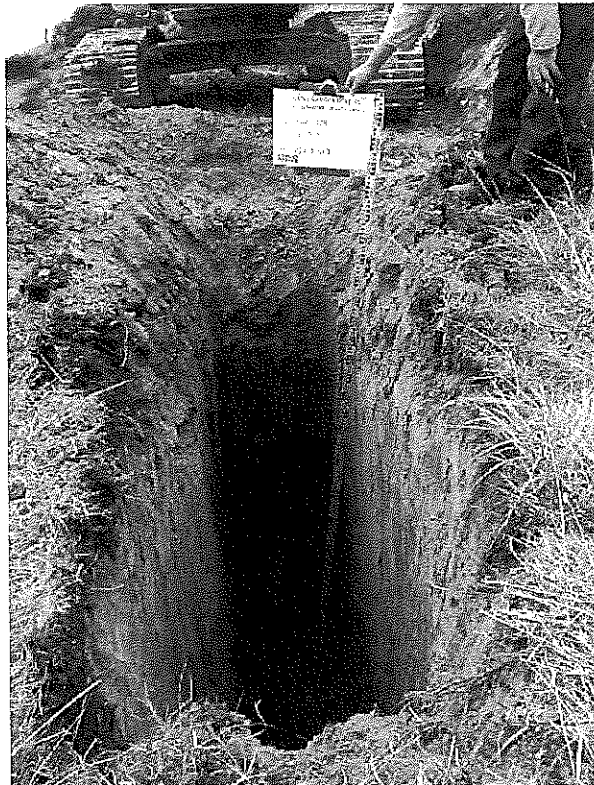
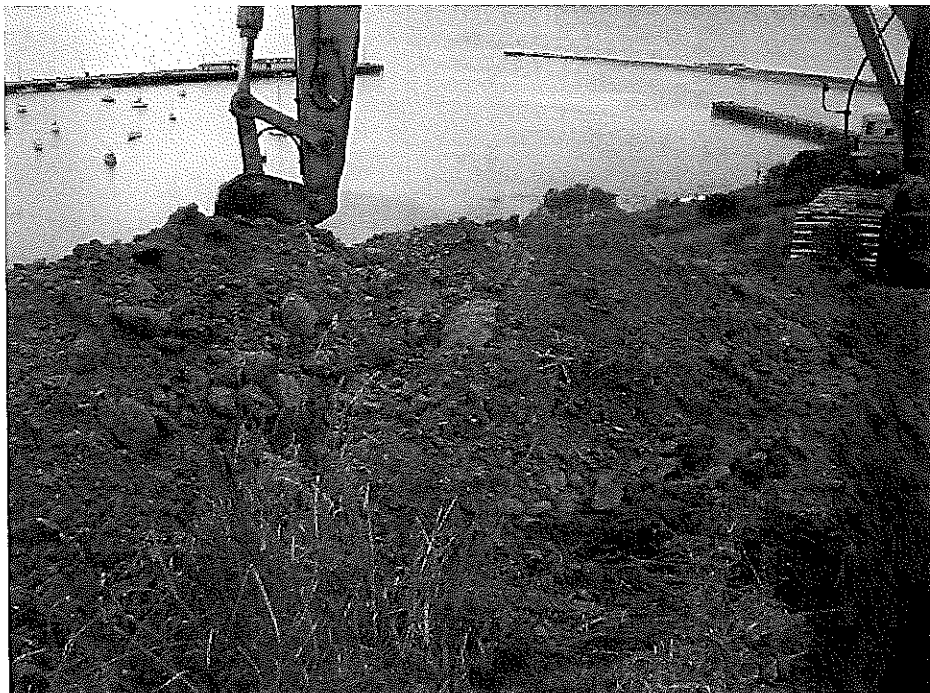
Test Pit TP6

SILT, light brown, homogeneous. Stiff, slightly damp, moderate plasticity,
with rare patches of white staining around rootlets at 1.2m.
