Beach Road Landfills Remediation

Assessment of Environmental Effects

Client: Waitaki District Council

AECOM New Zealand Limited

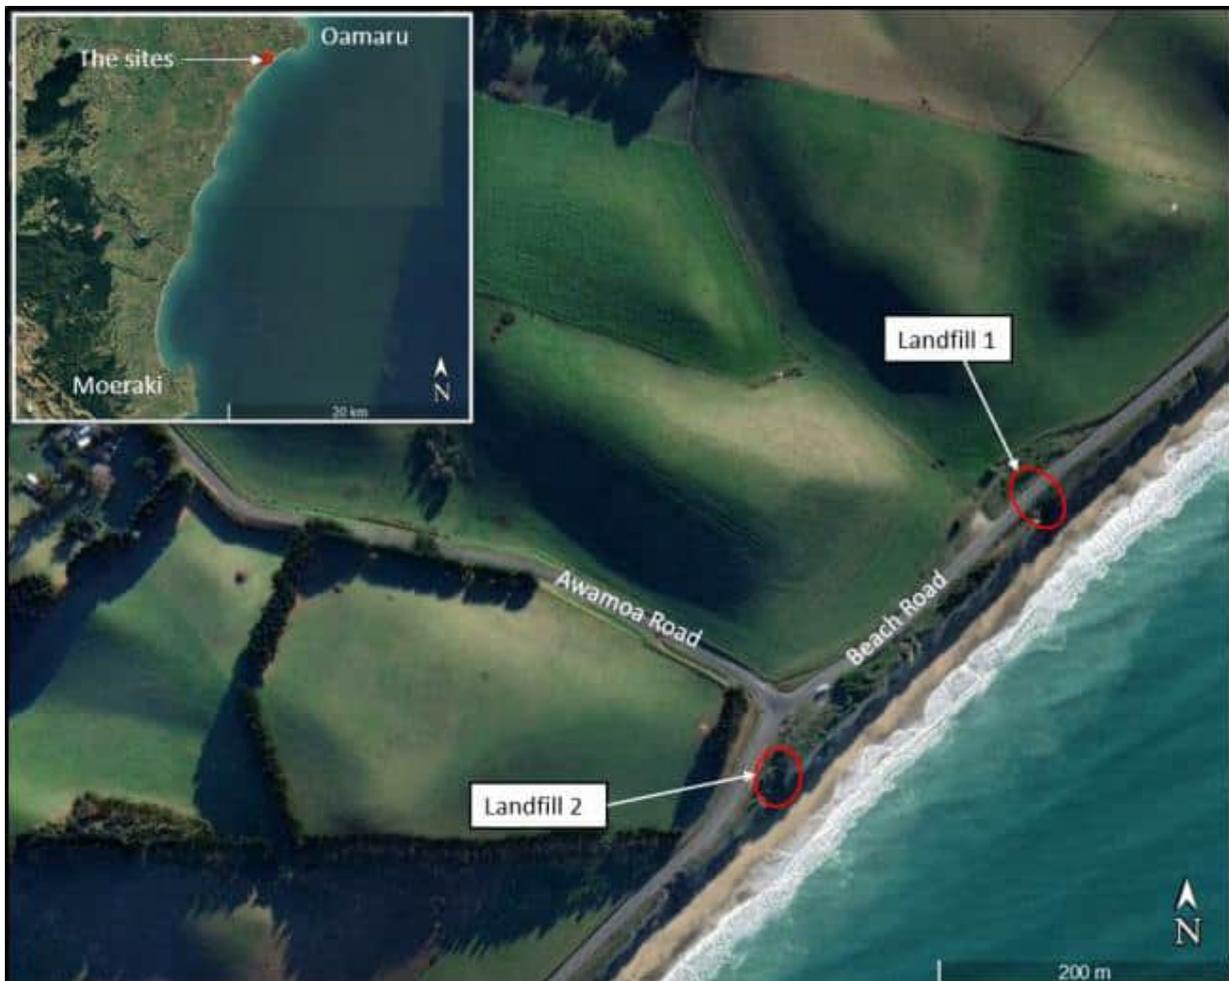
Figure 1 Location of landfill sites

Landfill 1 is located approximately 220m north east from the intersection with Awamoa Road and Beach Road and has an approximate total site area of 677m². Landfill 2 is approximately 10m south west of the intersection and has an approximate total site area of 722m². Beach Road traverses Landfill 1 and adjoins to the west of Landfill 2.

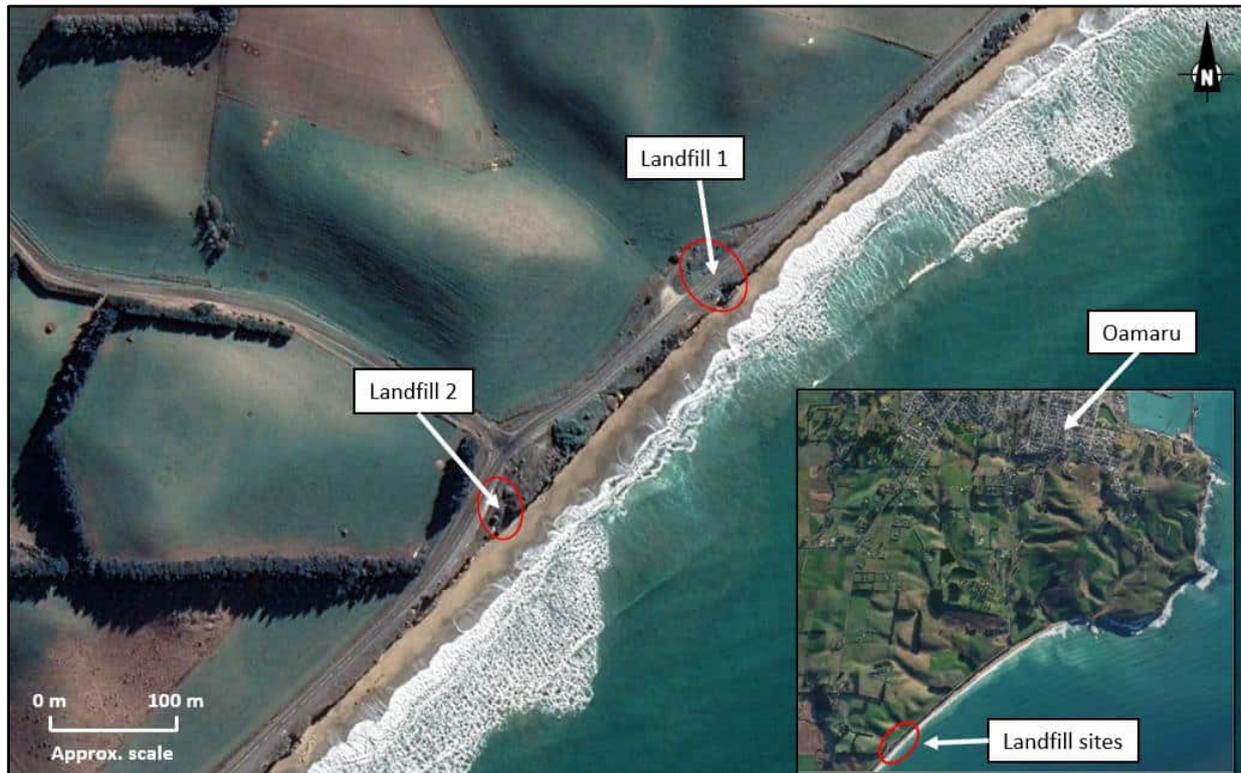
Figure 1 Site location of landfill sites (Google Earth imagery)

The two landfill sites, referred to as Landfill 1 and Landfill 2, are located along Beach Road, approximately 3 km south of Oamaru (Figure 1). The landfills are located within existing gullies along a steep, eroding, coastal cliff between Beach Road and the Pacific Ocean.

Landfill 1 is located approximately 220 m northeast from the intersection with Awamoa Road and Beach Road and has an approximate total site area of 677 m². Landfill 2 is approximately 10 m southwest of the intersection and has an approximate total site area of 722 m². Beach Road traverses Landfill 1 and passes inland of Landfill 2.

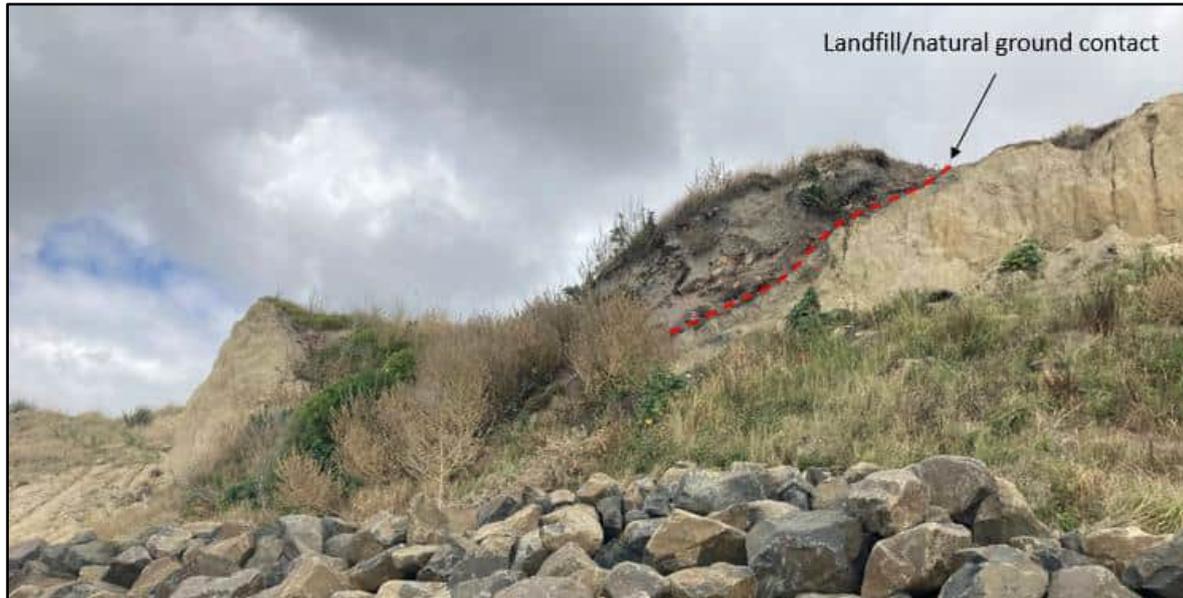
Figure 2 Northern extent of Landfill 1 illustrating contact between the landfill and natural ground

- The landfill area is dominantly vegetated with grass and small shrubs.
- Gabions are present at road level at the top of the cliff, retaining the road, approximately 8 m in length and at least 0.5 m high.
- Rock armouring is present at the base of the landfill, with a varying width from base of the landfill (5 to 8 m). The rock armour varies in size from approx. 0.3 m diameter, up to 1.5 m diameter.
- A steep access track from the road down to the beach has been established at the southern extent of the landfill.
- Sub vertical cliffs (dominantly loess overlaying marine sands) are adjacent to the landfill site. The contact between the loess and marine sand was obscured by collapsed cliff material.
- The contact between the landfill and natural ground is visible at the northern extent as shown in Figure 2. The approximate angle of this contact is 35 to 45 degrees.

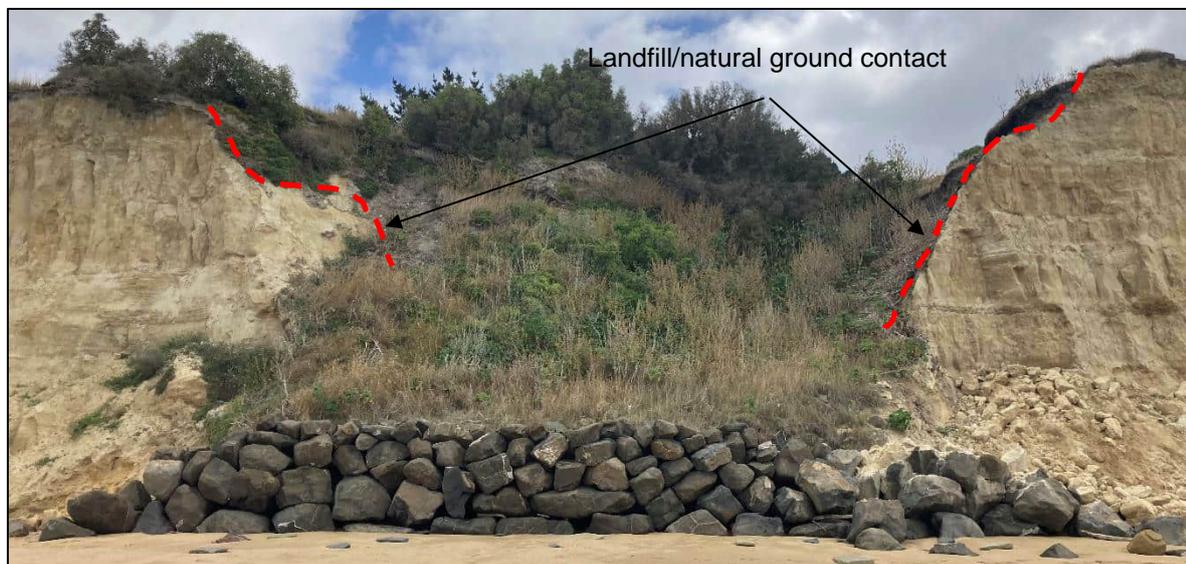
Figure 3 Landfill 2 illustrating contact between the landfill and natural ground

- The landfill area is dominantly vegetated with grass and small shrubs with some established trees.
- Surface drainage is present at road level, at the head of the landfill, parallel to the road. The unlined swale is approx. 0.8 m deep and 0.5 m wide at the base.
- Rock armouring is stacked vertically at the base of the landfill, approx. 1.5 to 2 m in height. The rock armour is typically larger rocks approx. 1 m diameter.
- Sub vertical cliffs (dominantly loess overlaying marine sands) are adjacent to the landfill site. The contact between the loess and marine sand was obscured by collapsed cliff material.
- The natural gully slope angles are estimated at approx. 35 to 40 degrees at the southern end and slightly steeper, 45 degrees, at the northern end shown in Figure 3.

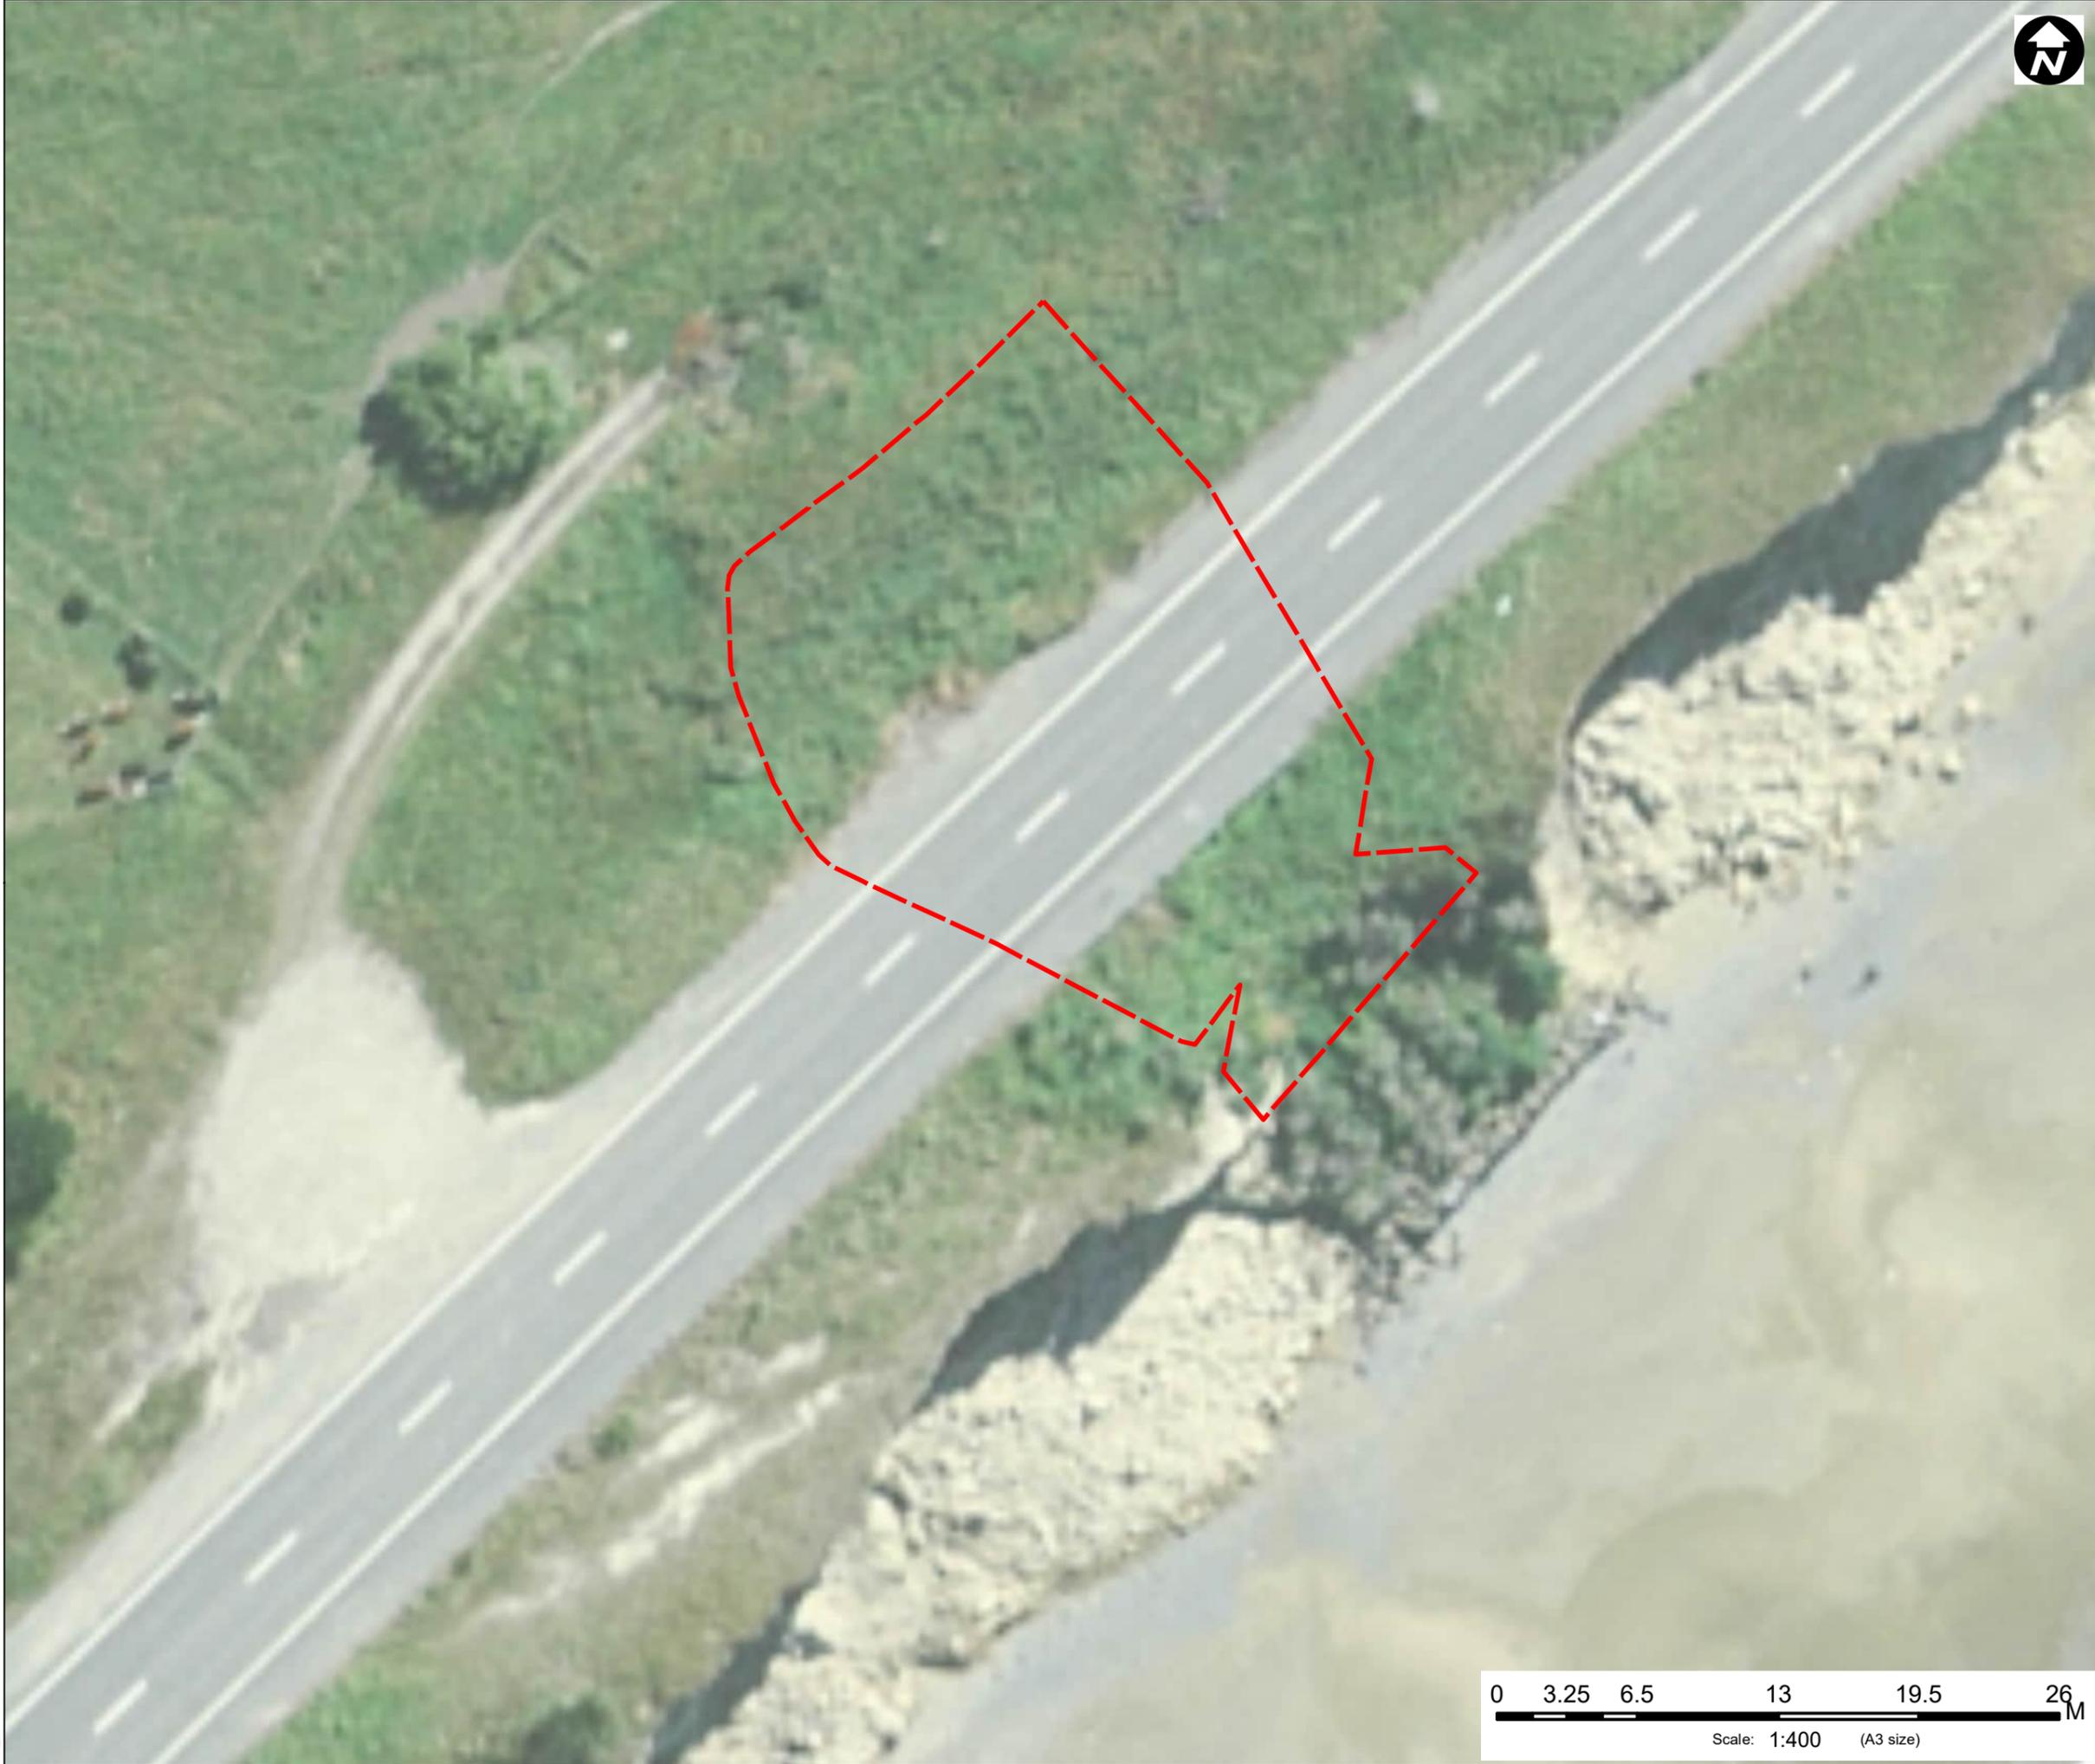
MAP NUMBER
FIGURE 2

SHEET TITLE
LANDFILL 1

Landfill 1 (see **Figure 2, Appendix A**) covers an area of approximately 676.95 m², with an estimated waste volume of 2,246 m³. It extends beneath Beach Road. Landfill 2 (see **Figure 3, Appendix A**) covers an area of approximately 721.79 m², with an estimated volume of 4,266.6 m³.

While the lateral extents of filling have been investigated, the landfill boundaries are not known definitively. The approximate landfill boundaries are shown on **Figure 2 and Figure 3 (Appendix A)**.

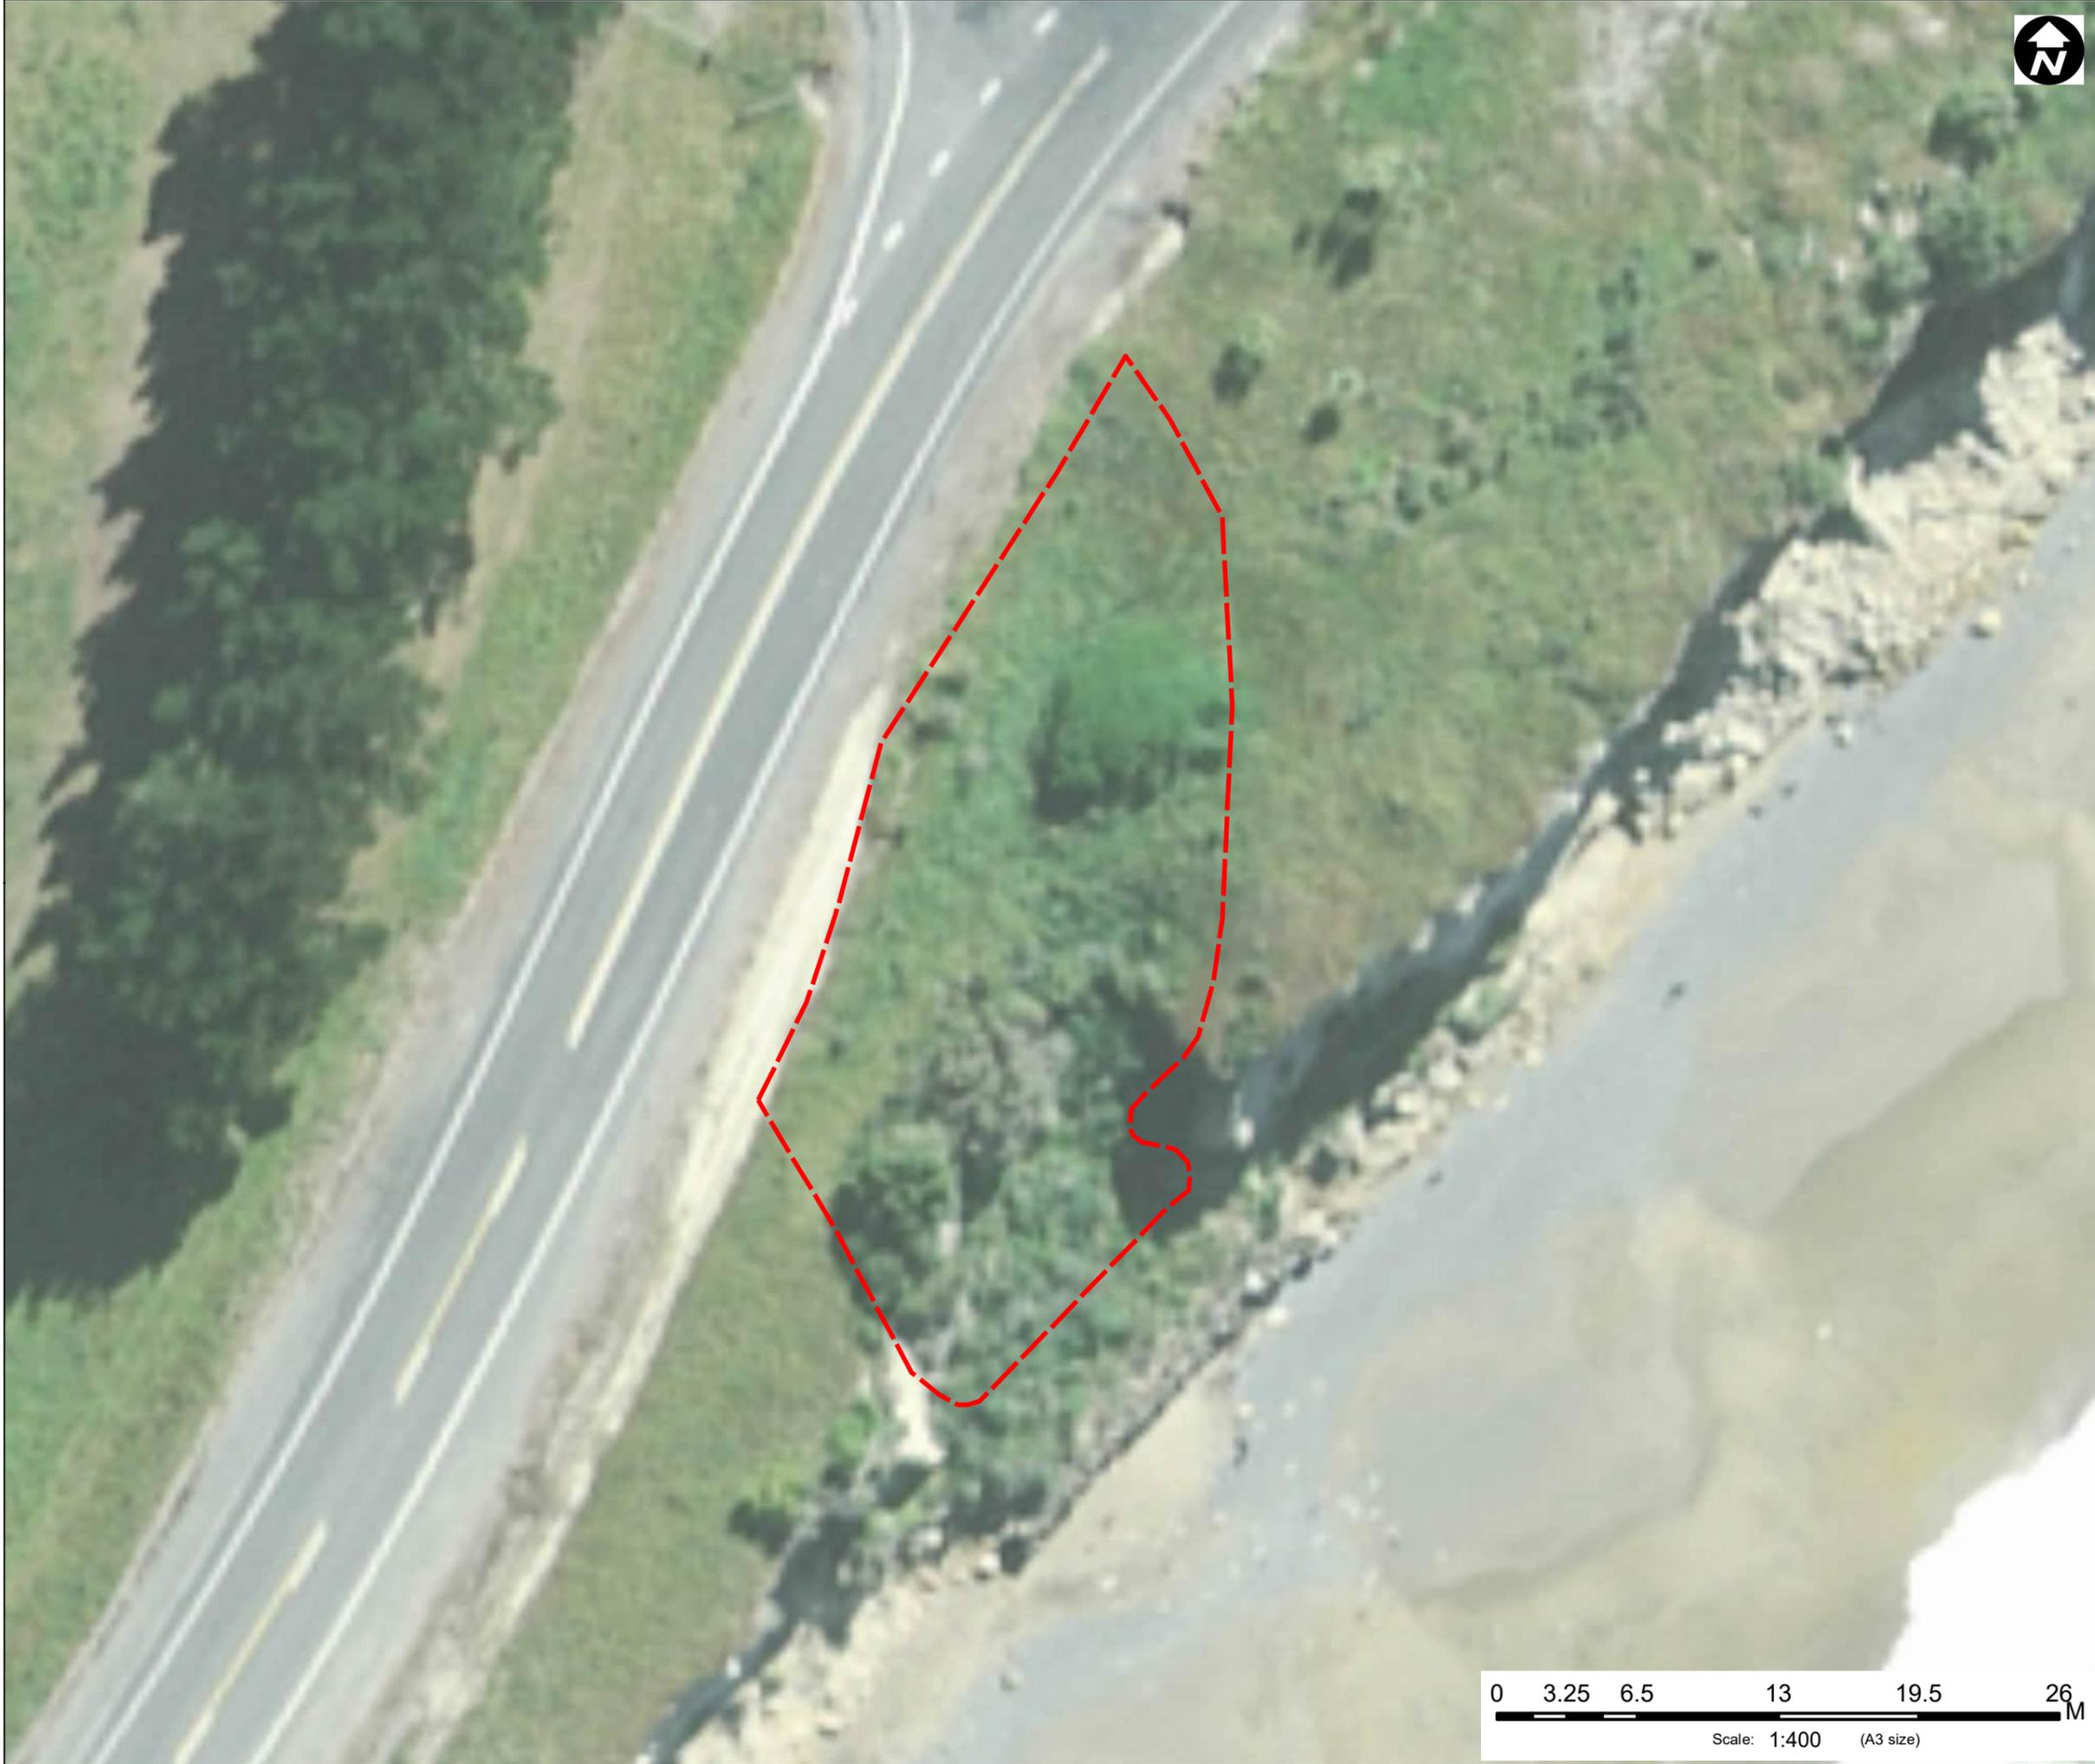
MAP NUMBER
FIGURE 3

SHEET TITLE
LANDFILL 2

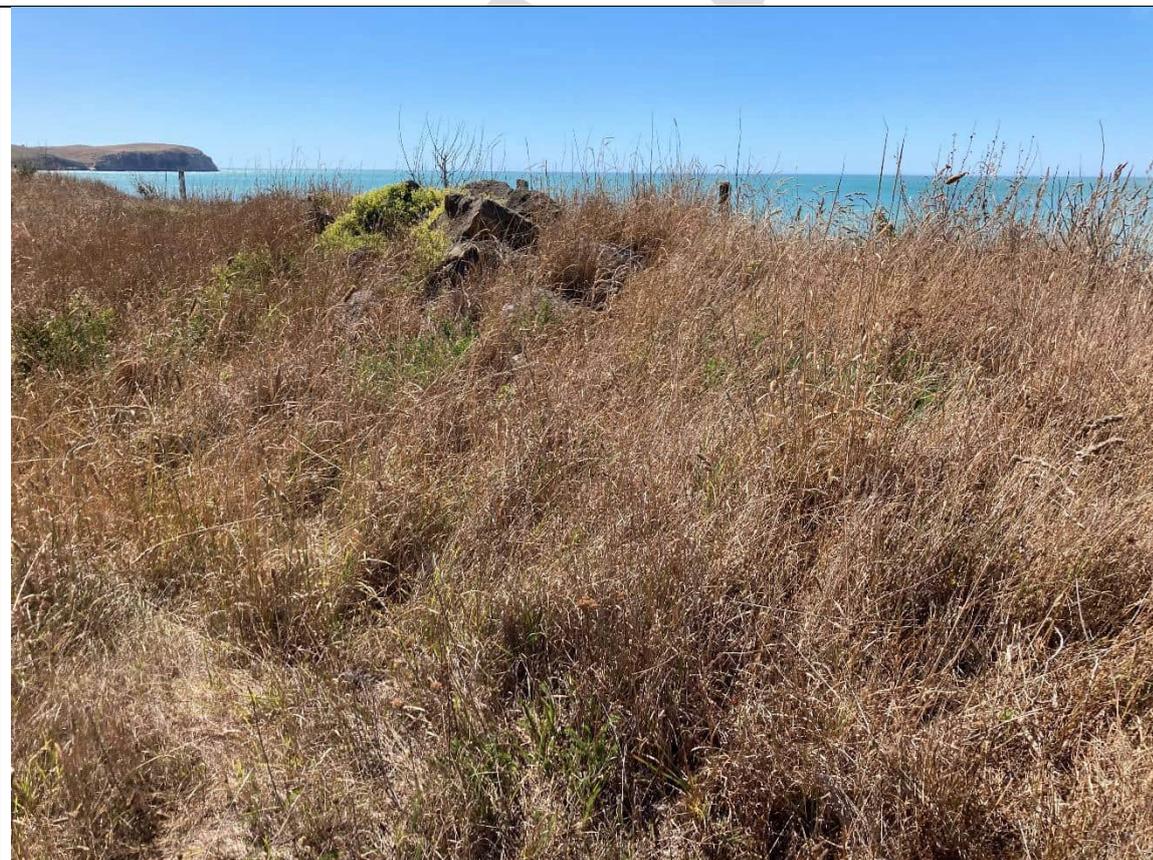
Figure 4-2Photo 1: Potential suitable habitat (EG – rank grass) for McCann’s skink associated with the Project area

During the site investigations, no indigenous lizards were identified during incidental observations. The Not Threatened McCann’s skink is however widespread and several records occur within 2 km of the Site. Habitat availability for this species was confirmed at both landfill sites during the Site walkovers, within the rank grass (EG) (Figure 4-3 Photo 1). During the site investigations, no suitable habitat of contiguous forest vegetation or rocky outcrops was present, that could sustain a population of the At Risk – Declining Korero gecko.

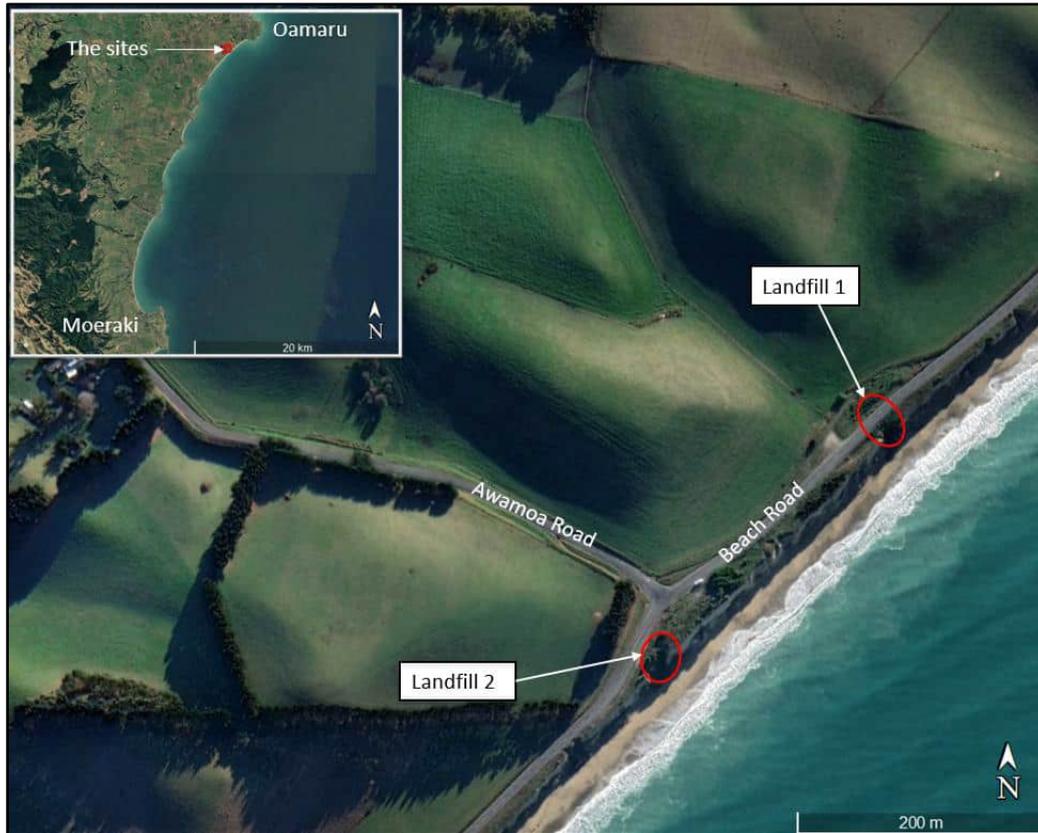
Figure 1 Site location. Inset on top left to illustrate wider coastal setting (Google Earth).

The two landfill sites, referred to as Landfill 1 and Landfill 2, are located along Beach Road, approximately 3 km south of Oamaru near the Awamoa Road intersection (Figure 1). The landfills are located within existing natural gullies along a steep, eroding, coastal cliff adjacent to Beach Road. The coastal cliff is within an approximately 7 km long bay, oriented northeast southwest that is confined by Cape Wanbrow to the north and Kakanui to the south. This is one of several bays within an overall larger embayment along the east coast of the South Island that is bound by the Cape Wanbrow to the north and Moeraki headland to the south.

Road level, the top of the landfills is approximately 17 m above sea level. Landfill 1 extends from the coastline and traverses beneath Beach Road, it is approximately 20 m to 30 m wide and 36 m in length. Landfill 2 is on the eastern side of Beach Road and is approximately 10 m to 20 m wide and 47 m in length.

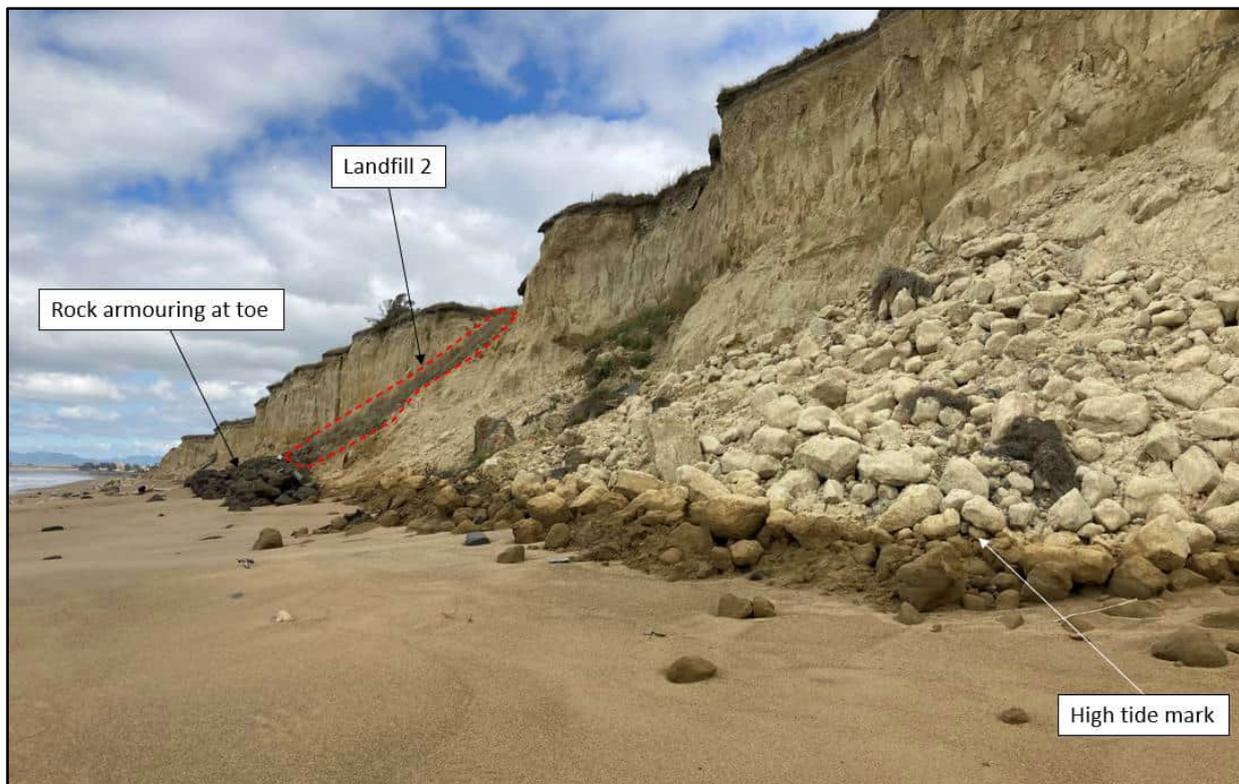
2.0 Scope of work

Figure 2 below illustrates the collapsed cliff material accumulated at the base of the cliff adjacent to Landfill 2. As illustrated in Figure 2, high tide reaches the base of these cliffs along the extent of the coastline in the vicinity of the landfills.

The beach materials are dominantly sand with occasional rounded gravels. Rock armouring has been placed at the toe of each landfill and protrudes slightly further out onto the beach than the cliff edge, this is illustrated in Figure 2 at Landfill 2.

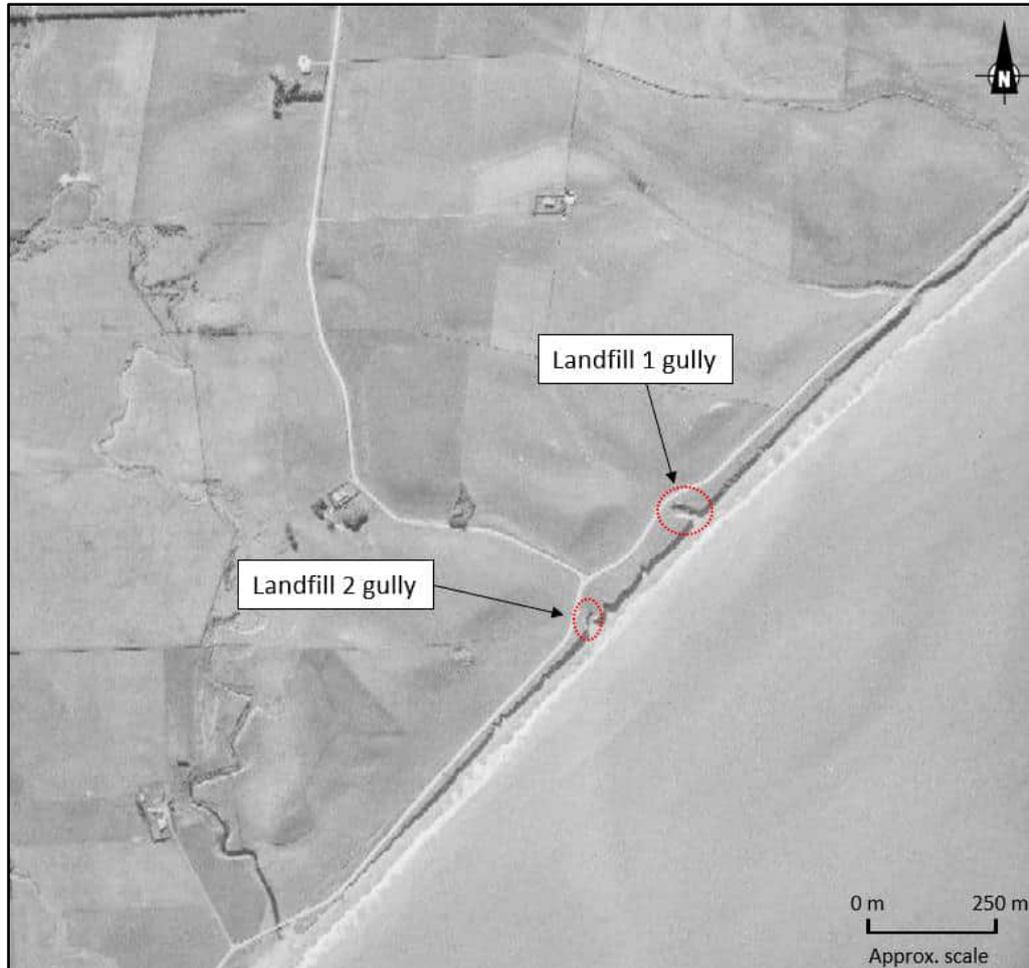
Figure 3 1955 Retrolens imagery illustrating the gully landforms prior to refuse filling.

Figure 3 below illustrates the extent and geometry of the two gullies prior to refuse filling.

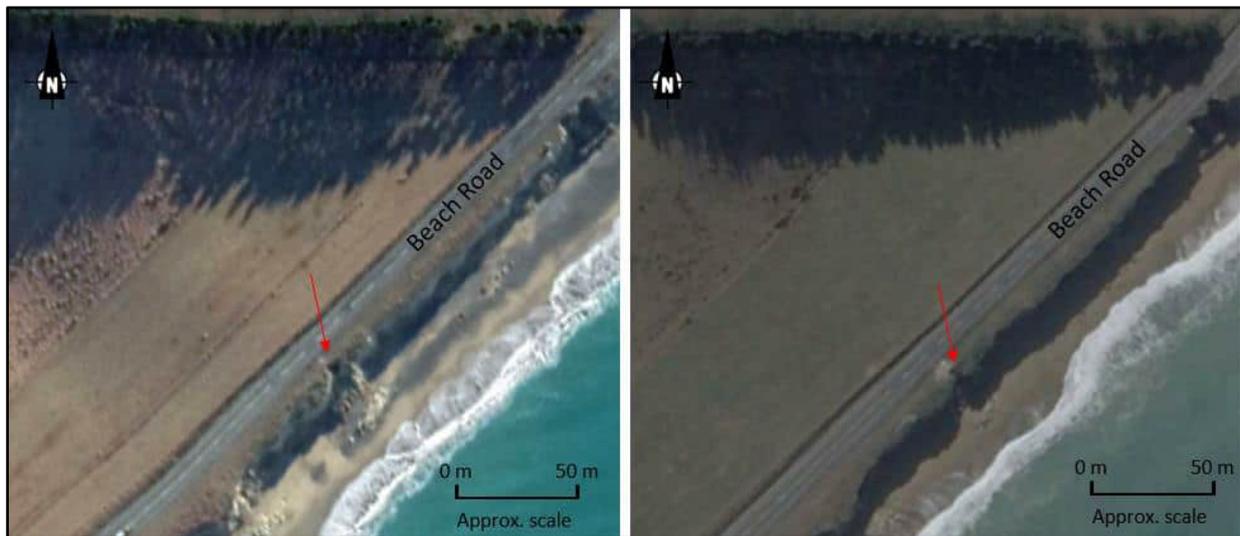
Figure 8 Left: Google Earth imagery dated July 2019 illustrating a natural gully with eroded material present on the beach. Right: Google Earth imagery dated August 2019 illustrating the same gully with most of the material on the beach washed away by wave action. Gully indicated by red arrow.

During the site visit it was noted that some of these eroded areas along the irregular cliff have been exacerbated by surface water runoff particularly in unvegetated areas.

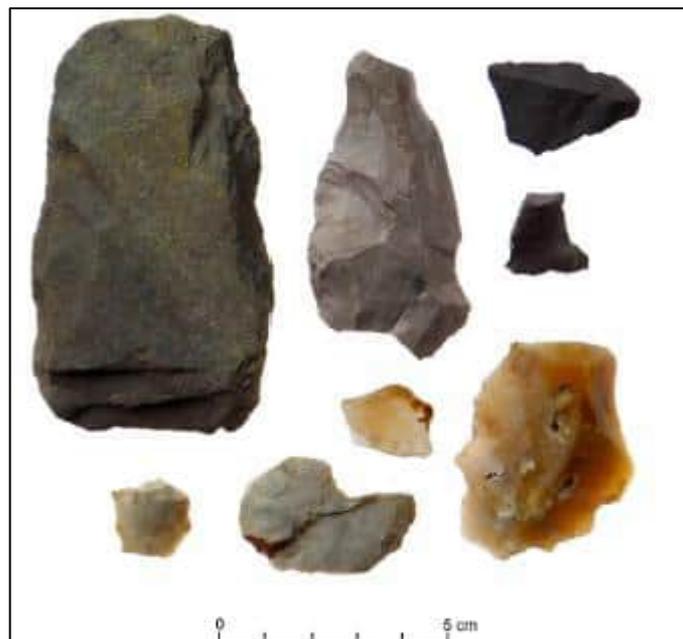
Figure 2-4. Lithics recovered from Site J42/210 in 2020 (Trotter, 2020).

At Hampden Beach, just north of the project area, small excavations were undertaken by Michael Trotter in 1965-7. The excavations uncovered what is believed to be a moa-hunter site that is estimated to extent over one hectare in area, with moa, bird, and fish bones as well as silcrete blades and basalt flakes uncovered (New Zealand Archaeological Association, 2020). Four previously recorded archaeological sites, J42/31 and J42/209-11, are situated between approximately 300-500m north of the project area (see Figure 2-1), and in 2020, these sites were again investigated by Trotter (2020). Trotter notes that although these sites have been previously damaged, there is reasonable cause to suspect that occupational deposits remain *in situ* westwards in the dune system. This theory is reinforced by the presence of artefacts, notably lithics (Figure 2-4), slowly eroding onto the surface in this area.

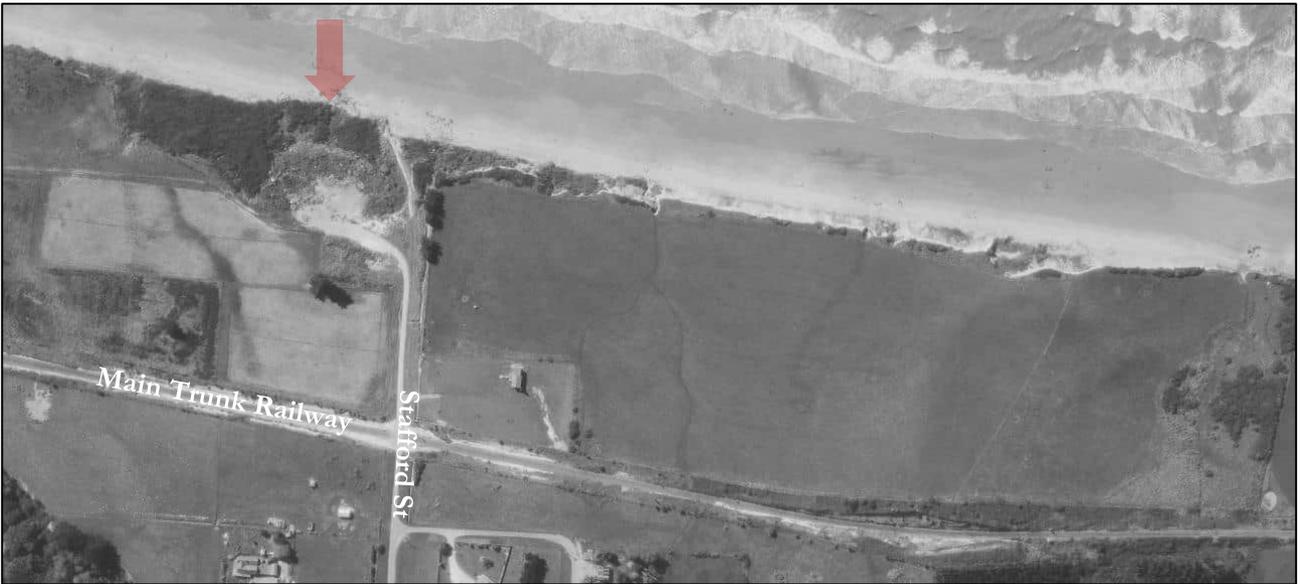
Figure 2-8. Late-twentieth century aerial photograph with the project area indicated (LINZ, 1987).

and telegraph station. and five boarding houses (Muirhead, 1990). By 1905, Hampden was described as a ‘pleasantly situated borough on the main line of railway... Hampden, as a progressive borough, has done much to beautify the district, and bathing sheds have been erected on the beach for the free use of residents and visitors’ (Cyclopedia Company Limited, 1905). Established gardens and fences can also be seen around the town in two 1907 photographs (see Figure 2-6 and Figure 2-7). However, these photographs do not show any such structures or modifications in the vicinity of the proposed project area. The Hampden landfill commenced accepting waste around 1970, and closed on 16 December 1996, having buried around 33,000m³ of Municipal Solid Waste (Waitaki District Council, 2021). An aerial photograph from 1987 (Figure 2-8) clearly shows the landfill and surrounding disturbance to the dune system.

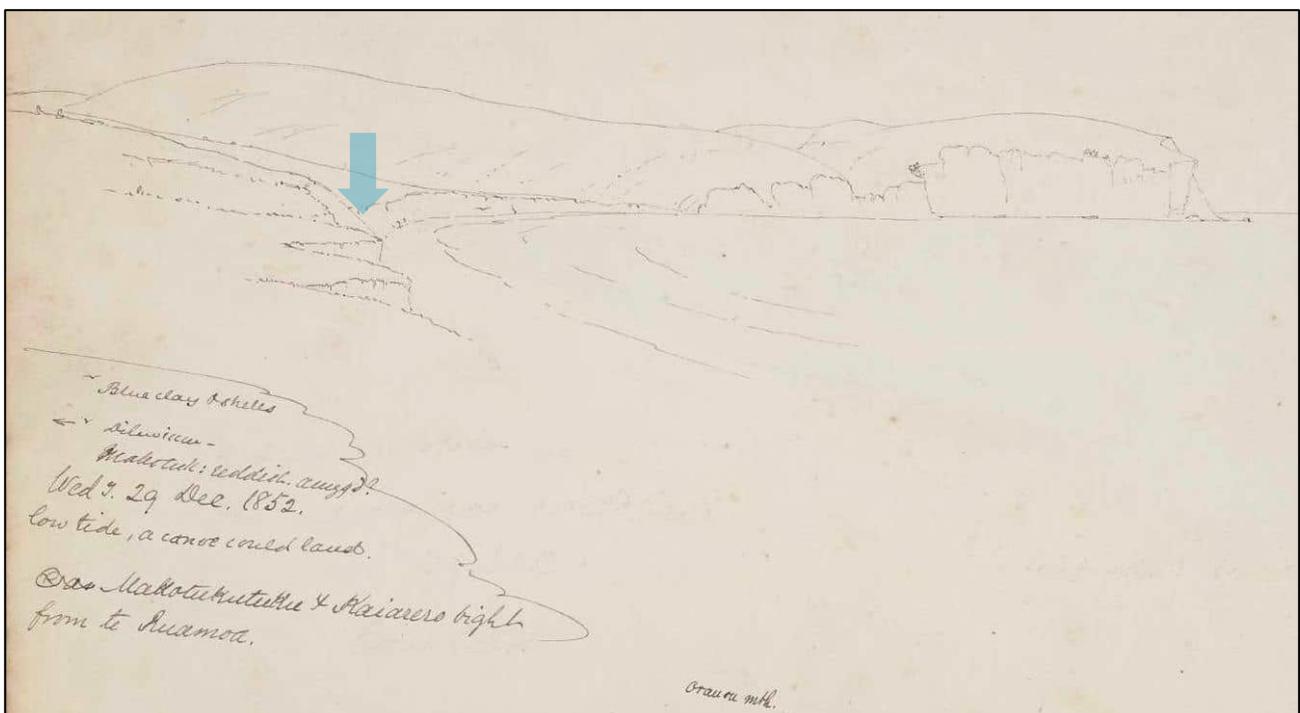
Figure 3-2. Sketch of the landscape north of Awamoa, looking towards Maktuktuku (Cape Wanbrow) with the approximate location of the project area indicated (Mantell, 1852).

Along the coastline to the north of the proposed project area (see Figure 3-2), there are clusters of archaeological sites, classified as midden/oven site types, largely relating to early and contact period lifeways activities. Although these sites have been recorded, they have not been systematically investigated. Archaeological investigations have focused instead on the early settlement of North Otago which was centred around settlements established at the mouth of the Waitaki River, the Awamoko River, and in Moeraki (Shaw, 1995). Occupation between these areas of more permanent settlement appears to have been sporadic with seasonal hunting and gathering activities likely forming part of the lifeways systems of Māori along Te Tai-o-Ārai-te-uru (Shaw, 1995).

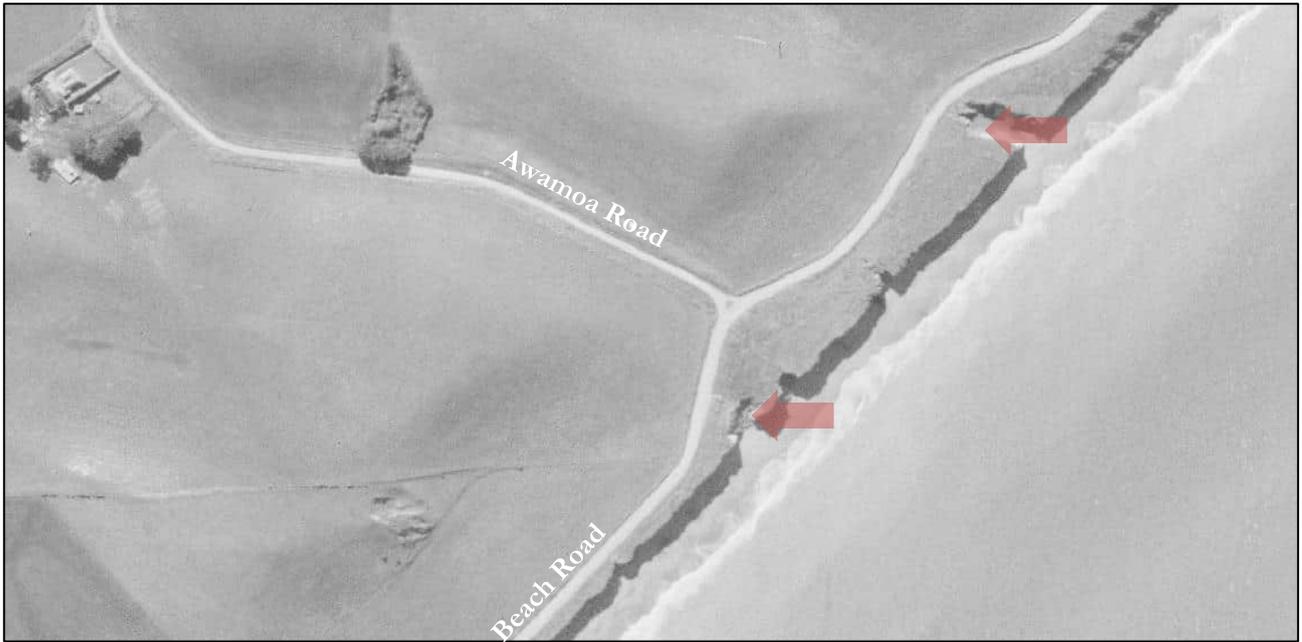
Figure 3-6. Mid-twentieth century aerial photograph with the project areas indicated (LINZ, 1955).

The proposed project area, situated to the east of the intersection of Awamoa and Beach Roads, was utilised by the public, with no involvement from the WDC, as *ad hoc* dump sites from the 1940s (see Figure 3-5) until ~1975 (Baddiley, 2020). Aerial photographs from the mid-twentieth do not show any structures or significant anthropogenic modifications, aside from pasture establishment and road construction, to the wider coastal landscape (Figure 3-6).

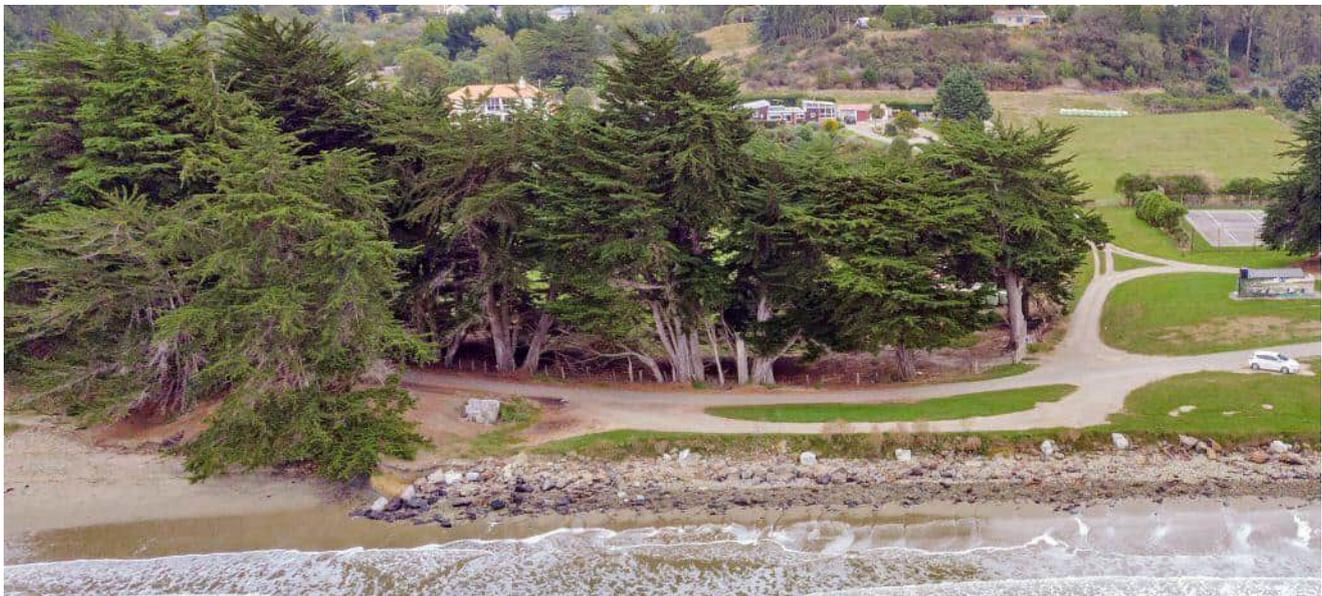
Further information came from field observations. Erosion of a beach bank caused by a storm with high seas in 1957 revealed an occupational deposit near the southern end of the main beach. (The above photograph shows the area in 2020 with a considerable amount of rock placed along the beach bank to inhibit further erosion.)
