Beach Road Landfills Remediation

Assessment of Environmental Effects

Client: Waitaki District Council

AECOM New Zealand Limited

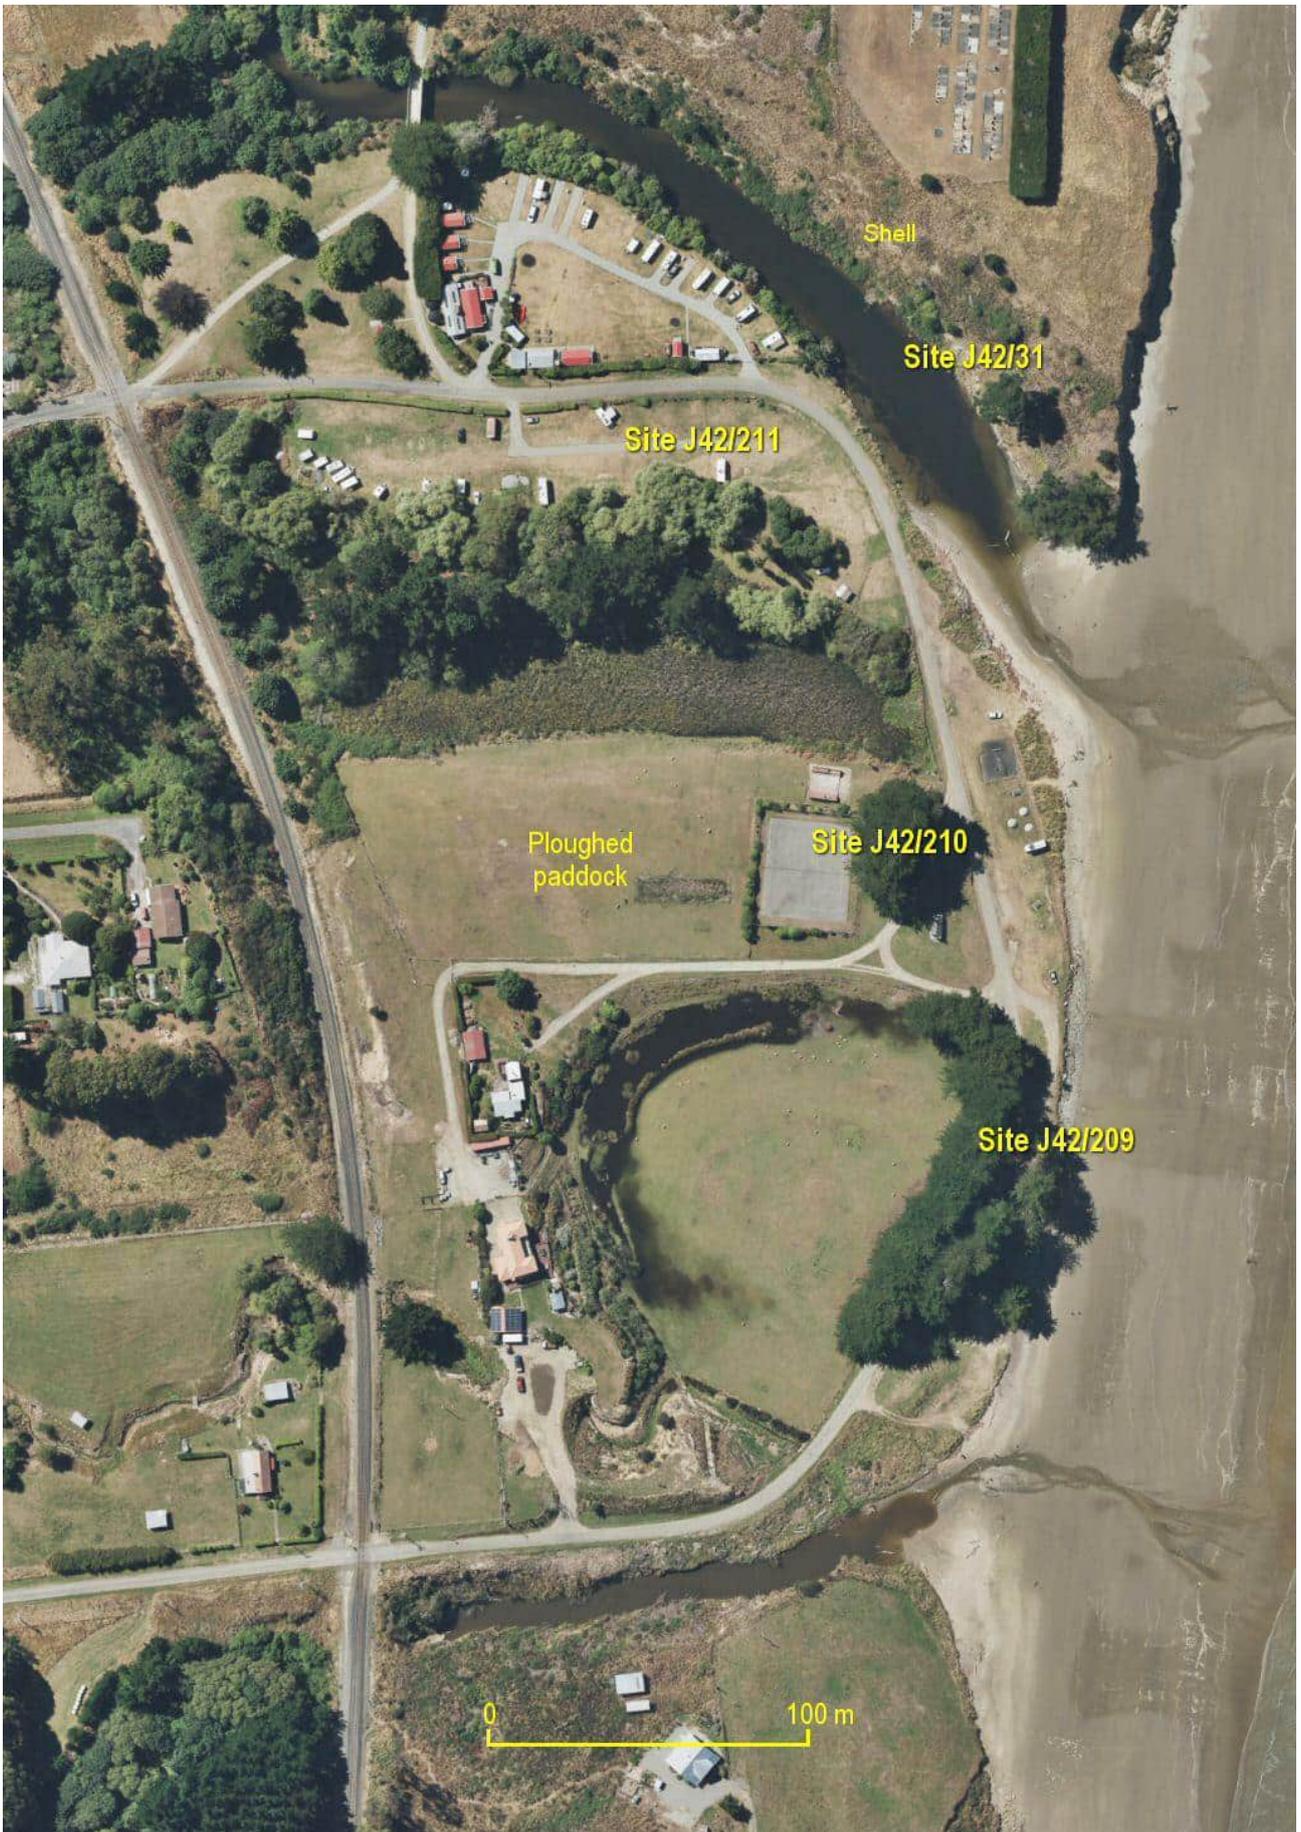
Aerial mapping photograph showing locations of recorded archaeological sites at Hampden Beach in 2020. Earlier aerial photographs show a pond directly north of the ploughed paddock, and swampy ground in the low-lying area adjacent to site J42/209.

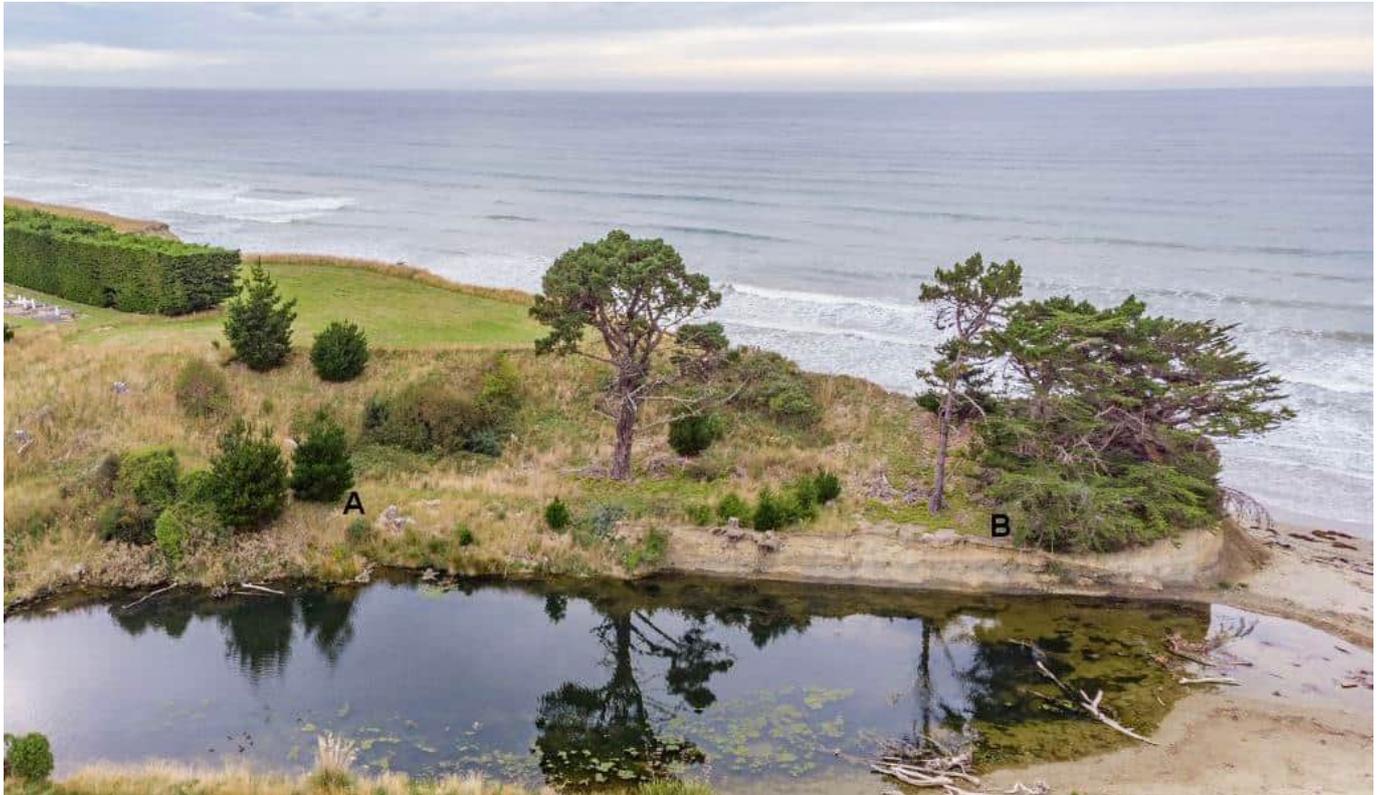
As the above 2020 photograph of the site shows, it is very different today from the pine plantation covered area of the 1950s and 60s. Back then there was some occupational evidence – sometimes sparse – between the points A and B, a distance of at least fifty metres, and the occupational deposit could be seen as a layer in the eroding creek bank to the right of A, where there is now redeposited soil. (The area where the excavations were carried out was a little to the right of A.)

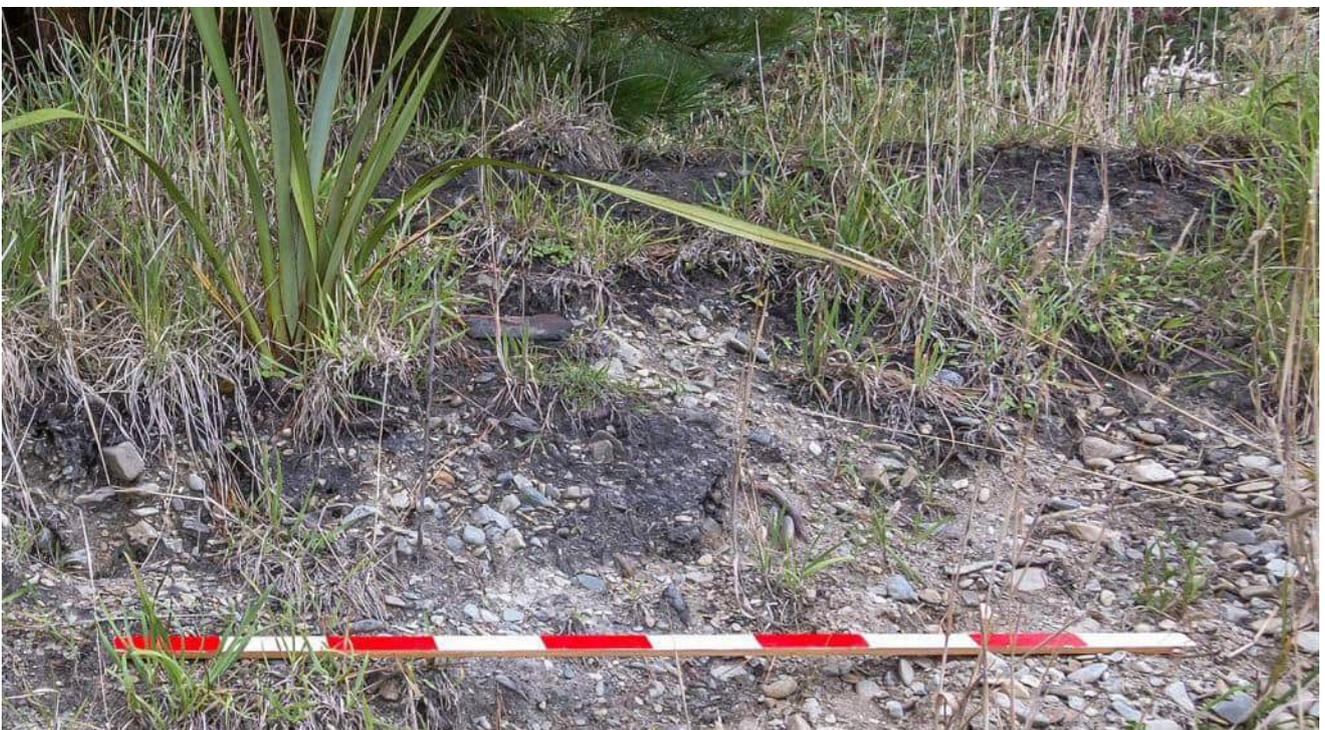
When the trees were harvested some years ago the ground appears to have been windrowed and a lot of topsoil bulldozed off the surface taking most of the site with it. In 2020 there were some stumps, piles of waste branches and roots, with the ground covered with grass and weeds, plus some wilding pines. The scraped up soil had probably been pushed over the edge of the bank to be washed away by the Big Kuri when in flood. All that could be found on inspection was some disturbed occupational material in the eroding bank near point A – photograph below with a metre long scale.
