# Water Services Delivery Plan

Waitaki District Council

9 June 2026

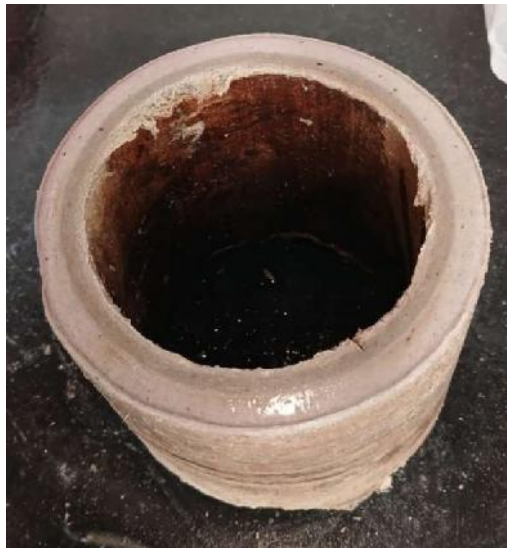
Fig 1: represents pipe asset ID WFROU857B

**Results:** No change in colour was observed for pipe wall thickness as shown in Fig 1.  
The pipe has experienced through-thickness deterioration.

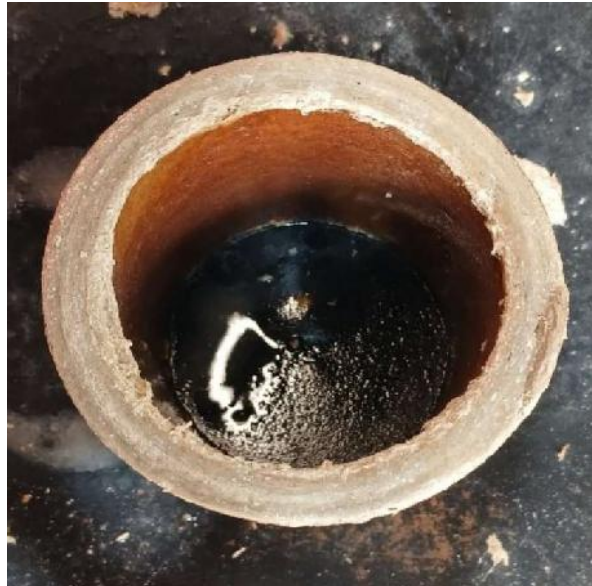
Fig 1: represents pipe asset ID WNHOM205

**Test:** Phenolphthalein test on asbestos cement pipes.  
**Equipment:** Digital callipers: Mitutoyo S/N 05662947  
**Sample Prep:** Hand polish with 120 grit sandpaper.  
**Pipe Dimensions:** Nominal OD: 96mm  
**Results:** No change in colour was observed for pipe wall thickness as shown in Fig 1.  
The pipe has experienced through-thickness deterioration.

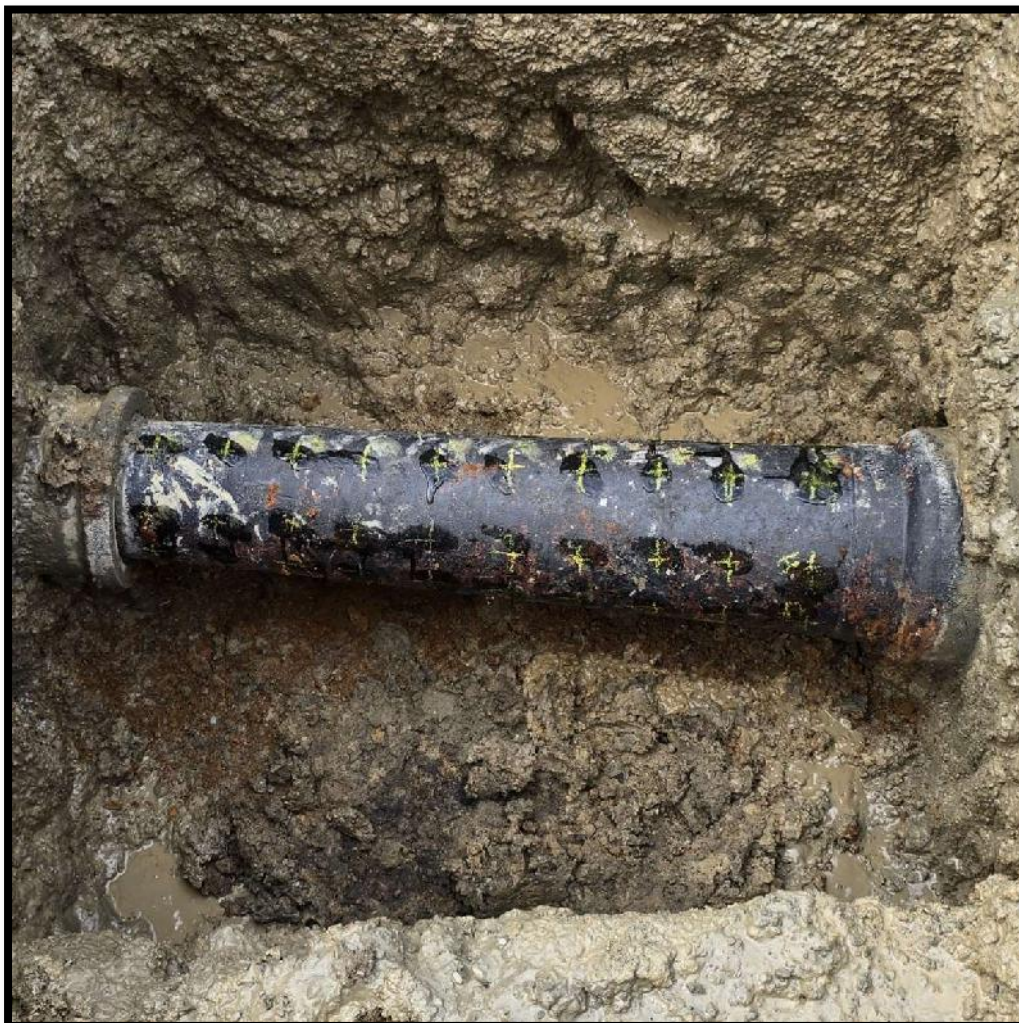
Grid size used on pipework is 100x100mm
