# **SUMPTER WHARF OAMARU CONSERVATION REPORT**

Structural Assessment of Sumpter Wharf Oamaru  
For the NZ Historic Places Trust, North Otago Branch

**SUMPTER WHARF  
INSPECTION REPORT**

September 2011

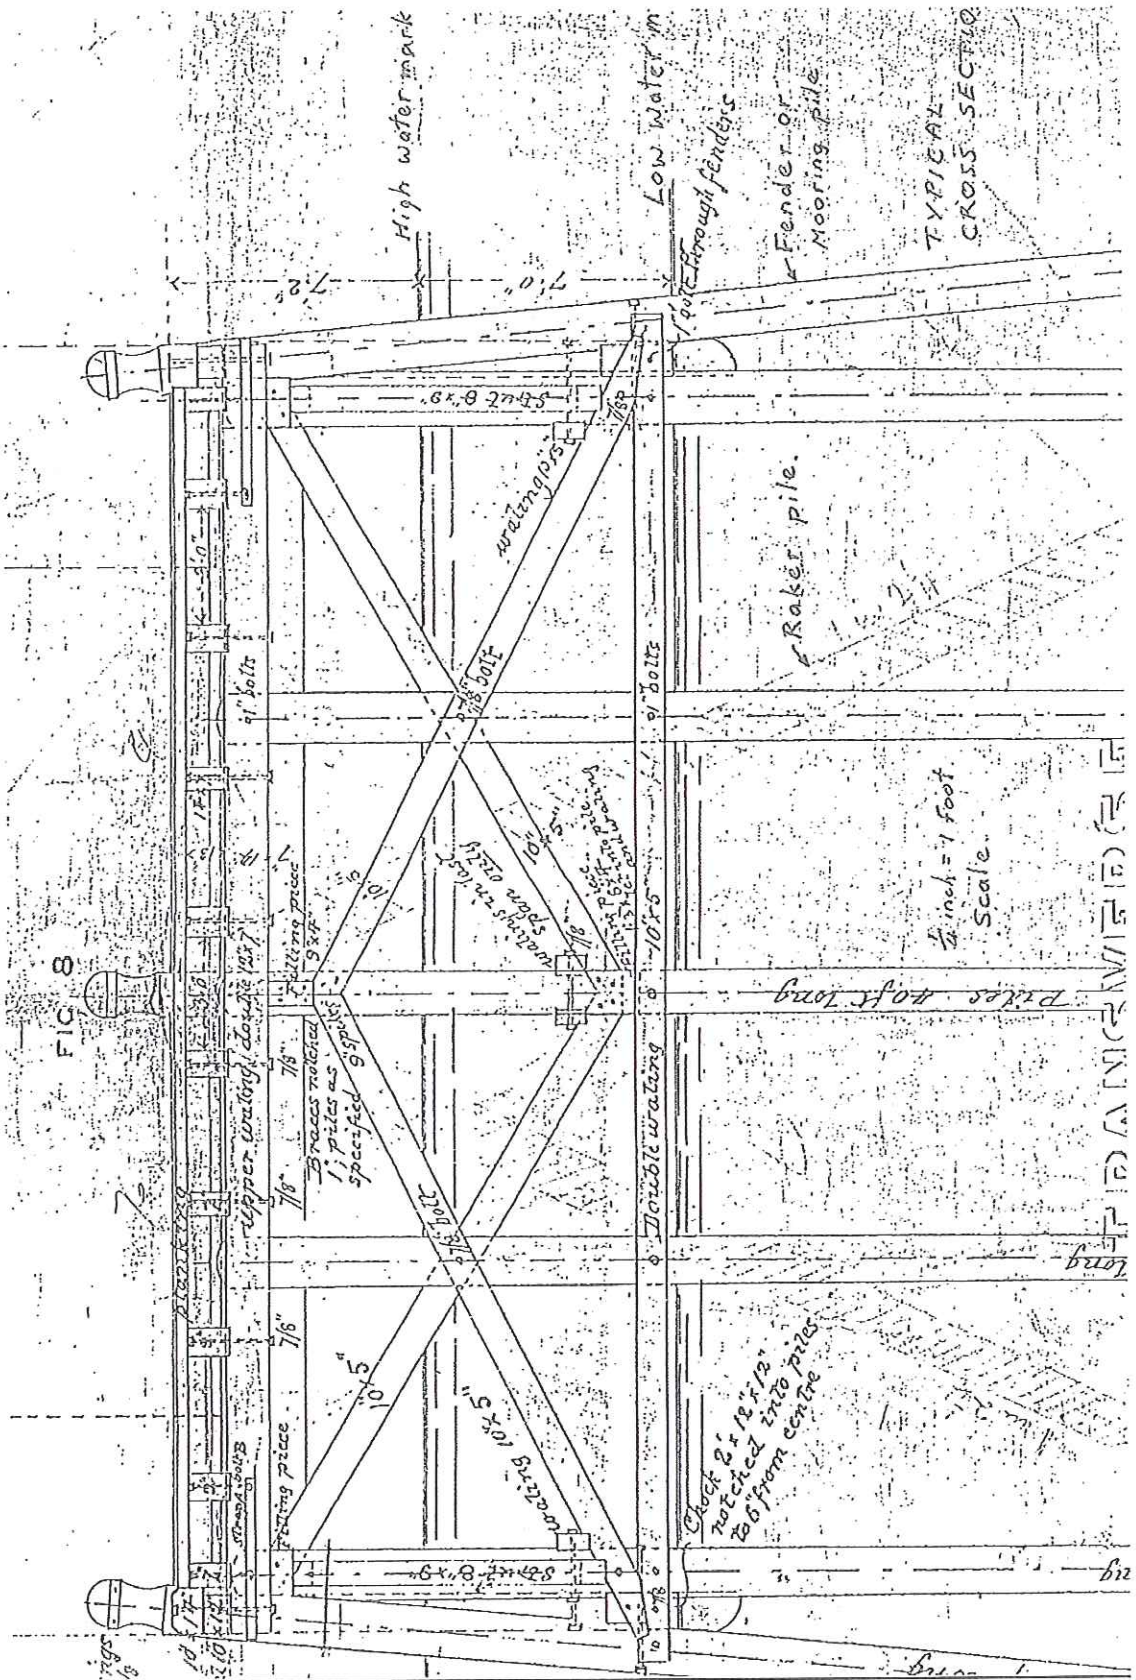
As can be seen in the photo illustrations, the diagonal bracing has deteriorated very badly from the half tide mark downwards. The marine borers *Limnoria* and *Bankia* do not survive long out of seawater and their attack is focused on the timber between half tide and just below low water.

As with all older wharves, the bracing bolt holes through timber and piles appear to be the starting point of borer attack and decay.

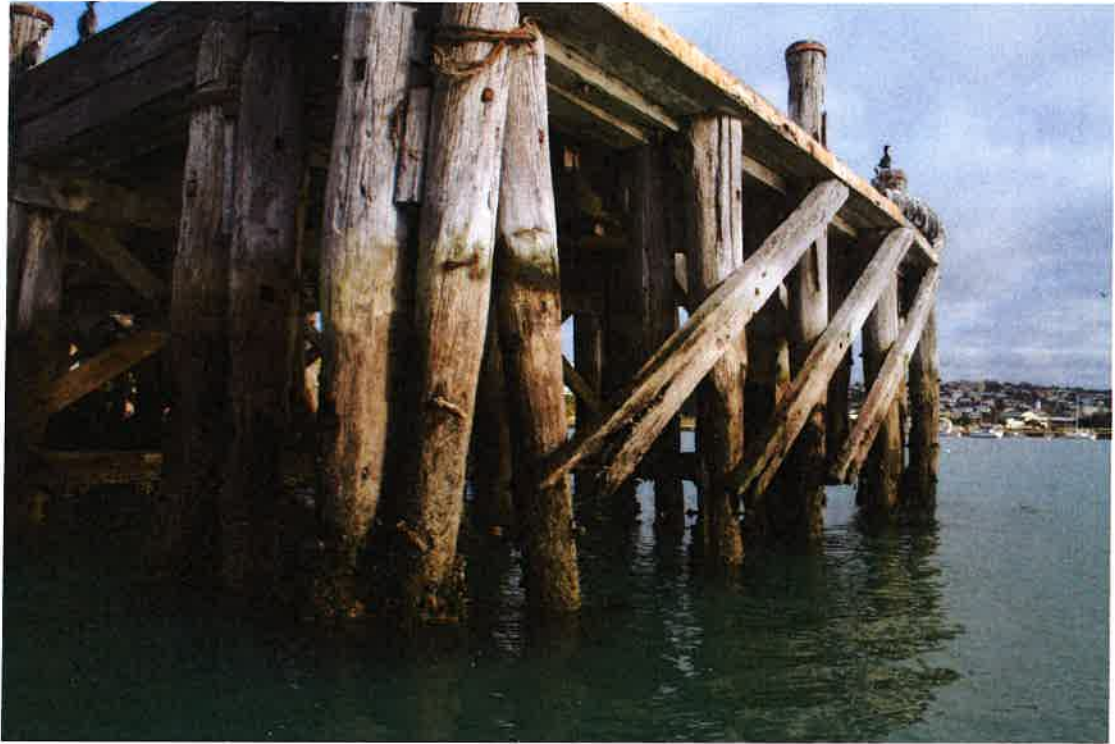
The wharf is currently in a very dilapidated condition and has been so for some time. While from a distance - cover photograph - the wharf looks in relatively good condition considering its age, the original form has been preserved, closer inspection - Photograph No 1 - shows that it is in a precarious condition principally due to the condition of the piles at low tide level. The original design life of the wharf would have been of the order of 50 years, it is now close to 130 years old. While it is no longer capable of taking load and has been fenced off to the public its distinctive form remains. In its current state vessels are not allowed to berth alongside it and it has become a roosting area for hundreds of shags. The deck is carpeted with pebbles regurgitated by the shags and the shag guano has accelerated deterioration of the deck timbers.

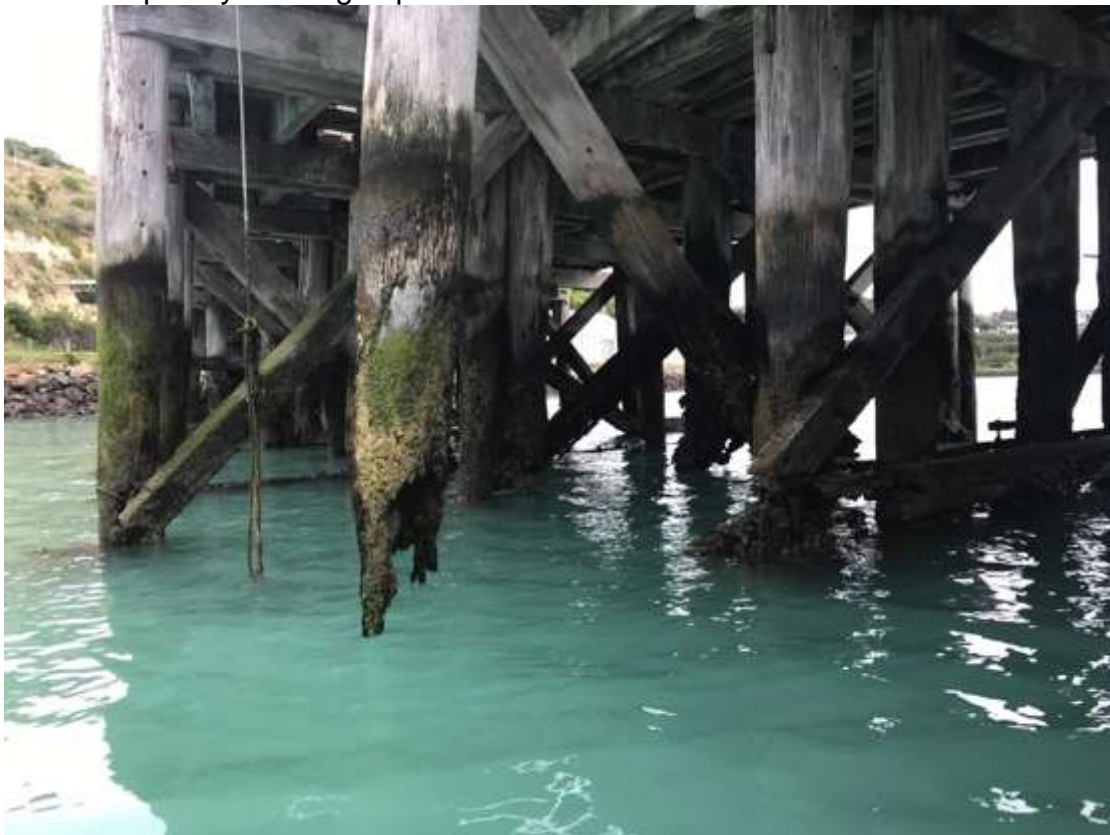
Piles completely missing in parts
